**SAS Superstructure**

**Daily Diary Report by Bid Item**

Contract No.: 04-0120F4

04-0120F4  
04-SF-80-13.2/13.9  
Self-Anchored  
Suspension Bridge

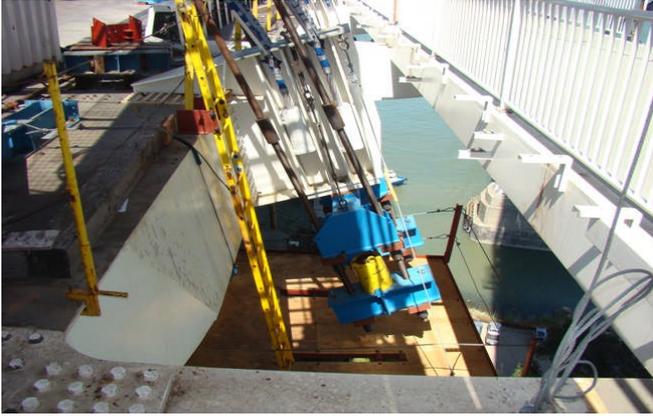
Jacking bracket for the suspender ropes at cable band 10E looking east.

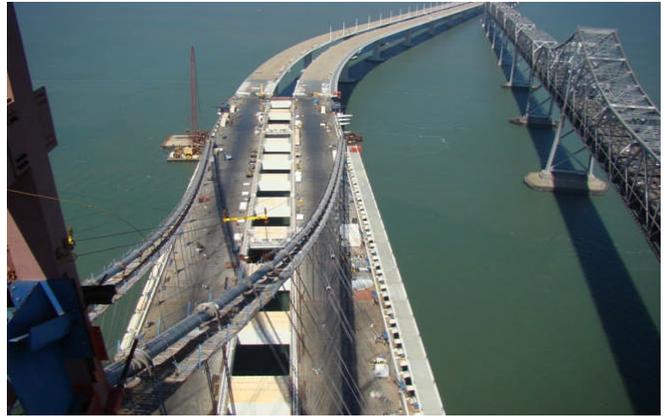
View of the east end of the SAS looking east where ABF surveyors had identified and spray painted orange OBG centerline points.

- Continued to assess placing new control points on the tower saddle and shear link beams to monitor the tower during load transfer. While working on this preplan I had noticed that ABF surveyors had identified and spray painted orange the OBG centerline points. I plan to also survey the OBG centerlines before load transfer, however the cradles for OBG lifts 13 and 14 must be fully released essentially making the east end a cantilever from the E2 cap beam.
