SAS Superstructure

Daily Diary Report by Bid Item

Diary #: 653 Const Calendar Day: 81 Date: 24-Aug-2012 Friday

04-0120F4
04-SF-80-13.2/13.9
Self-Anchored
Suspension Bridge

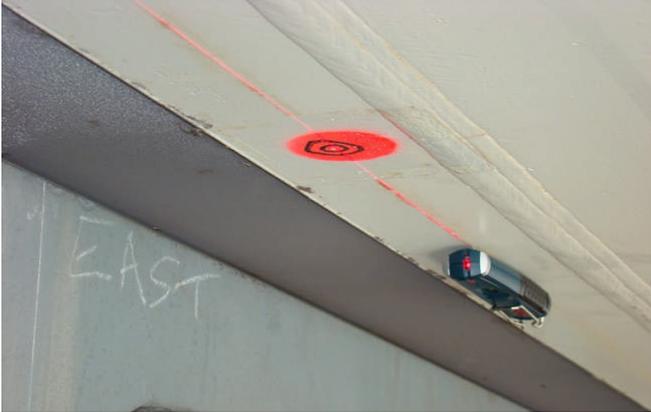
Laser level line projected through the China punchmarks backsighting the adjacent one for a reference line to measure from.

- Measured the local longitudinal dimensions of the Shear Keys and Bearings from 9:30am to 11:00am. A laser level was shot in between the 2.000m offset punchmarks placed on the underside (bottom plate) of the OBG in China, see photos below for more details.

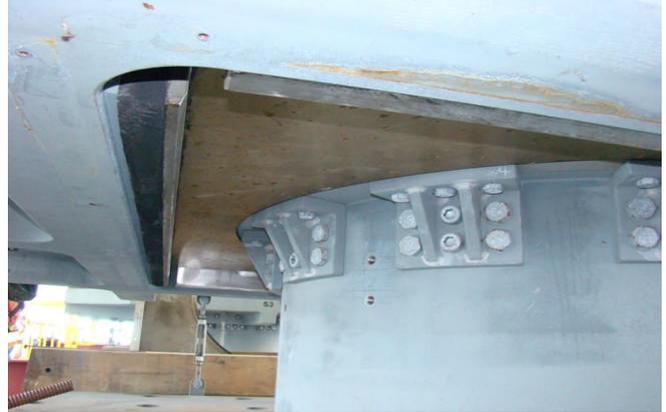
Exposed lower housing of Shear Key S4 looking north.

- Went to inspect the Shear Key lower housings with Bob Brignano at 1:00pm in response to RFI 3006R00. The dust covers were recently removed and orientation of these components was double checked. Also the vertical center of rotation of the spherical bearing of the Shear Key lower housing was inspected. Bob and myself began to devise ways of checking this critical structural element of the bridge. It should be noted that the center of movement for all eight components needs to be along the same plane to mitigate any eccentric loading of the Bearing and Shear Key components.

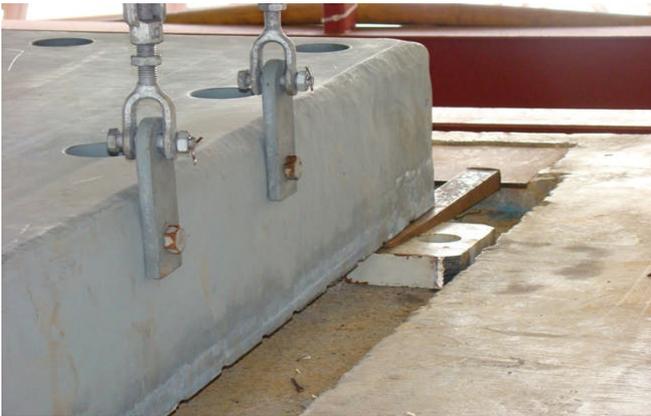
Shims placed to ensure no vertical displacement between the upper and lower housings of the Shear Keys to take out the dust covers.

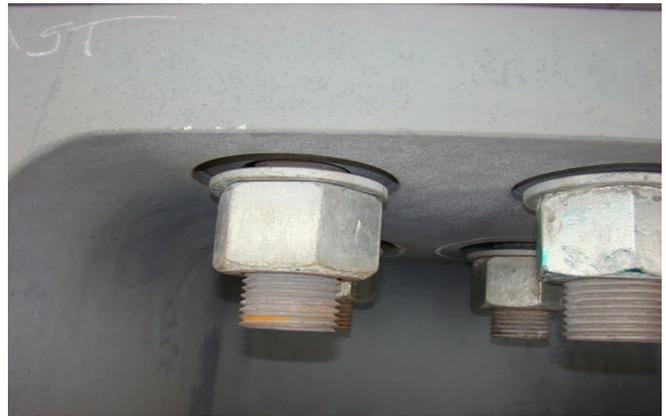
Loose bolts were seen in all of the Shear Key and Bearing upper housings while measuring.

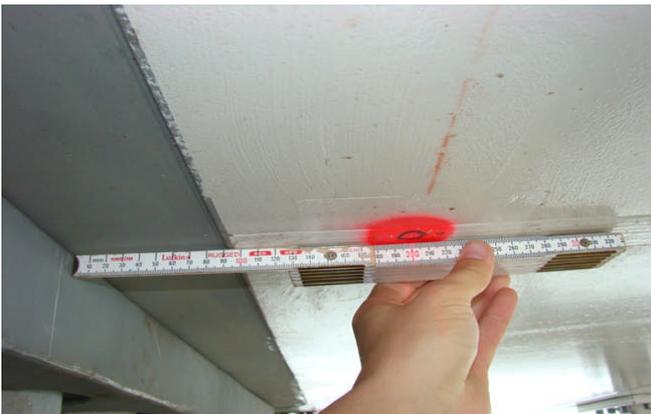
Typical longitudinal local measurement taken of the Shear Key and Bearing upper housing using the China 2.000m offset punchmarks.

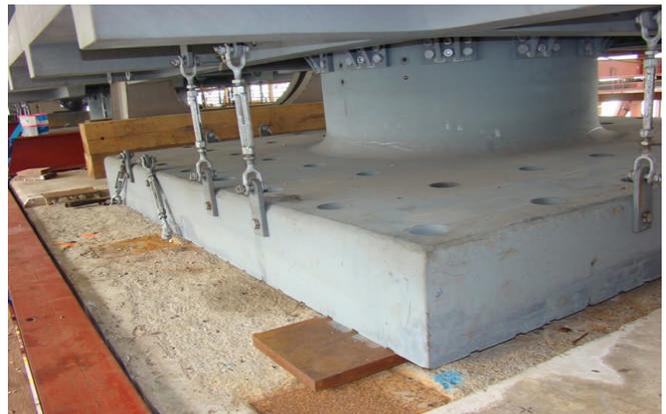
Shear Key S4 lower housing shown, notice the removal of the turnbuckles between the two components.
