SAS Superstructure

Daily Diary Report by Bid Item

Diary #: 662 Const Calendar Day: 94 Date: 06-Sep-2012 Thursday

04-0120F4
04-SF-80-13.2/13.9
Self-Anchored
Suspension Bridge

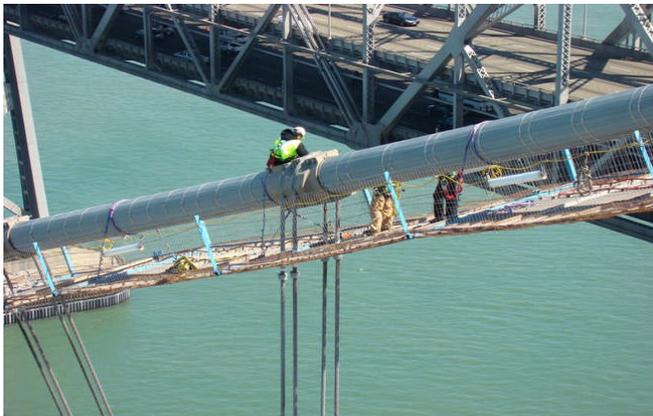
The ABF ironworkers were not in a hurry to stress cable band bolts today. Similarly the Smith Emery technicians responsible for measuring the cable band bolt elongations with the Extensometer were taking multiple breaks on the South Mainspan catwalk.

Smith Emery consultants seen taking one of their many breaks during the shift.

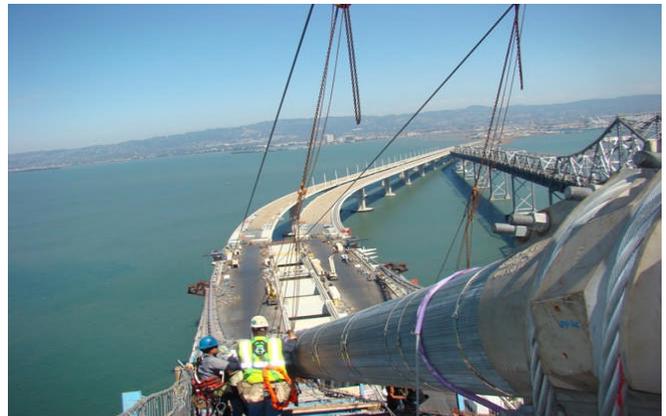
The equipment storage bins are scraping the cable zinc coating when mobilizing to a new cable band due to the current highline position.
