Daily Diary Report by Bid Item

Contract No.: 04-0120F4

04-0120F4
 04-SF-80-13.2/13.9
 Self-Anchored
 Suspension Bridge

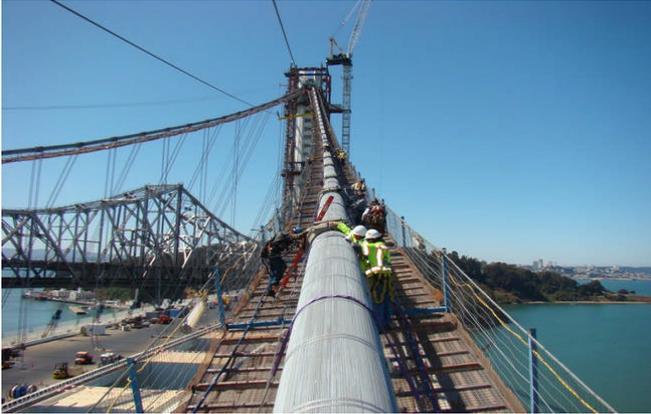
ABF ironworker crews and Caltrans engineers working on the North Mainspan cable band bolt stressing.

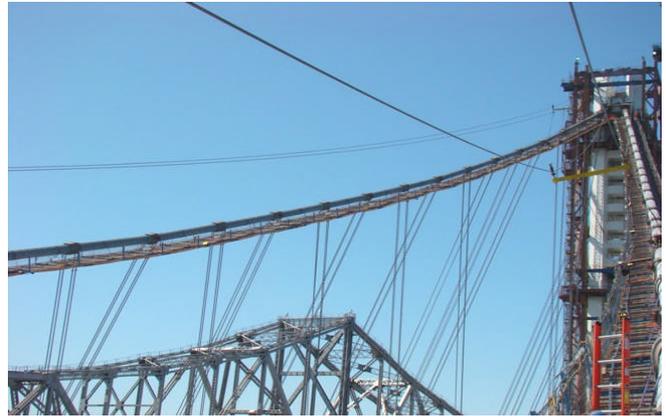
The pronounced kinks seen in the South Mainspan cable as Phase 1 of load transfer is in progress pulling this cable down and to the south.

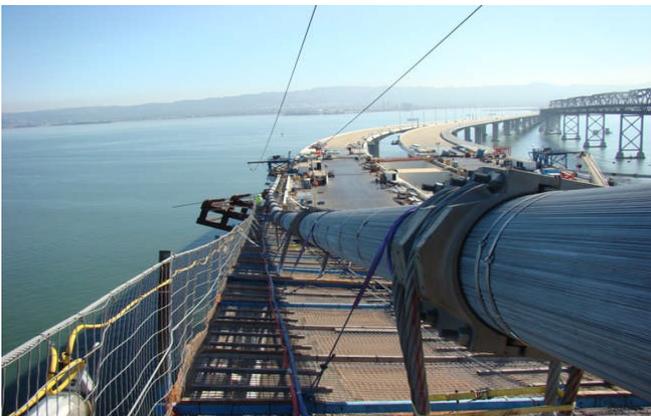
The pronounced kinks seen in the North Mainspan cable as Phase 1 of load transfer is in progress pulling this cable down and to the north.

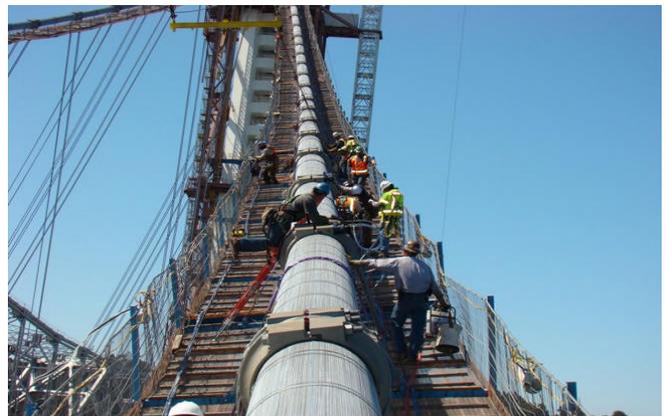
ABF ironworker crews and Caltrans engineers working on the North Mainspan cable band bolt stressing.
