SAS Superstructure

Daily Diary Report by Bid Item

Diary #: 676 Const Calendar Day: 112 Date: 24-Sep-2012 Monday

04-0120F4
04-SF-80-13.2/13.9
Self-Anchored
Suspension Bridge

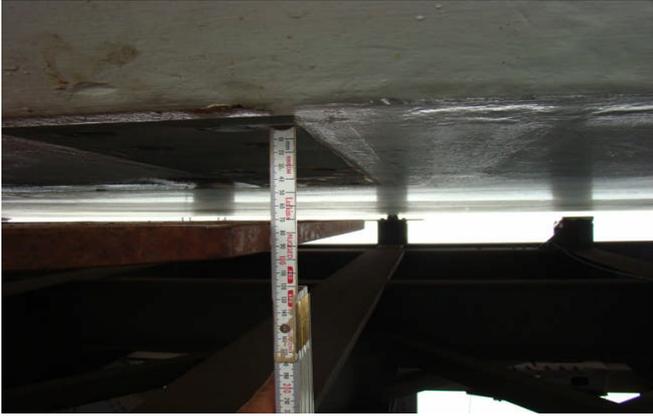
Measurement of 73mm taken from the top of the seismic shear plate to the bottom of OBG lift 8E in the northwest corner.

- Inspected the cradles on the temporary trusses since the OBG is supposed to lift off of the support near the current stages of load transfer. The inspection and measurements were done from 9:40am to 10:30am which is when Step 7b of Phase 1 load transfer was in progress. Below are the following measurements taken on the cradle seismic shear plates from the top surface to the bottom plate of the OBG:

All measurements above were started on the northeast cradle seismic shear plate progressing in a counterclockwise direction. It should be noted that throughout the day the conditions at the cradles changed as Steps 6a South to 11a North were completed during the 12hr shift.

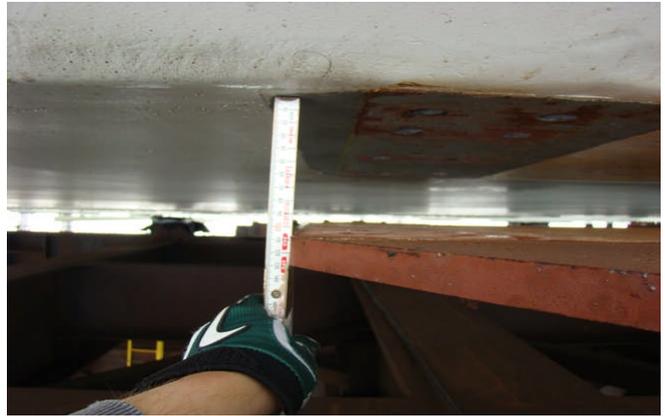
Measurement of 108mm taken from the top of the seismic shear plate to the bottom of OBG lift 10W in the northeast corner.

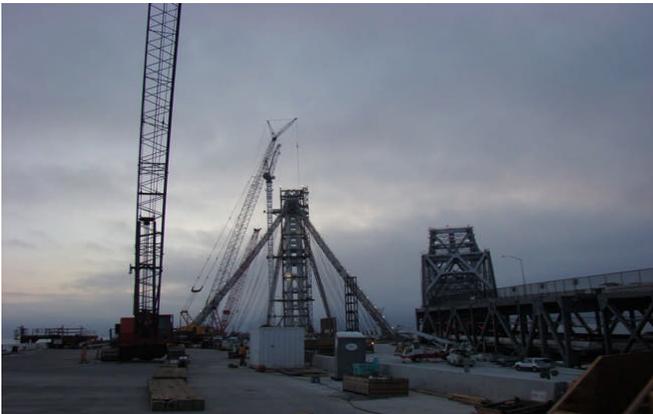
Conditions after surveying the tower tie-back release deflection distance from the YBITS W-Line bridge.

- Surveyed the tower before the start of shift where the current deflection was 95mm to the west. The theoretical deflection of the tower tie back system at this point of load transfer is supposed to be 122mm to the West. The total distance that the tower has moved/been release since load transfer began is 430mm to the East of plumb. The survey was done at the end of Step 6a North, with work continuing this morning on Step 6a South.

The survey was done under uniform ambient conditions where the time of survey (taking shots on the tower) was conducted from 6:55am to 7:10am. The official time of sunrise per weather.com was 7:00am. The ambient temperature during the survey was 54F under cloudy skies. The wind speed was measured from the south southwest direction at 4mph with a barometric pressure of 29.95"Hg.

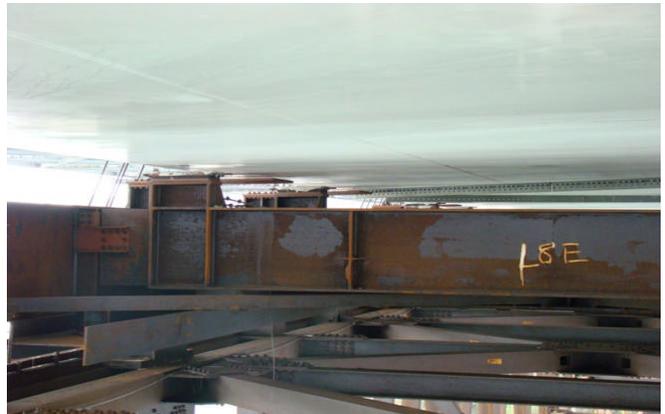
OBG lift 8E seen off of the single cradle looking west.
