SAS Superstructure

Daily Diary Report by Bid Item

Diary #: 690 Const Calendar Day: 128 Date: 10-Oct-2012 Wednesday

04-0120F4
04-SF-80-13.2/13.9
Self-Anchored
Suspension Bridge

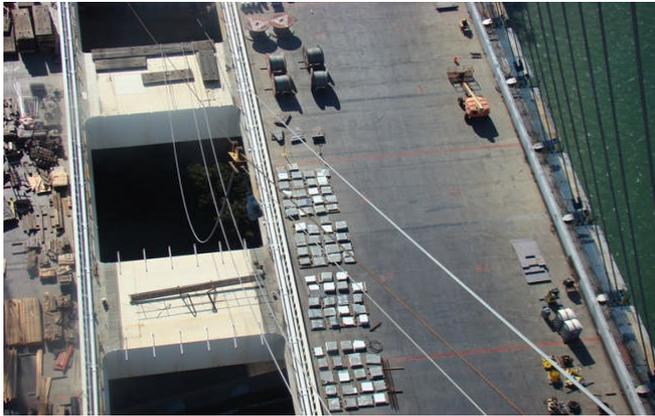
Tower tie back cable in the process of being coiled around the spool on the ground guided from the pulley system seen in the photo

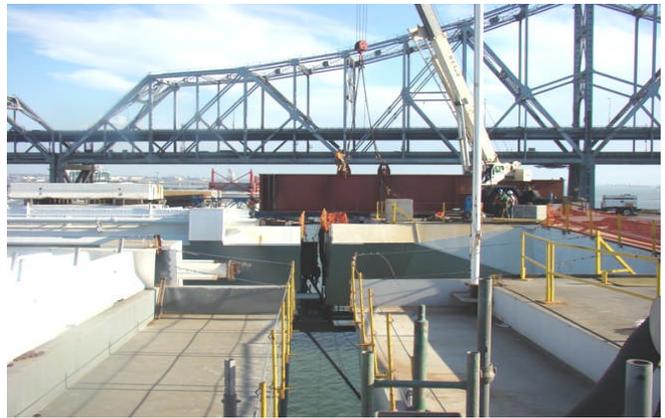
Strongback system being installed on the E-Line SAS and Skyway OBG deck sections for alignment.
