SAS Superstructure

Daily Diary Report by Bid Item

04-0120F4
04-SF-80-13.2/13.9
Self-Anchored
Suspension Bridge

04-0120F4 Bid Item: 067 C-PWS-WCS.067 Wrap Cable System
AMERICAN BRIDGE/FLUOR, A JV

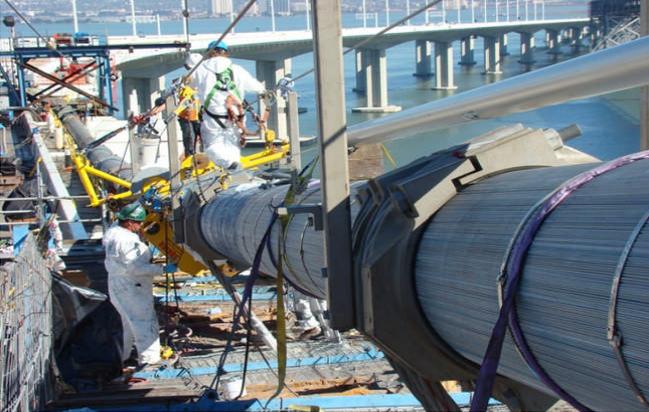
ABF ironworker crews on the South Mainspan in the process of wrapping the main cable with S-wire.

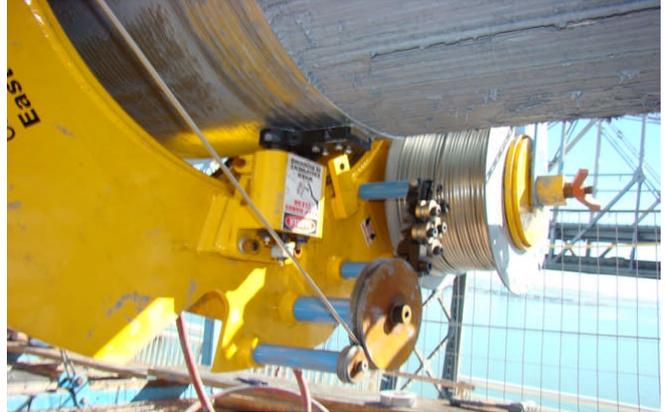
When the but splice was finally completed, wrapping began at 11:45am. The wrapping machine had a difficult time placing the S-wire into the grooves while revolving around the main cable. S-wires were seen being underlapped and overlapped (see photo below) due to the instability of the wrapping machine. The ironworkers had to use come-alongs in addition to applying a tension to pull the machine ranging from 360lbs to 680lbs. Once a S-wire was seen not going into the previous wire groove, the operation was stopped to correct the seating of the S-wire grooves. Approximately 2ft or less of the main cable in this location was wrapped today. Laborers placed a protective plastic cover over the areas where zinc paste

S-wire overlap not in the grooves while spinning the wrapping wire around the cable which is an issue the ironworkers struggled with all day.

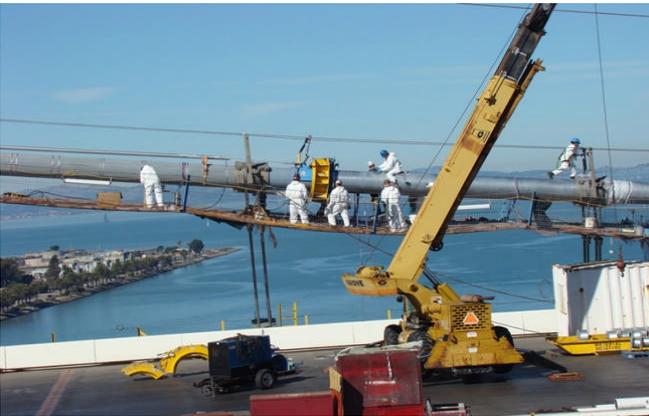
ABF ironworker crews on the North Mainspan in the process of wrapping the main cable with S-wire.

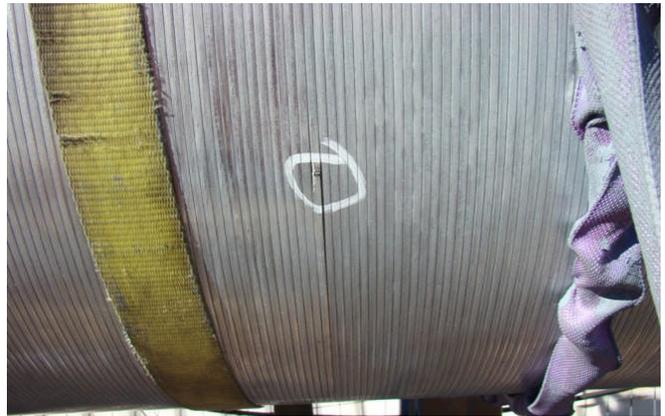
Once the wrapping machine with the attachments pointed in the uphill direction was installed, the next order of work was to splice the S-wire before proceeding with wrapping. It took approximately 1hr to complete 2 but splices due to this crew of ironworkers inexperience of performing the microweld. ABF engineer Ben Jones was present to assist the crew with technical issues.

Microweld but splice of two S-wires seen on the South Mainspan cable in between cable bands 102 and 100.
