SAS Superstructure

Daily Diary Report by Bid Item

Contract No.: 04-0120F4

04-0120F4
04-SF-80-13.2/13.9
Self-Anchored
Suspension Bridge

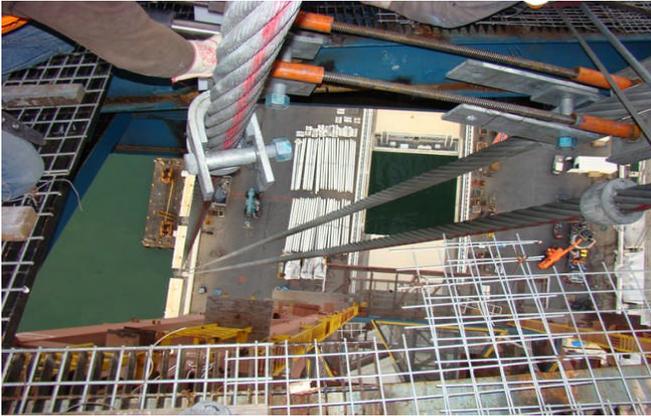
Looking down through the hole in the tower catwalk support frame to the OBG while installing the suspender clamp on 44N-Downhill.

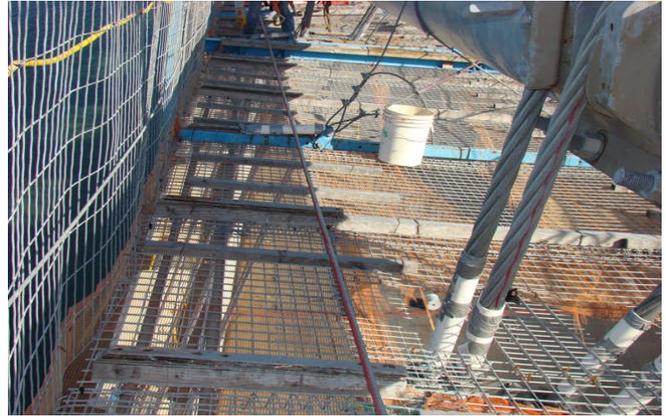
Messenger cable being protected by PVC pipe on the catwalk while being hoisted and dragged uphill by the highline spreader beam winch.

Ethan Kent, Jose Alfaro, and Thomas Cervantes worked on the South Sidespan today where they draped the messenger cable from each handrope post while loosely installing the U-bolt/nuts or crosby clips to the stanchion post support bracket. Also it should be noted that Tony Costa's crew hauled the two messenger cables for the North Mainspan up the catwalk today. Myself and Doug Wright performed the inspection of this operation to ensure that the cable wasn't damaged during the hauling with the highline spreader beam winch and dragging the cable on the catwalk. See the photos below and Doug's diary for more details on

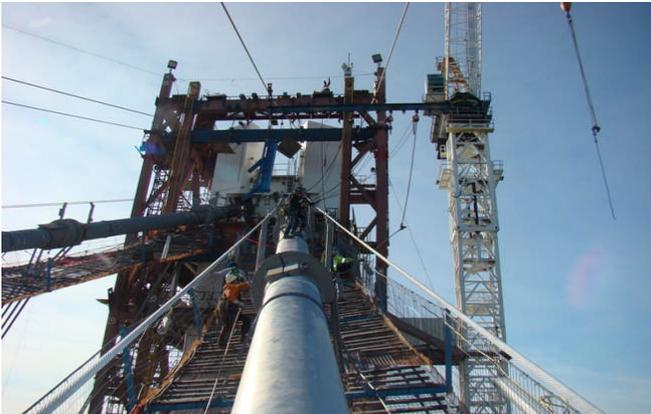
ABF ironworkers seen hoisting the messenger cables for the North Mainspan uphill by the highline spreader beam.

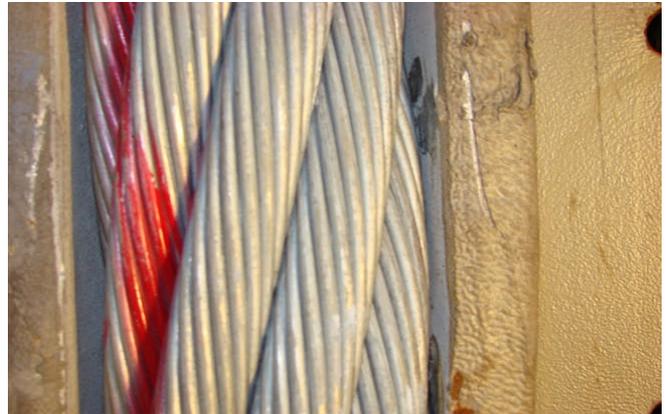
Diary: Dispute
Work description. 067 C-SUS-SCC.067
- ABF ironworkers Stanley Dalie, Rene Esquivel, and Carlos Alverado completed installing the two suspender rope clamps on the North Mainspan today at panel points 48N, 46N, and 44N. There was no significant issues related with this operation today. However it was discovered that a few Phase 2 cable bands on both cables some superficial damage was done to the suspender rope groove paint, see photo below for more details and comments.

Suspender rope on the outboard side of cable band 46S where paint was scrapped off of the inside suspender rope groove presumably due to clamp install
