SAS Superstructure

Daily Diary Report by Bid Item

04-0120F4
04-SF-80-13.2/13.9
Self-Anchored
Suspension Bridge

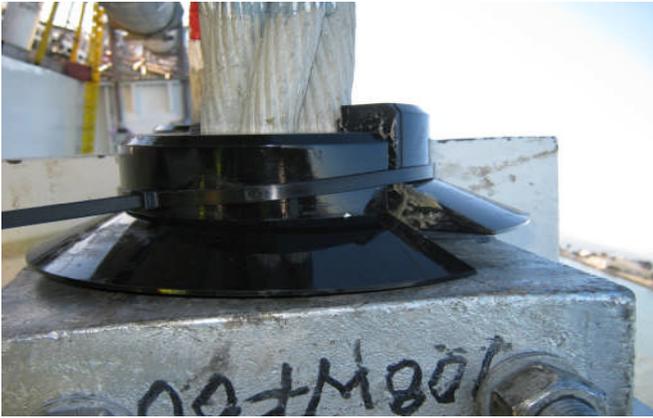
- The load was transferred from the temporary load transfer rods to the suspender ropes.
- The elastomeric collars were installed.
- The front halves of the split collars were installed.
- Note: When the split collars compressed against the elastomeric collars, there was separation between the halves of the elastomeric collars. See attached photo. The suspender ropes at this PP want to push against one half of the collar more than the other half of the collar, which causes additional squeezing & stretching of that half of the elastomeric collar. They made 2 attempts at the installation of these collars, with similar results.
- The load transfer jacking equipment was removed.
- The suspender anchor rods were tensioned up to 16,400 psi with the bolt-tight tensioners. After the anchor rods were tensioned, the jam nuts were installed on the anchor rods.

Separation of elastomeric collar at PP 108N (east-outboard)
