SAS Superstructure

Daily Diary Report by Bid Item

04-0120F4
04-SF-80-13.2/13.9
Self-Anchored
Suspension Bridge

04-0120F4 Bid Item: 034 X-W2C-GTT.034 E-W Line Cross Over W2 Cap Stress & Grout Transverse Tendons

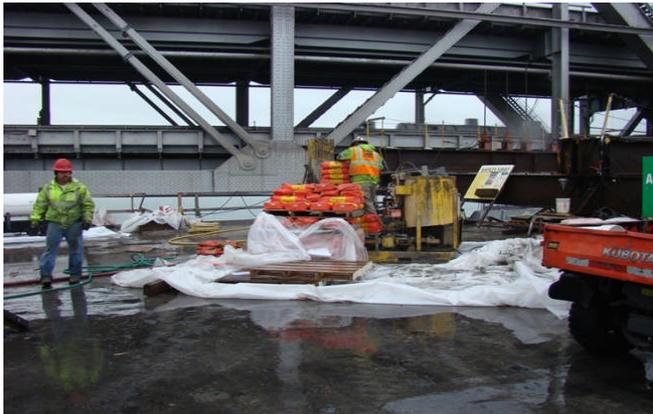
Different grout pump onsite today mobilized in the same location as the one yesterday.

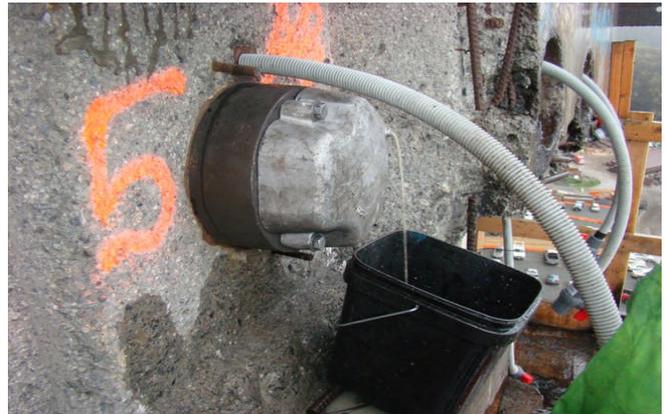
While grouting CBT-9 it was observed that residual water from the water jetting operation was pushed out of the grout cap and grout tube. The SDI ironworker waited until a good stream of grout was flowing out of the cap and tube before sealing the connection to pressure the tendon full of grout. Finally the only other event out of the ordinary was that CBT-5 had to be grouted twice due to SDI not filling up the dead end pipe sleeve on the north end of the W2 cap beam prior to closing the grout tube valve.

Residual water from the water jetting operation being pushed out of the grout cap on the north end of CBT-9.
