**SAS Superstructure**

**Daily Diary Report by Bid Item**

Contract No.: 04-0120F4

04-0120F4  
04-SF-80-13.2/13.9  
Self-Anchored  
Suspension Bridge

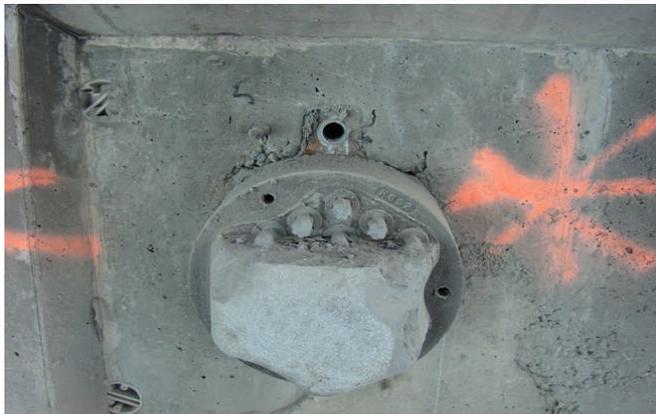
Close up of broken grout on the anchorage of CBT-9 south.

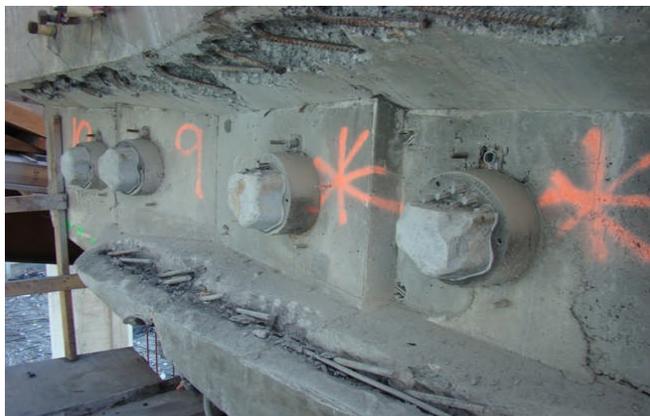
- Checked the exposed grout on the anchorheads of transverse tendons CBT-1 to 10 since SDI ironworkers removed the caps this morning, see photos below for more details and comments.

Removed caps on the south side of the W2 cap beam where some of the consolidated grout broke off while removing the caps, CBT-1, 5, 9, and 10 seen.

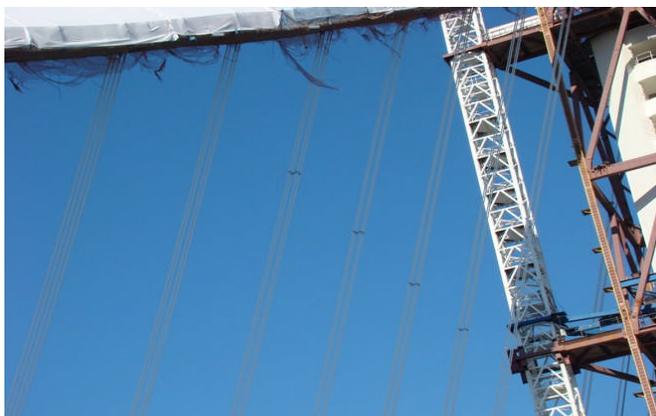
Installed suspender rope separators on the north side of the bridge near the tower.

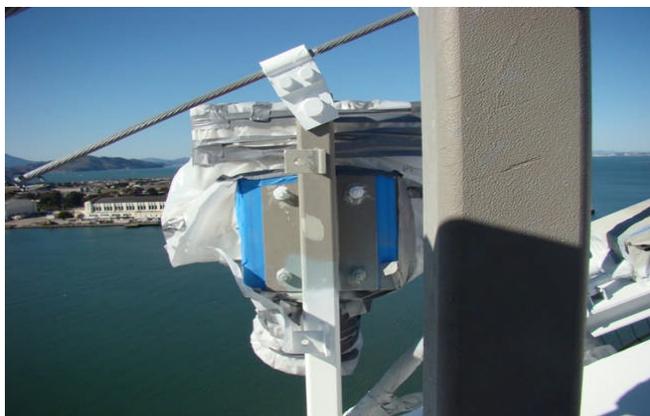
- Took measurements for the cable security gate per the request of Rob Kobal at panel point 12N. Previously the painters were painting the main cable in this area at the time of the initial request, therefore preventing proper access to the cable band for taking measurements. Similar to the three other cable bands (12S, 96S, and 96N) the 2 measurements performed were angle/actual slope of the cable band and the side to side distance of the cable band, see photos below for more details.

Observed offset of the stanchion posts at panel point 12N while measuring the side to side distance between the two posts.
