SAS Superstructure

Daily Diary Report by Bid Item

Diary #: 527 Const Calendar Day: 307 Date: 07-Apr-2013 Sunday

04-0120F4
04-SF-80-13.2/13.9
Self-Anchored
Suspension Bridge

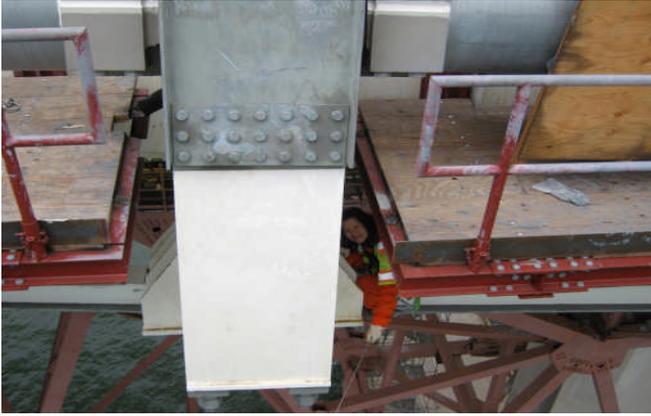
- From 11:00 until 12:30, Laraine & I inspected the A354 Grade BD rods in the B14 cable brackets at PPs 112N, PP 114N, PP 116N, PP 112S, PP 114S, & PP 116S. The following items were checked on each of the B14 rods: 1) a visual inspection to see if the bearing nut had separated from the bearing plate on both the top & bottom nuts of the rod (Note: the bottom nut visual inspection was with inspection mirrors); 2) a hands on inspection to see if the nuts were loose on the top of the rod (the bottom nuts on the rods were inaccessible for a hands on inspection; & 3) a general visual inspection to look for any damage or rust on the rods. All of the rods appeared OK

Laraine checking the bottom nut on the B14 anchor rods at PP 116S with an inspection mirror
