SAS Superstructure

Daily Diary Report by Bid Item

Diary #: 874 Const Calendar Day: 406 Date: 15-Jul-2013 Monday

04-0120F4
04-SF-80-13.2/13.9
Self-Anchored
Suspension Bridge

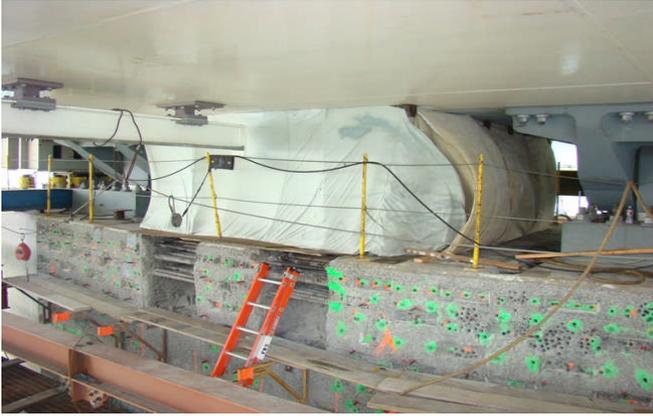
Containment set up for painting the S1 Shear Key lower base after machining.

Also informed ABF engineers Levi Gatsos and Adam Reeve about protecting the lower portion of the S1 and S2 Shear Key housings during painting operations. Jeff in METS was also informed about this issue to be resolved with CCC painters prior to starting the operation.

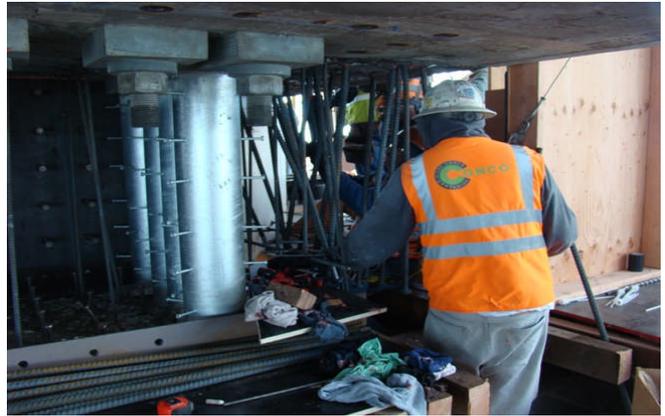
Conco carpenters installing headed #25 rebar dowels at the southeast corner of the S1 Shear Key retrofit.

- See Pamela Gagnier's diary for the S1/S2 Shear Key modification work today as she is tracking the labor, equipment, and work progress of Conco and ABFJV personnel. However I did inspect the installation of 19 #25 headed rebar dowels be placed in the vertical position from 12:30pm to 4:00pm (end of Conco shift). When I arrived per Pamela's request (she is responsible for this work) the drilled holes were covered with ducttape and presumably clean from any concrete dust. Hilti 500 epoxy was used and the amount of epoxy varied per hole from 30-50 pumps with the gun for any given drilled hole. The reason being is due to converged drilled holes. It should be noted that the Conco carpenters had to be the majority of the bars approximately 30 degrees to install into the drilled hole. See photos below for additional comments and progress of the retrofit work.

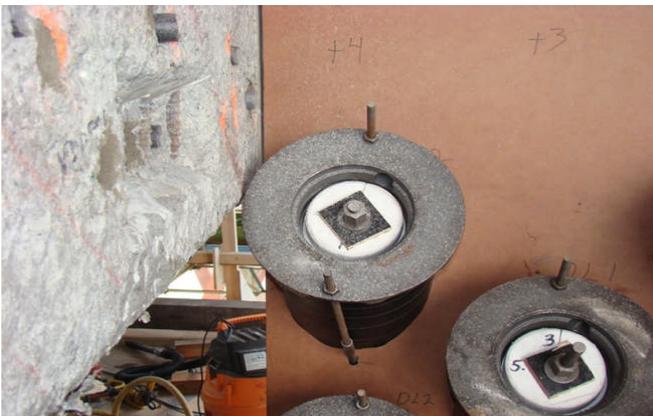
DL2 blockout with bearing plate placement adjacent to existing concrete on the S1 Shear Key southwest side.

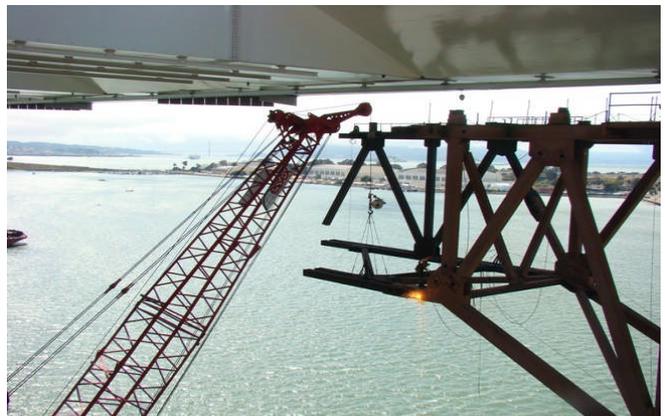
ABF ironworkers cutting more sections of the W-Line temporary truss near the E2 cap beam.
