Daily Diary Report by Bid Item

Contract No.: 04-0120F4

04-0120F4
 04-SF-80-13.2/13.9
 Self-Anchored
 Suspension Bridge

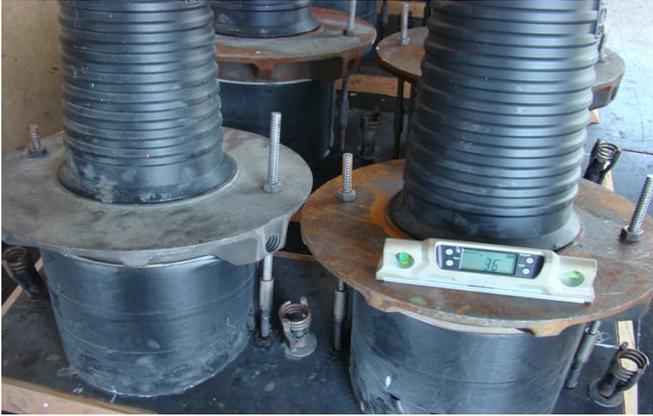
Transverse angle of the North A5 West S1 Shear Key retrofit Vertical PT tendon, also note the bearing plates touching each other.

Vertical Tendon bearing plate angles were measured per plan sheet 519S3 using a SMART level. The longitudinal spacing was measured with tree calipers using the bearing plate edges. Also the surveyed S1 Shear Key centerline on the east/west soffit was used to locate the transverse spacing of the Vertical tendons.

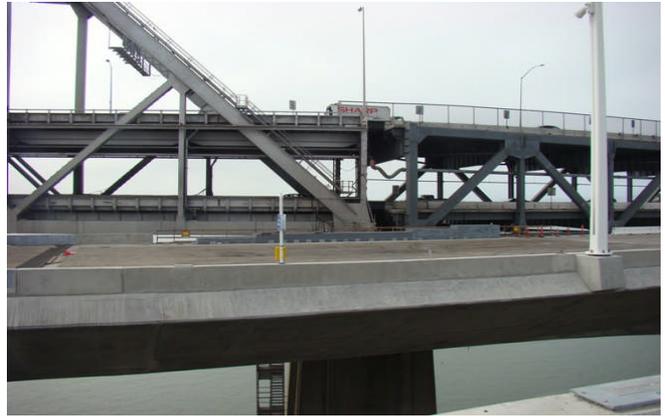
Steel plates used as a counterweight on the E-Line YBITS bridge near the Hinge KE joint for the bikepath.

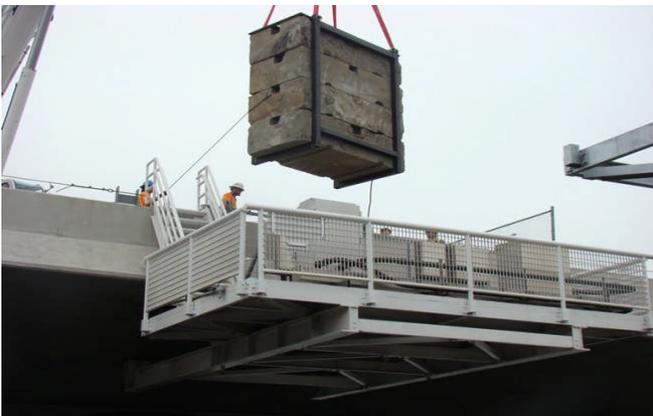
Concrete deadmen and support frame seen being hoisted onto the OTD Westbound support frame for a seismic load test of the concrete anchors.

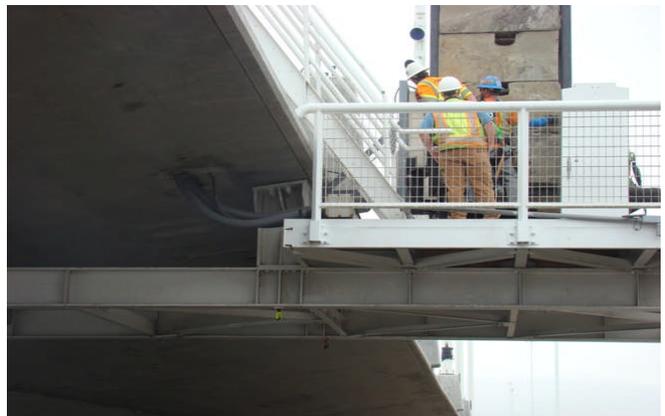
Location of the load on the platform, also note the location where Thanh Dickerson placed the mini prisms below the outboard support.

- Surveyed the two mini prisms set on the Westbound OTD service platform per the request of Gary Lai. The prisms were placed directly below the outboard supports to primarily monitor settlement of the platform as it is subjected to a load for multiple hours. The points were shot five times during the operation at the following times:

- 1.) 7:55am - check baseline measurements prior to loading
- 2.) 8:37am - after initial/partial load placed on the platform
- 3.) 9:00am - full load placed on the platform
- 4.) 12:55pm - check supports after a couple hours of loading
- 5.) 4:10pm - check supports after multiple hours of loading
