**Daily Diary Report by Bid Item**

Contract No.: 04-0120F4

04-0120F4  
 04-SF-80-13.2/13.9  
 Self-Anchored  
 Suspension Bridge

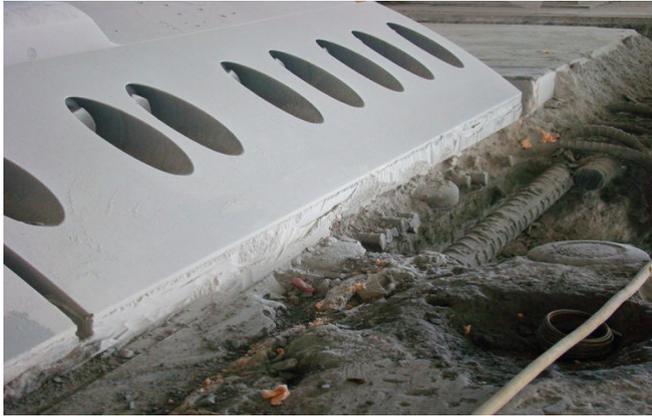
Stripped and cut section of grout from the S1 Shear Key retrofit grout pad placement done yesterday.

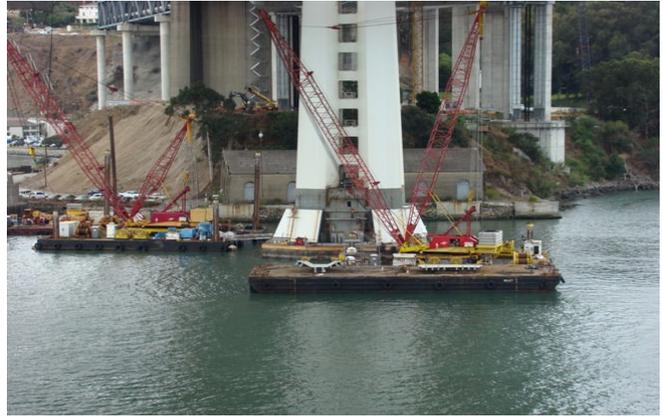
Progress of the T1 tower skirt seen from the E2 cap beam.

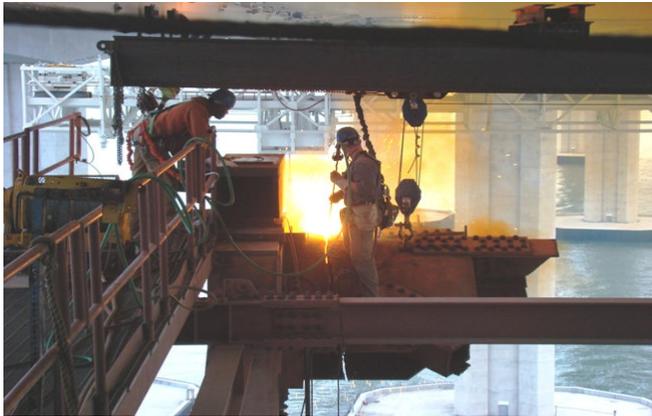
ABF ironworkers seen cutting a section of the W-Line truss for the S1 Shear Key retrofit saddle erection.

- ABF crews continued to work on the saddle retrofit erection beams attached to the bottom of the OBG, cut the temporary truss, etc. See Brian Wolcott's diary for ABF labor and equipment and Pamela Gagnier's diary for Concos labor and equipment.

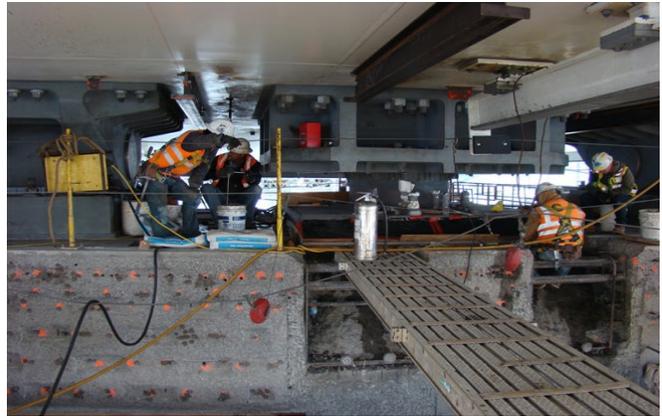
- Monitored the S2 Shear Key retrofit wedge plate grouting operation today. Conco laborers began mixing grout cement with water at 8:05am. ABF engineer Levi Gatsos was again in charge of this grouting operation today with Smith Emery technician Sal Moreno performing the QC tests on the fluid grout.

The ambient temperature at the time of the first batch of grout done in the shade was 58F. As a result the grout temperature of the first batch was 66F. The efflux time after Conco laborers mixed one bag of grout cement and water (1 gallon + 2 pints) was 36 seconds. Today Levi and the Conco laborers conceded that more water should be added to get closer to the manufacturers recommended efflux time. Smith Emery made 12 grout cubes for compressive strength tests and Caltrans made 3 total of the BASF Masterflow 928. Also it should be noted that the specific gravity of the grout was taken. The observed S.G for the first batch was 2.28, however the value was adjusted to 2.21 after calibrating the mud balance which yielded a value of 1.03.

The grout was placed from the low side to the high side and was tamped as well. Just like yesterday approximately 6 bags of Masterflow 928 were used for one side under the two wedge plates. There was a minor delay in the grouting operation due to ABF ironworkers completing cutting rebar for saddle installation on the west side of S2. Placement of grout for the S2 Shear Key retrofit wedge plates was completed at 9:45am. Today after the operation was complete wet rags instead of curing blankets were placed over the exposed grout surfaces.

S2 Shear Key retrofit wedge plate grouting operation seen from the E-Line temporary truss looking east
