Daily Diary Report by Bid Item

Contract No.: 04-0120F4

Diary #: 931 Const Calendar Day: 471 Date: 18-Sep-2013 Wednesday

04-0120F4
 04-SF-80-13.2/13.9
 Self-Anchored
 Suspension Bridge

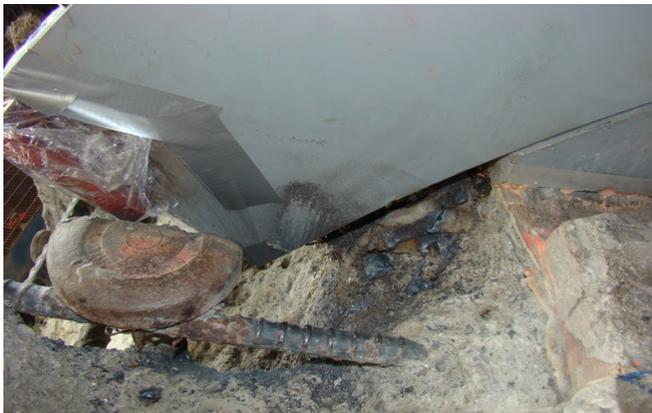
Cut rebar that slightly bound the S1 IB upper saddle segment in the SW corner from bearing completely on the lower base yesterday looking north.

- ABF crews readjusted the S1 Shear Key Inboard Upper saddle segment this morning after cutting some additional rebar, see photos below. Also Pamela got concurrence from TY-Lin designers for the drilled and tapped hole where ABF proposed to dye grind. See her diary for more details as she worked with ABF and the designers to resolve this issue. The rest of the day was spent housekeeping for the 10hr shift. See Brian Wolcott's diary for ABF labor and equipment and Pamela Gagnier's diary for Concos labor and equipment.

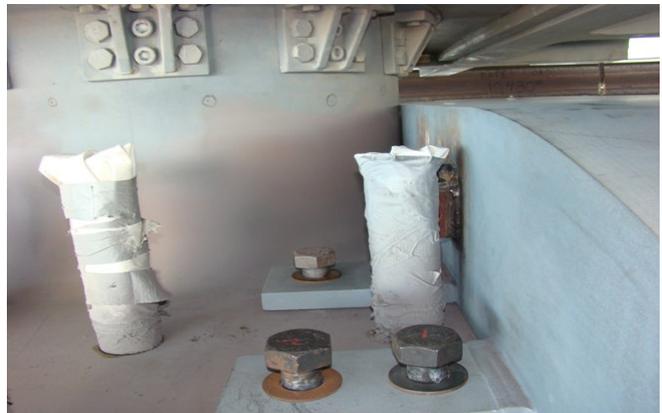
Placement of the S1 IB upper saddle looking east where the bolts were loosely connected.

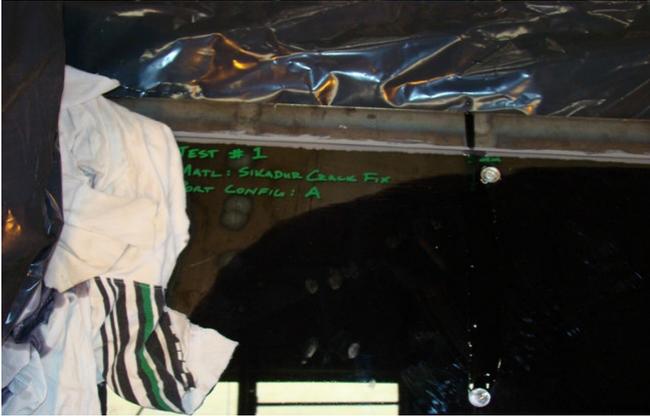
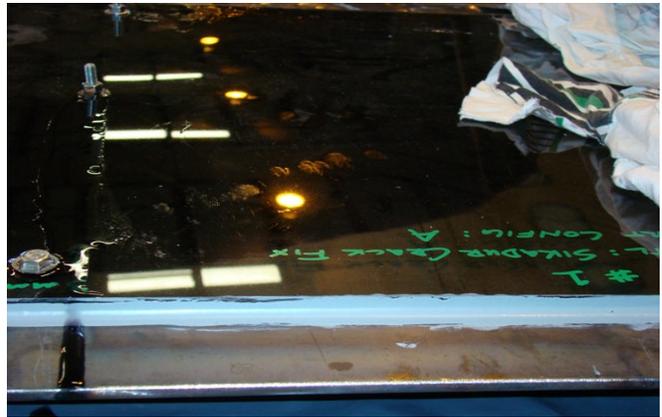
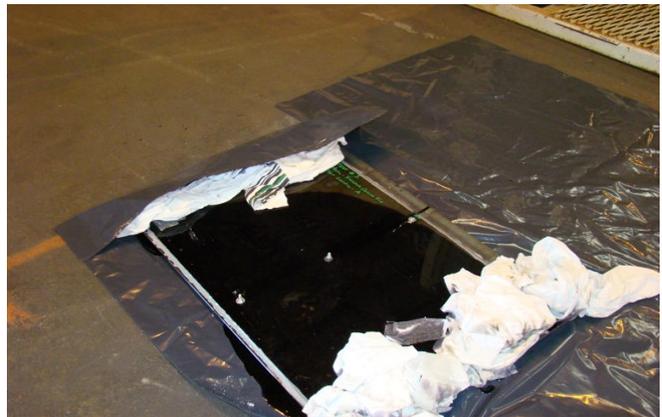
Sikadur placed in a plexiglass mockup this afternoon.

See Pamela and Jason Wilcox's diaries for more information on the Sikadur mockup in the Pier 7 warehouse. ABF was supposed to perform the mockup at 2:00pm but instead they did it after the weekly Shear Key retrofit meeting. I was not informed of this change otherwise I would have observed the mockup for the filler material to be injected in the wedge plate to upper saddle gap.

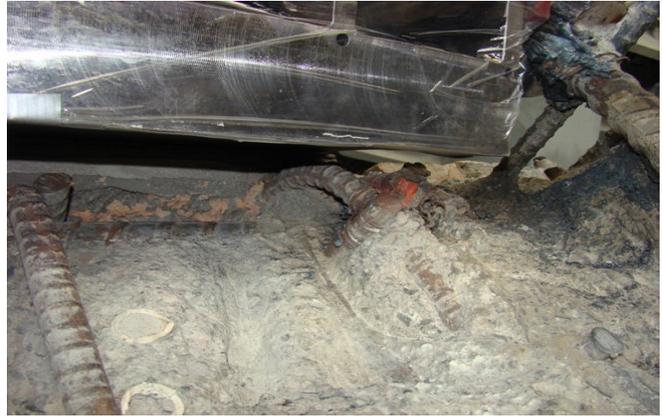
Cut rebar that slightly bound the S1 IB upper saddle segment in the SW corner from bearing completely on the lower base yesterday looking east.

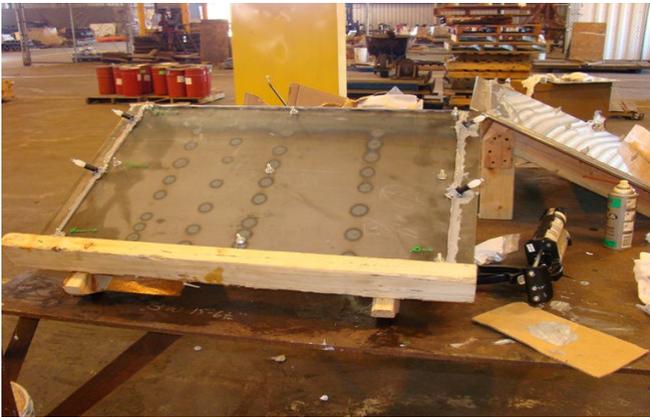
Unused mockup test plate with plexiglass for the wedge plate filler material seen in the Pier 7 warehouse.

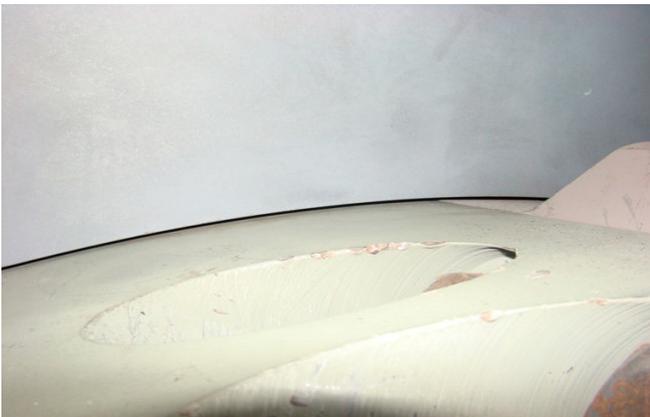
Gap on the S1 IB upper saddle east side looking south between the wedge plates.
