Daily Diary Report by Bid Item

Contract No.: 04-0120F4

04-0120F4
 04-SF-80-13.2/13.9
 Self-Anchored
 Suspension Bridge

// E2 Cap Beam Shear Key Retrofit //

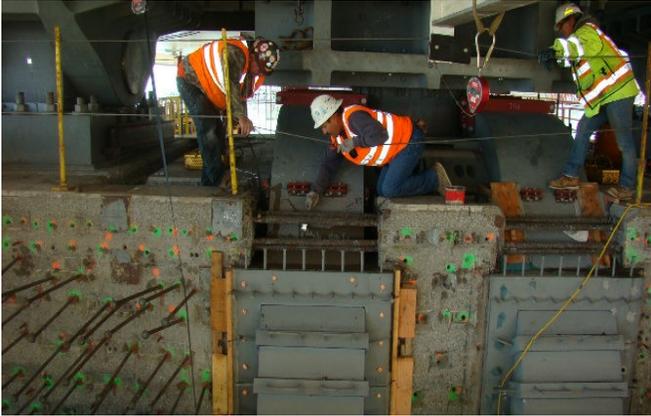
Conco personnel finishing off the grout between the vertical face of the S1 NW lower saddle and the existing E2 concrete.

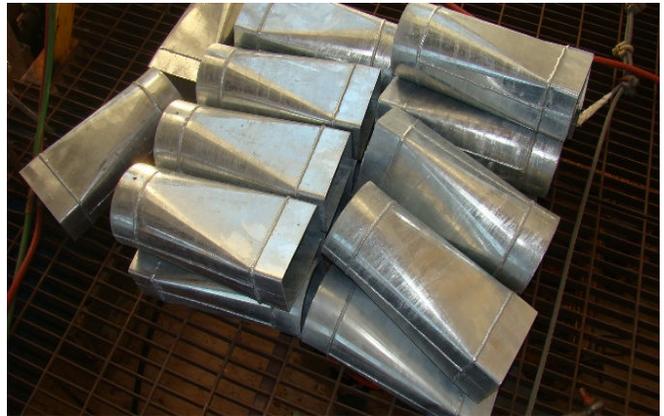
Transition couplers for the lower saddle segments to the rigid PT ducts.

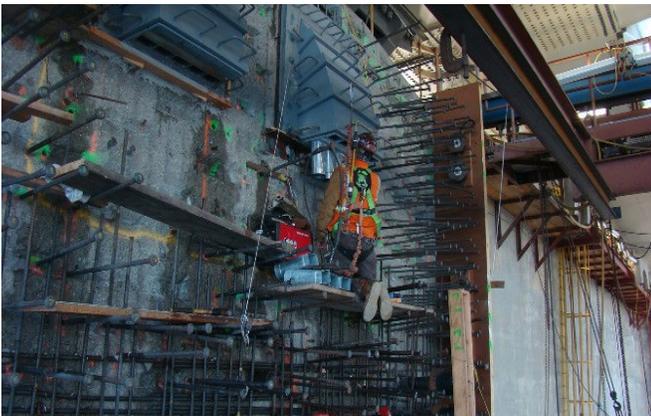
ABF welder installing the transition couplers for the S1 SW lower saddle.

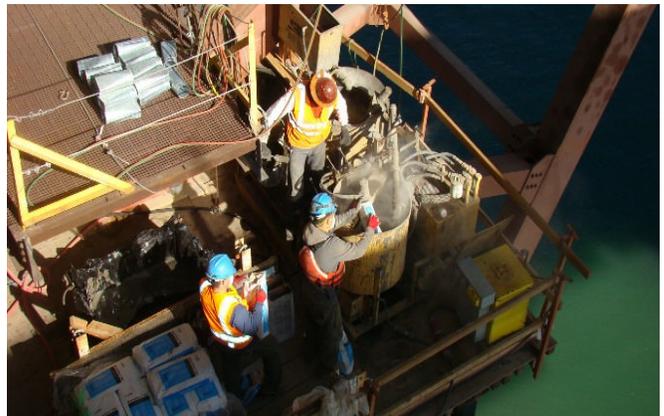
ABF and Conco laborers in the process of mixing water and cementitious grout.

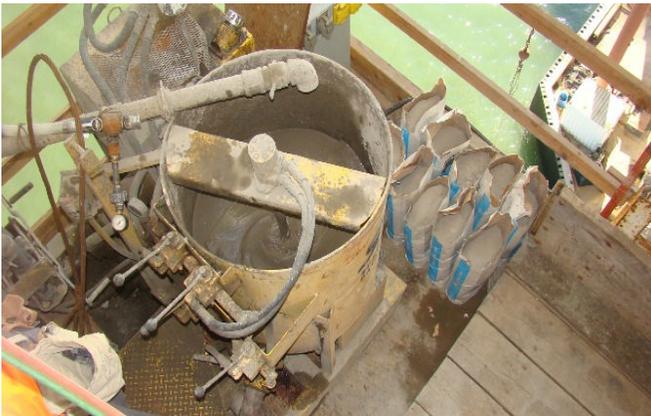
Smith Emery technician Sal Merino was onsite to perform tests on the fluid grout. The grouting operation began at 8:55am and was completed at 11:30am. The ambient temperature at the beginning of the operation was 52F under partly cloudy skies with a grout temperature of 60F. The efflux time after mixing 10 bags of cementitious grout and 12.62 Gallons of water was 37seconds. Smith Emery made 12 grout cube samples for compressive strength tests and Caltrans made 3 cubes. It should be noted that the technician was tamping the fluid grout lifts 25 times instead of the 5 prescribed by ASTM at first. I informed him that for the 2 fluid grout lifts, each needs to be tamped 5 times with 4 in the corners and once in the middle. The only other issue during the grouting operation was at 10:30am the pump became blocked due to the thick grout. Hand mixing began and mixing at the pump was scaled back to 5 bags at 10:30am as the laborers cleared the pump hoses of blocked grout.

Mixing 10 bags of the Masterflow 928 grout in the pump.

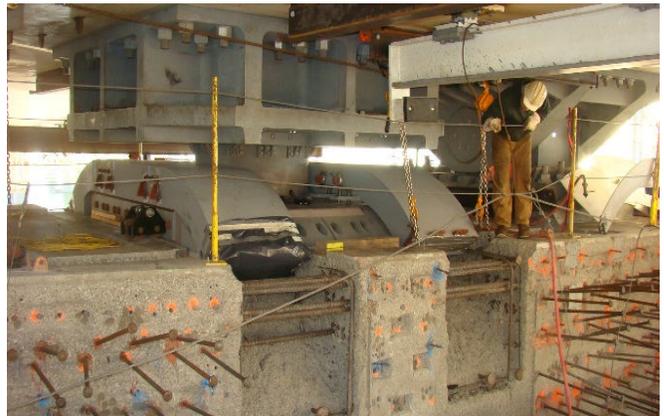
Partially installed S2 Upper Outboard saddle segment, as the ironworkers still need to dye grind the west stub plate holes.
