Contract #: 04-0120F4Cty: SF/ALA Rte: 80 PM: 13.2/13.9File #: 69.15**SOURCE INSPECTION REPORT****Resident Engineer:** Pursell, Gary**Address:** 333 Burma Road**City:** Oakland, CA 94607**Report No:** SIR-000563**Date Inspected:** 29-Apr-2009**Project Name:** SAS Superstructure**OSM Arrival Time:** 0**Prime Contractor:** American Bridge/Fluor Enterprises, a JV**OSM Departure Time:** 12**Contractor:** Zhenhua Port Machinery Company, Ltd (ZPMC), Changxing Island **Location:** Changxing Dao, Shanghai

Other: Surface Preparation and Coatings Application**Bridge No:** 34-0006**Component:** OBG 7BW, 7AW, 6CW**Bid Item:** 79, 80, 81**Lot No:** B226**Summary of Items Observed:**

SOURCE INSPECTION REPORT

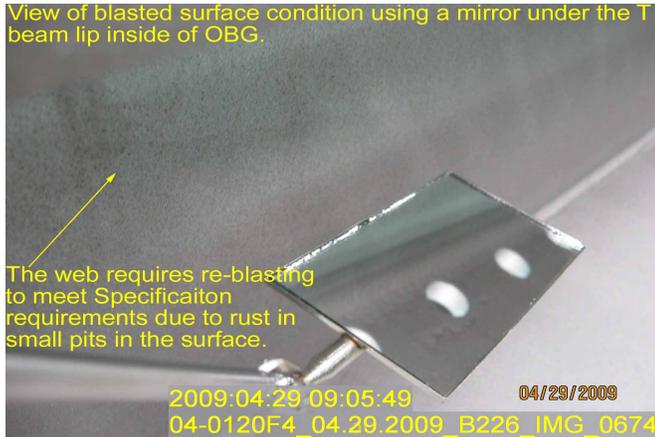
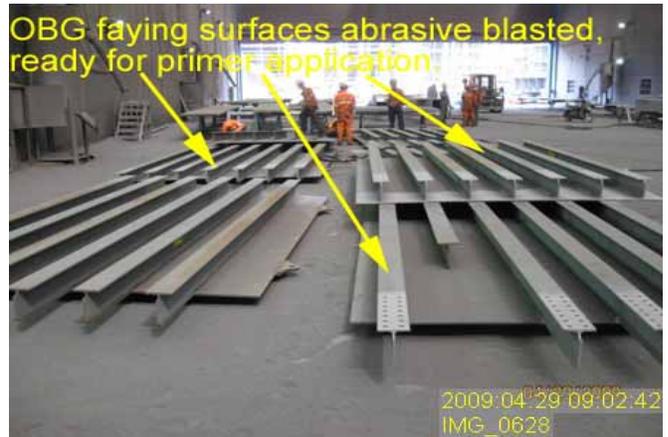
Caltrans QA Coatings Inspectors received a Notice of Inspection for to attend a joint inspection with ABF and ZPMC QC for visual inspection of the surface preparation of faying surfaces of the floor beam T clip connections in OBG 7BW, 7AW and 6CW.

The visual inspection met the contract requirements of SSPC SP10. Residual Chlorides (soluble salts) tests were performed on the abrasive blasted surfaces. The test results showed that the surface was acceptable to be coated with Interzinc 22 zinc primer.

The highest registered reading of salts contamination was 10 micro Siemens per square centimeter which is below the contract maximum of 10 micrograms per square centimeter. Surface profile Testex Tape was used by ZPMC QC personnel to record the blast profile. The Testex tape was measured using a dial micrometer. The readings were within the contract requirements of 40 and 86 microns. Ambient conditions were within Contract required parameters. After the visual inspection of the surface preparation, Interzinc 22 primer was applied within the specified 8 hour window after the start of abrasive blasting. The coating was mixed under the supervision of Caltrans QA Coatings Inspector Jordan, and QC personnel representing ABF and ZPMC. Coating application

Fabrication on assembled components of the OBG's are not complete. Coating damage requiring re-blast is expected.
