DEPARTMENT OF TRANSPORTATION

Quality Assurance and Source Inspection

Contract #: 04-0120F4Cty: SF/ALA Rte: 80 PM: 13.2/13.9File #: 50.28**WELDING INSPECTION REPORT****Resident Engineer:** Pursell, Gary**Address:** 333 Burma Road**City:** Oakland, CA 94607**Report No:** WIR-000041**Date Inspected:** 13-Nov-2006**Project Name:** SAS Superstructure**OSM Arrival Time:** 800**Prime Contractor:** American Bridge/Fluor Enterprises, a JV**OSM Departure Time:** 1730**Contractor:** Zhenhua Port Machinery Company, Ltd (ZPMC), Jiangyin**Location:** Shanghai, China**CWI Name:** Liu Liu**CWI Present:** Yes No**Inspected CWI report:** Yes No N/A**Rod Oven in Use:** Yes No N/A**Electrode to specification:** Yes No N/A**Weld Procedures Followed:** Yes No N/A**Qualified Welders:** Yes No N/A**Verified Joint Fit-up:** Yes No N/A**Approved Drawings:** Yes No N/A**Approved WPS:** Yes No N/A**Delayed / Cancelled:** Yes No N/A**Bridge No:** 34-0006**Component:** N/A**Summary of Items Observed:**

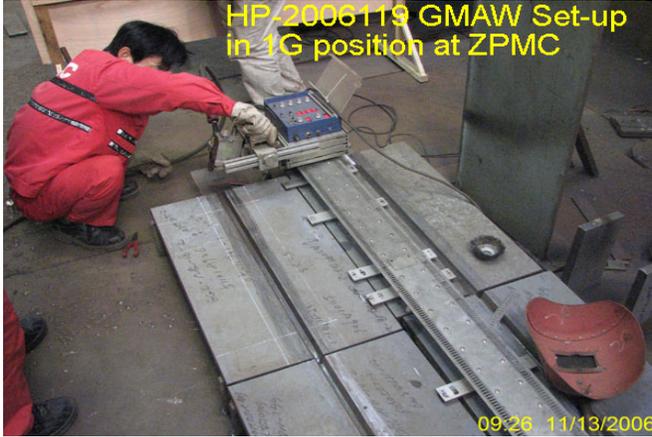
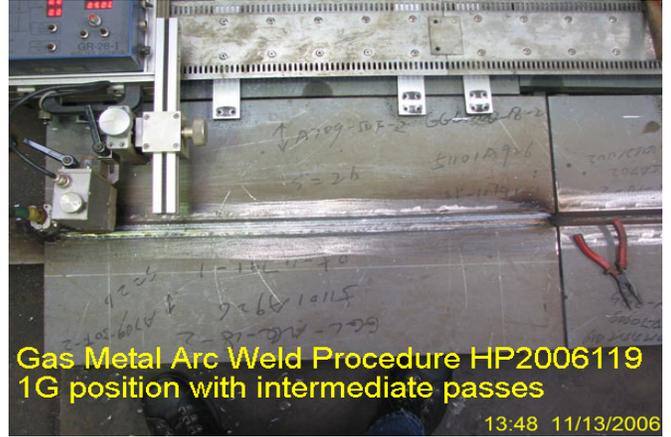
This Quality Assurance Inspector observed the Quality Control Inspector, Mr. Gu Xin Zai witnessing the running of the gas metal arc welding procedure qualification test HP2006119 in the shop at ZPMC. The test was being run to Paragraph 5.13 for this flat groove weld (1G) position. The welder was Lei Li Chao who was using Hyundai, SM 70, and 1.4 millimeter diameter wire with 10% CO2 gas and 90% Argon at a flow rate of 21 Liters/minute and welding procedure specification PWPS-B-T-2241-F. Welding of this 1G procedure qualification was completed at 1430. (See Welding Inspection Report 6032 B72-053-06 dated 11-11-2006 for details)
