Contract #: 04-0120F4Cty: SF/ALA Rte: 80 PM: 13.2/13.9File #: 69.28**WELDING INSPECTION REPORT****Resident Engineer:** Pursell, Gary**Address:** 333 Burma Road**City:** Oakland, CA 94607**Report No:** WIR-000074**Date Inspected:** 09-Feb-2007**Project Name:** SAS Superstructure**OSM Arrival Time:** 800**Prime Contractor:** American Bridge/Fluor Enterprises, a JV**OSM Departure Time:** 1330**Contractor:** Zhenhua Port Machinery Company, Ltd (ZPMC), Changxing Island **Location:** Shanghai, China

Office of Structural Materials Quality Assurance Inspector (QA), Mark Wright was present as requested to observe quality control functions related to procedure qualification record (PQR) testing at the ZPMC facility in Shanghai, China for the San Francisco Oakland Bay Self Anchored Suspension Bridge.

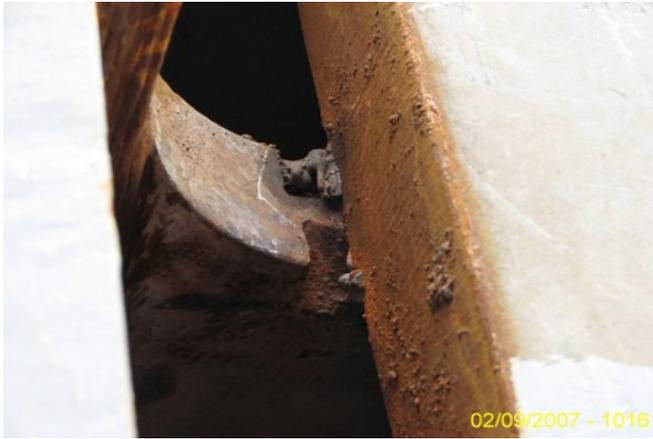
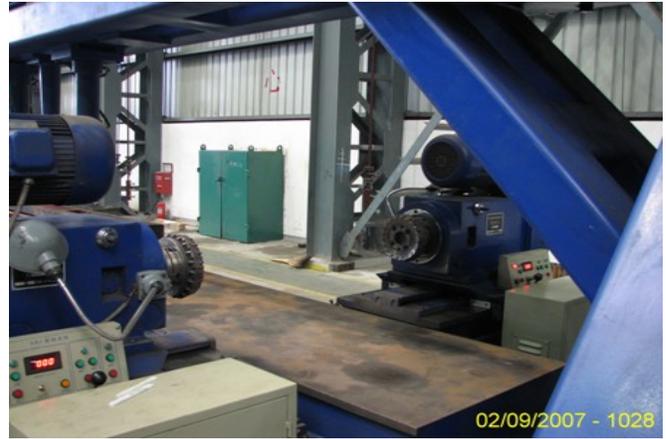
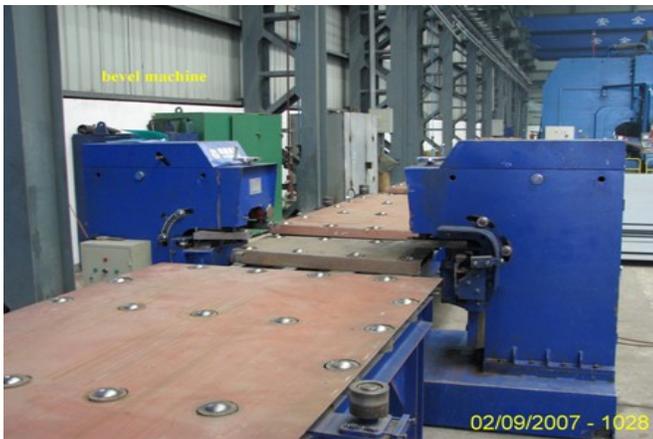
The Caltrans QA Inspector also toured the closed rib production site at ZPMC and observed the plate milling machine and the plate beveling machine as shown in the photos below. The ZPMC representative explained the the process would be assembly line type work, with the squaring of the plate followed by the beveling and then the ribs will be form and placed on a panel which will be placed inside of a prebend jig for welding of the closed ribs as shown in the photos below.
