DEPARTMENT OF TRANSPORTATION

Contract #: 04-0120F4Cty: SF/ALA Rte: 80 PM: 13.2/13.9File #: 69.28**WELDING INSPECTION REPORT****Resident Engineer:** Pursell, Gary**Address:** 333 Burma Road**City:** Oakland, CA 94607**Report No:** WIR-000098**Date Inspected:** 12-Mar-2007**Project Name:** SAS Superstructure**OSM Arrival Time:** 800**Prime Contractor:** American Bridge/Fluor Enterprises, a JV**OSM Departure Time:** 1400**Contractor:** Zhenhua Port Machinery Company, Ltd (ZPMC), Changxing Island **Location:** Shanghai, China**CWI Name:** Liu Liu**CWI Present:** Yes No**Inspected CWI report:** Yes No N/A**Rod Oven in Use:** Yes No N/A**Electrode to specification:** Yes No N/A**Weld Procedures Followed:** Yes No N/A**Qualified Welders:** Yes No N/A**Verified Joint Fit-up:** Yes No N/A**Approved Drawings:** Yes No N/A**Approved WPS:** Yes No N/A**Delayed / Cancelled:** Yes No N/A**Bridge No:** 34-0006**Component:** N/A**Summary of Items Observed:**

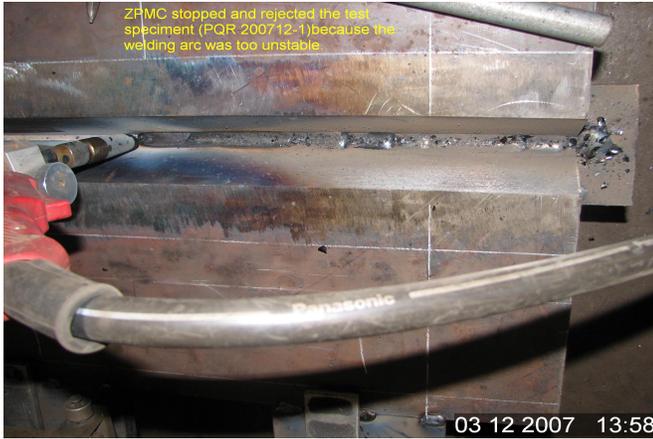
The CALTRANS Quality Assurance (QA) Inspector, Alfredo Acuna was present for the welding qualification testing pertinent for the welding qualification record (PQR) HP200712 scheduled for this project. ZPMC, welder operator Zhan Xing Jin was observed by the QA Inspector performing welding operations following the preliminary welding procedure specification PWPS-B-T-223(2)1T-1 for the PQR identified as HP200712. Base metal was designated as A-709-50-2/Z25 (Heat # 06102938N) and appeared to meet the non fracture critical impact test requirement. The root opening of the joint was approximately 6 mm. ZPMC followed AWS 5.13 the production procedure WPS using the automatic flux cored arc welding gas (FCAW-G) process in the flat (1G) position with the 1.4 mm diameter TWE-711 electrode. The QA Inspector verified dimensions for the test coupon, amperages, voltages, travel speeds and preheats temperature. The QA inspector recorded welding parameters on 300 mm. ZPMC stopped and rejected the test coupon because the welding arc was too unstable (the ceramic backing appeared to be no arcing properly). The QA inspector had a conversation with ZPMC Testing Center Director Liu Liu. Mr. Liu relayed that the root pass with the ceramic was difficult to accomplish with the parameters established on the PQR HP200712 and the root opening of 6 mm. The welding procedure qualification was postponed to the next day because ZPMC needed to fit up another test coupon.

The digital photographs below shows the failed test coupon on the PQR HP200712-1
