Quality Assurance and Source Inspection

Contract #: 04-0120F4Cty: SF/ALA Rte: 80 PM: 13.2/13.9File #: 69.28**WELDING INSPECTION REPORT****Resident Engineer:** Pursell, Gary**Address:** 333 Burma Road**City:** Oakland, CA 94607**Report No:** WIR-000345**Date Inspected:** 08-Aug-2007**Project Name:** SAS Superstructure**OSM Arrival Time:** 800**Prime Contractor:** American Bridge/Fluor Enterprises, a JV**OSM Departure Time:** 1500**Contractor:** Zhenhua Port Machinery Company, Ltd (ZPMC), Changxing Island **Location:** Shanghai, China

WELDING INSPECTION REPORT

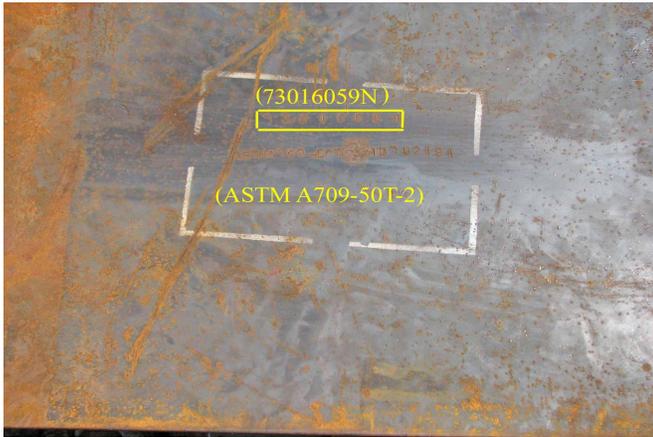
The Caltrans Quality Assurance (QA) Inspector was present at the time requested to observe welding being performed on a Procedure Qualification Record (PQR). The welding is being performed by ZPMC welder with the submerged arc welding (SAW) process in the 1G or flat groove position. The PQR weld joint is a single V groove with a 20 degree included groove angle, a 16 millimeter root opening with a 20 millimeter thick by 200 millimeter wide steel backing strip. ZPMC QA Representatives Huang Wei and Fu Jun were observed monitoring preheat, welding amperage, welding voltage and travel speed. The QA Inspector also performed random verification of the above welding parameters. The test was discontinued at the end of the shift after completing weld pass.
