Quality Assurance and Source Inspection

Contract #: 04-0120F4Cty: SF/ALA Rte: 80 PM: 13.2/13.9File #: 69.28**WELDING INSPECTION REPORT****Resident Engineer:** Pursell, Gary**Address:** 333 Burma Road**City:** Oakland, CA 94607**Report No:** WIR-000392**Date Inspected:** 31-Aug-2007**Project Name:** SAS Superstructure**OSM Arrival Time:** 2330**Prime Contractor:** American Bridge/Fluor Enterprises, a JV**OSM Departure Time:** 800**Contractor:** Zhenhua Port Machinery Company, Ltd (ZPMC), Changxing Island **Location:** Shanghai, China

Caltrans Quality Assurance (QA) Inspector, Mike Hasler was present to observe the fitup and welding of the Caltrans Mock-up #77.00, for the San Francisco Oakland Bay Self Anchored Suspension Bridge, at Zhenhua Port Machinery Company (ZPMC) facility on Changxing Island.

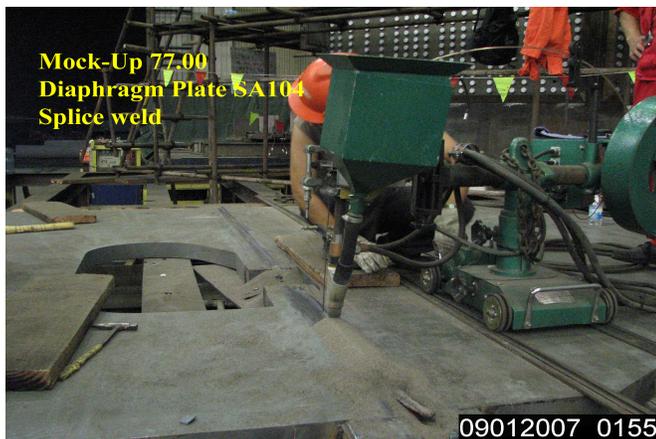
Caltrans QA Inspector observed submerged arc welding (SAW) in progress. The assembly is identified as Diaphragm Plate SA104, plate splice weld. The approved welder operator is observed welding a complete joint penetration (CJP) fill and cover in the flat position. Welder is identified as Ms. Shen Mei. The welder is using welding procedure specification WPS-B-T-3221-B-U3c-S, Revision 1. Caltrans QA Inspector measured current welding parameters at approximately 630 amps, 31 volts and travel speed, 505 millimeters per minute (mm/min). Preheat and interpass temperatures were verified during welding activities. Preheat temperature prior to the start of welding measures more than 180 degrees Celsius (350 degree Fahrenheit) but less than 232 degrees Celsius (450 degrees Fahrenheit) during maximum interpass temperature verification. SAW consumables were verified and identified as LA85, classification ENi5, diameter 4.8 mm (.189 inches) electrode and, Mil800-HPNi, classification F9A4 flux. Following digital picture illustrates welding in progress.

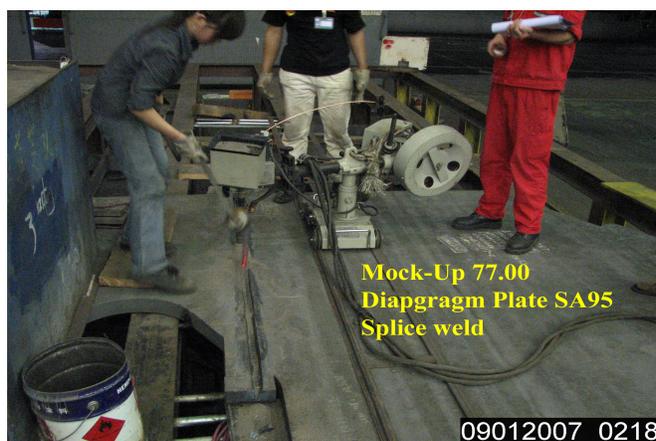
Item	Description	WBS	Dwg No.	Status
1	Diaphragm Plate SA95	NA	NA	Welding in progress

Caltrans QA Inspector observed submerged arc welding (SAW) in progress. The assembly is identified as Diaphragm Plate SA95, plate splice weld. The approved welder operator is observed welding a complete joint penetration (CJP) fill and cover in the flat position. Welder is identified as Mr. Xue Yian. The welder is using welding procedure specification WPS-B-T-3221-B-U3c-S, Revision 1. Caltrans QA Inspector measured current welding parameters at approximately 640 amps, 31 volts and travel speed, 490 millimeters per minute (mm/min). Preheat and interpass temperatures were verified during welding activities. Preheat temperature prior to the start of welding measures more than 180 degrees Celsius (350 degree Fahrenheit) but less than 232 degrees Celsius (450 degrees Fahrenheit) during maximum interpass temperature verification. SAW consumables were verified and identified as LA85, classification ENi5, diameter 4.8 mm (.189 inches) electrode and, Mil800-HPNi, classification F9A4 flux. Following digital picture illustrates welding in progress.
