Contract #: 04-0120F4Cty: SF/ALA Rte: 80 PM: 13.2/13.9File #: 69.28**WELDING INSPECTION REPORT****Resident Engineer:** Pursell, Gary**Address:** 333 Burma Road**City:** Oakland, CA 94607**Report No:** WIR-000517**Date Inspected:** 30-Aug-2007**Project Name:** SAS Superstructure**OSM Arrival Time:** 630**Prime Contractor:** American Bridge/Fluor Enterprises, a JV**OSM Departure Time:** 1530**Contractor:** Zhenhua Port Machinery Company, Ltd (ZPMC), Changxing Island **Location:** Shanghai, China**CWI Name:** Ye YongJun**CWI Present:** Yes No**Inspected CWI report:** Yes No N/A**Rod Oven in Use:** Yes No N/A**Electrode to specification:** Yes No N/A**Weld Procedures Followed:** Yes No N/A**Qualified Welders:** Yes No N/A**Verified Joint Fit-up:** Yes No N/A**Approved Drawings:** Yes No N/A**Approved WPS:** Yes No N/A**Delayed / Cancelled:** Yes No N/A**Bridge No:** 34-0006**Component:** Tower Mock-Up 77Meter**Summary of Items Observed:**

Tower Mock-up 77 Meter Elevation

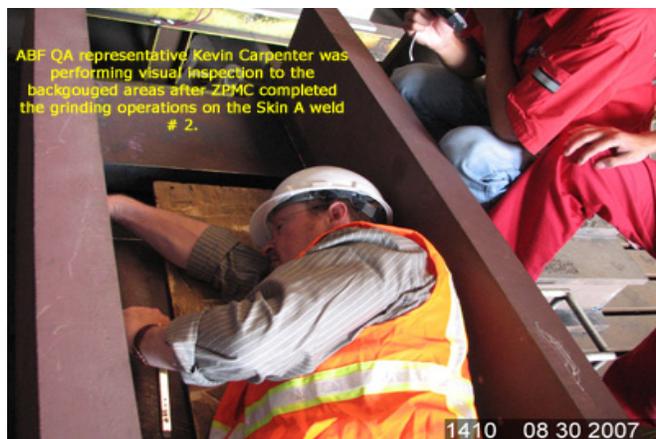
1	<p>Visual Inspections to the Backgouged Areas after ZPMC ground the Skin A weld joint # 2</p> <p>The QA inspector performed visual inspection to the backgouged areas at the Skin A weld joint # 2 after grinding. The QA inspector observed numerous locations where the backgouging areas were not ground to bright metal. The QA inspector had a conversation with the ABF QA supervisor Kevin Carpenter. The QA inspector brought it to Mr. Carpenter's attention that ZPMC has been having difficulties complying with the bright metal requirement after backgouging operations. Mr. Carpenter verified the backgouged area after grinding and agreed with the QA inspector.</p> <p>Mr. Carpenter asked ZPMC representatives which tool they were using to grind the backgouged areas. ZPMC relayed that they were using a conventional grinder. Mr. Carpenter relayed to ZPMC representative that ZPMC needed to use a die grinder to get to the small and tight areas. After ZPMC ground the gouged areas with a die grinder the areas of concern, the QA inspector found that the backgouged areas that were reground appeared to be in compliance with contract documents. The photograph below reflects Mr. Carpenter performing visual inspection of the backgouged areas after grinding.</p>

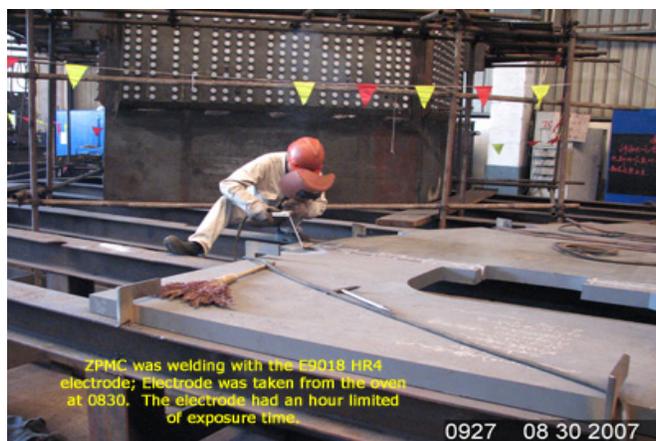
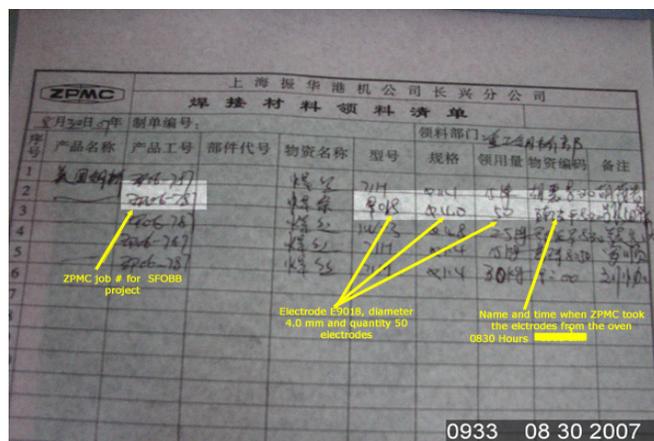
2	<p>Exposure Time for the Electrode E-9018-HR4</p> <p>The QA inspector observed welder Zhang Quanfa performing tacking operations to the bottom diaphragm (A709 HPS 485W) at the junction of the shop splice for the SA-104 subassembly to the run on tabs (A409 HPS 485W). The QA Inspector verified amperage, voltage, preheat and heat interpass temperatures for the tack welding. The QA inspector found that the welding parameters recorded after ZPMC approved Certified Welder Inspector Xu Lefeng appeared to be in accordance with the contract documents. The QA inspector had a conversation with the ABF representative Song Wemin. The QA inspector brought it to the attention of Mr. Song that 50 electrodes E-9018 H4R were taken</p>			
---	--	--	--	--

from the oven by ZPMC at 0830 hours (according with ZPMC electrode control log sheet) and the allowable time of exposure was one hour. Mr. Song and the QA inspector verified the temperature inside of the portable holding ovens with the use of a thermal infrared hand held gun temperature indicator. The temperatures recorded were between 80 ° to 110° Celsius on the two ovens. Even though Mr. Song and the QA inspector agreed that the infrared gun temperature indicators were not as accurate as conventional thermometers or temperature heat indicators. After speaking with the Senior task Leader Dave McClary, the QA inspector relayed to Mr. Song and Mr. Carpenter that ZPMC could extended the exposure time to more than an hour (as required by table 4.7 AWS D1.5 2002) if ABF could prove that ZPMC was maintaining a continuous temperature inside the portable oven at 120 ° Celsius or greater. ABF and ZPMC conveyed to the QA inspector that ZPMC was going to rebake the electrodes inside of the portable holding ovens and replace with electrodes fresh from the oven. The photographs below show the ZPMC's consumable control log and welder Zhang Quanfa performing welding operation before ZPMC stopped and changed the welding electrodes.
