DEPARTMENT OF TRANSPORTATION

Contract #: 04-0120F4Cty: SF/ALA Rte: 80 PM: 13.2/13.9File #: 69.28**WELDING INSPECTION REPORT****Resident Engineer:** Pursell, Gary**Address:** 333 Burma Road**City:** Oakland, CA 94607**Report No:** WIR-000482**Date Inspected:** 21-Sep-2007**Project Name:** SAS Superstructure**OSM Arrival Time:** 630**Prime Contractor:** American Bridge/Fluor Enterprises, a JV**OSM Departure Time:** 1530**Contractor:** Zhenhua Port Machinery Company, Ltd (ZPMC), Changxing Island **Location:** Shanghai, China**CWI Name:** Xu Bing**CWI Present:** Yes No**Inspected CWI report:** Yes No N/A**Rod Oven in Use:** Yes No N/A**Electrode to specification:** Yes No N/A**Weld Procedures Followed:** Yes No N/A**Qualified Welders:** Yes No N/A**Verified Joint Fit-up:** Yes No N/A**Approved Drawings:** Yes No N/A**Approved WPS:** Yes No N/A**Delayed / Cancelled:** Yes No N/A**Bridge No:** 34-0006**Component:** Mock Up**Summary of Items Observed:**

WELDING INSPECTION REPORT

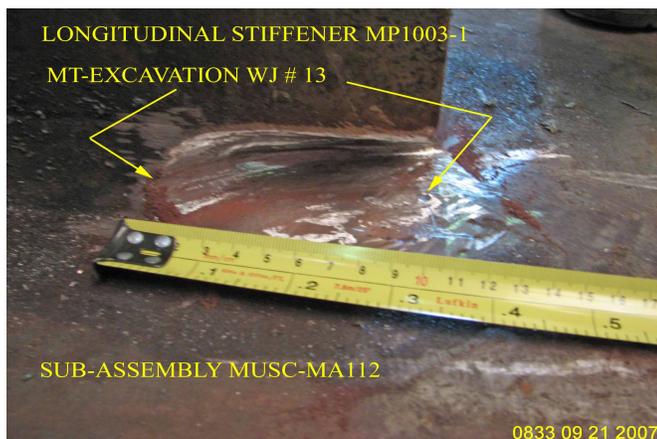
The QA Inspector randomly observed ZPMC Non Destructive Testing Technician Cai Xin Xin, utilizing the Magnetic Particle Testing Method (MT) to examine 1 excavation each in the CJP WJ's numbers 10 and 13 attaching longitudinal stiffeners piece marks MP1003-1 and MP1003-2 to SA MUSC-MA112 Face C (Skin Plate C), prior to performing first time weld repairs. The attached photograph provides additional detail.

The QA Inspector asked ZPMC QA Representative Shen Xue Jun if he knew what the total length was of the defects found in WJ's 10 and 13, attaching longitudinal stiffeners piece marks MP1003-1 and MP1003-2 to SA MUSC-MA112 Face C (Skin Plate C). Mr. Shen informed the QA Inspector that he did not. The QA Inspector then asked Mr. Shen if he could get a copy of the Ultrasonic Testing Report, and Mr. Shen informed the QA Inspector that he would do so.
