Contract #: 04-0120F4Cty: SF/ALA Rte: 80 PM: 13.9/14.3,0.0/1.6File #: 69.28**WELDING INSPECTION REPORT****Resident Engineer:** Pursell, Gary**Address:** 333 Burma Road**City:** Oakland, CA 94607**Report No:** WIR-000857**Date Inspected:** 15-Nov-2007**Project Name:** SAS Superstructure**OSM Arrival Time:** 630**Prime Contractor:** American Bridge/Fluor Enterprises, a JV**OSM Departure Time:** 1530**Contractor:** Zhenhua Port Machinery Company, Ltd (ZPMC), Changxing Island **Location:** Shanghai, China**CWI Name:** Cui Ri Yu**CWI Present:** Yes No**Inspected CWI report:** Yes No N/A**Rod Oven in Use:** Yes No N/A**Electrode to specification:** Yes No N/A**Weld Procedures Followed:** Yes No N/A**Qualified Welders:** Yes No N/A**Verified Joint Fit-up:** Yes No N/A**Approved Drawings:** Yes No N/A**Approved WPS:** Yes No N/A**Delayed / Cancelled:** Yes No N/A**Bridge No:** 34-0006**Component:** OBG Mock-up shop**Summary of Items Observed:**

WELDING INSPECTION REPORT

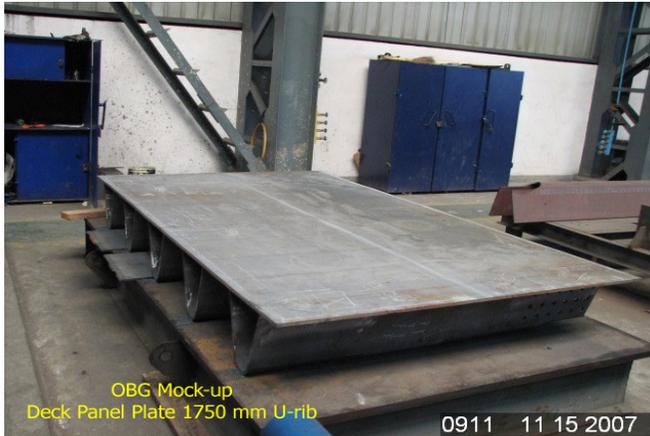
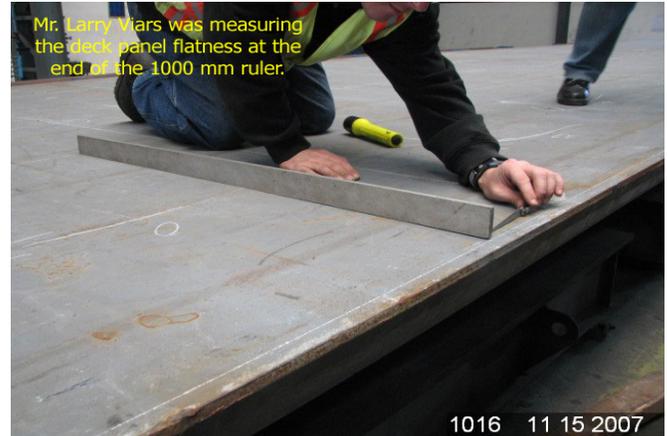
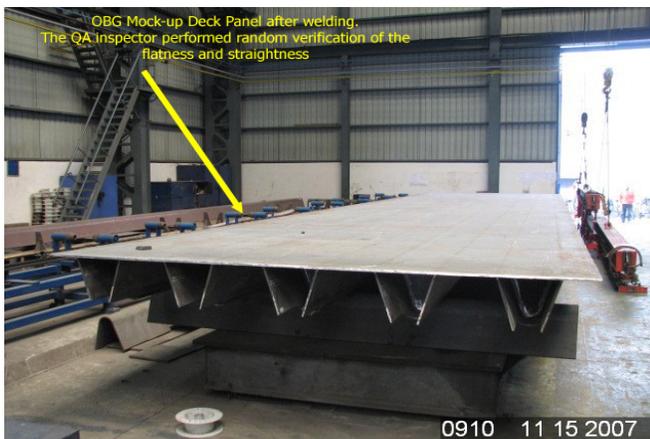
Item Description	WBS	Dwg No.	Status
1 OBG Mock-up flatness and straightness verifications			
The QA inspector performed random flatness and straightness verifications on the OBG Mock-up with the QA inspector Larry Viars after ZPMC welded the long deck panel to the U-ribs (approximately length of the U-ribs 13158 mm) and for the short deck panel to the U-ribs (approximately length of the U-ribs 1750 mm). The QA inspector found that the transverse deck and the longitudinal deck plate flatness appeared to be in general compliance with the contract documents.
