Contract #: 04-0120F4Cty: SF/ALA Rte: 80 PM: 13.2/13.9File #: 69.28**WELDING INSPECTION REPORT****Resident Engineer:** Pursell, Gary**Address:** 333 Burma Road**City:** Oakland, CA 94607**Report No:** WIR-000914**Date Inspected:** 11-Nov-2007**Project Name:** SAS Superstructure**OSM Arrival Time:** 630**Prime Contractor:** American Bridge/Fluor Enterprises, a JV**OSM Departure Time:** 1530**Contractor:** Zhenhua Port Machinery Company, Ltd (ZPMC), Changxing Island **Location:** Shanghai, China**CWI Name:** Cui Ri Yu**CWI Present:** Yes No**Inspected CWI report:** Yes No N/A**Rod Oven in Use:** Yes No N/A**Electrode to specification:** Yes No N/A**Weld Procedures Followed:** Yes No N/A**Qualified Welders:** Yes No N/A**Verified Joint Fit-up:** Yes No N/A**Approved Drawings:** Yes No N/A**Approved WPS:** Yes No N/A**Delayed / Cancelled:** Yes No N/A**Bridge No:** 34-0006**Component:** Tower Mock-up and OBG**Summary of Items Observed:**

CALTRANS Quality Assurance (QA) Inspector, Alfredo Acuna was present for the fabrication scheduled for this project at the ZPMC facility in Shanghai, China for the San Francisco Oakland Bay Self Anchored Suspension Bridge.

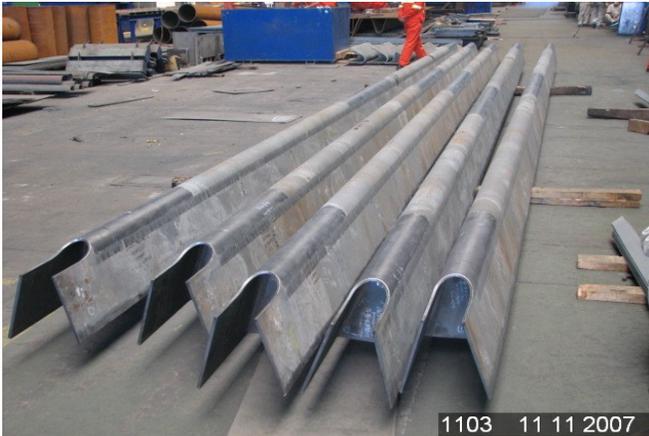
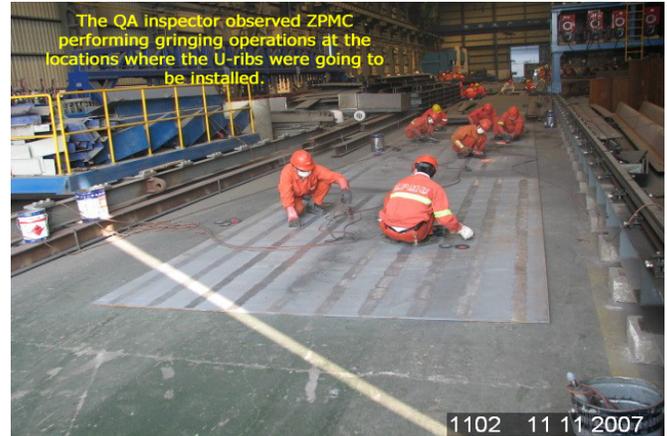
1	OBG Mock-up deck U-ribs		
---	-------------------------	--	--

The QA inspector observed that the U-ribs U-01 thru U-05 from the OBG mock-up were turned outside down. The QA inspector had a conversation with ABF representative Zhang Xu Liang. The QA inspector asked Mr. Zhang Xu Liang what had ZPMC resolved regarding the root face less than 1 mm located at 13158 mm U-ribs for the OBG Mock-up. Mr. Zhang Xu Liang relayed that ZPMC had not informed him about that issue. The QA inspector observed ZPMC grinding the paint off the deck plate at the locations where the U-ribs were going to be installed.

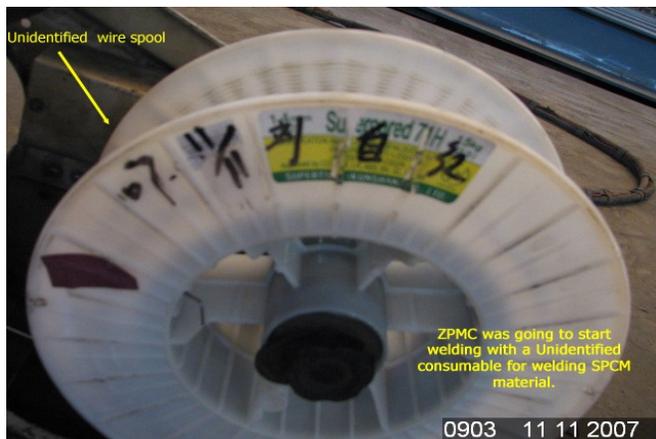
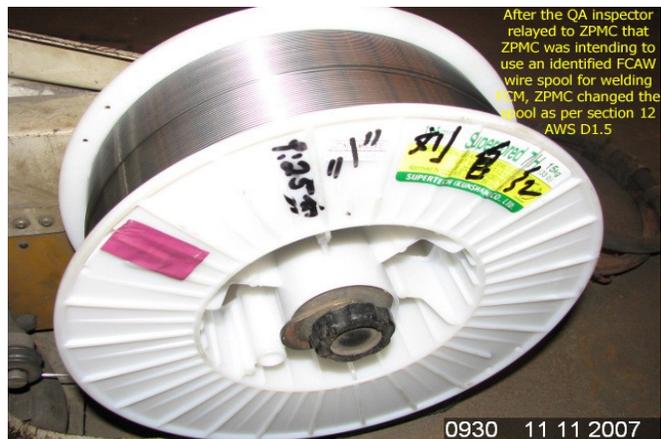
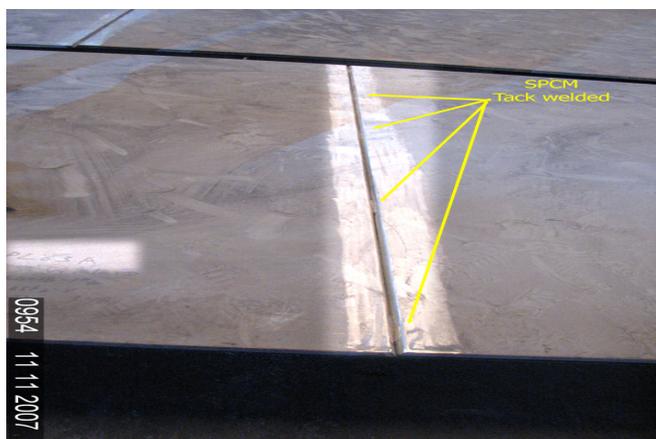
2 OBG Fracture Critical Members (FCM) Electrode Consumables

The QA inspector observed on the OBG shop # 3 that ZPMC was going to start welding using the flux cored arc welding process fracture critical members bottom, plates PL 35A to 35B and 33A and 33 B with consumable that was not identified as per section 12 AWS D1.5(2002). The QA inspector had a conversation with ZPMC representative Xu Jun (Eric). The QA inspector asked Mr. Xu Jun how the flux cored arc welding (FCAW) spool of wire that was almost empty (questionable atmosphere exposure time) comply with ZPMC fracture critical control plan. Mr. Xu Jun, QC personnel and production were not aware of the limitations of the exposure time on section 12 for FCM at that time. The QA inspector recommended Mr. Xu Jun that ZPMC follows the AWS D1.5 subsection 12.6.7.4 Electrode Storage. Mr. Xu Jun agreed after verifying that the electrode did not comply with AWS D1.5 section 12 and instructed to the QC and production personnel to follow subsection 12.6.7.4 requirement. ZPMC agreed to change the spool of wire from another coming directly from the manufacturer packaging. Mr. Xu Jun added that ZPMC would write the time and date on the electrode spool and would not used for welding FCM after the exposure time expired. The digital photographs below show the identified spool of wire that ZPMC intend to use to weld FCM and the spool of wire used for welding FCM.

Later, the QA inspector observed three plates designated for FCM marked as PL63A to PL63B side plate, PL36A to PL36B and PL37A to PL37B that were already tack welded. The QA inspector asked Mr. Xu Jun and ABF representative Zhan Xu Liang when and how the plates were tack welded. Mr. Xu Jun relayed to the QA inspector that the plates were tack welded on November 10 but he did not know which electrode was used for tack weld those FCM plates. The QA inspector relayed to Mr. Xu Jun that ZPMC needed to demonstrated that the mentioned plates were welded in compliance with section 12.

Later on the second shift, the QA inspector had a phone conversation with Caltrans QA inspector Mr. Charlie Franco. Mr. Charlie Franco relayed to the QA inspector that he reviewed ZPMC records with Mr. Xu Jun and ABF representative Mr. Huang Li who translated the log for him (tracking log were in Chinese characters). Mr. Charlie Franco said that according with ABF and ZPMC representatives ZPMC's tack welder Mr. He Yu Mei (tack welder observed by Caltrans QA inspector Mr. Rosco Dixson around 1600 hours performing tack welding operations on the FCM material) signed out for new spool of electrode(15 Kgs)at 1230 hours. Mr. Charlie Franco added that Mr. Xu Jun relayed to him that "luckily the tack welder took a spool of wire from packaging according with their records".

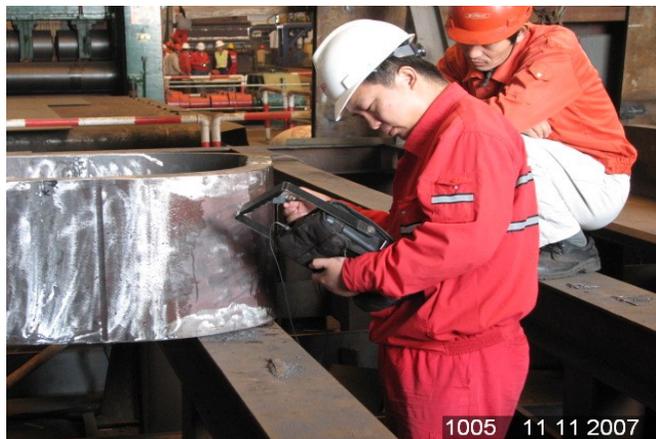
- 3 Tower Mock-up 77 Ultrasonic Testing (UT) at the Flange reinforcement ring SA274
- The QA inspector witnessed UT examination to the flange reinforcement ring SA-274 weld joints # 1 thru 5. The QA inspector observed Mr. Li Li Ming and Xue Hai Yong performing UT verifications. The QA inspector found that ZPMC UT verifications appeared to be in general compliance with the contract documents.
- The QA inspector performed 10 % random UT verifications to the flange reinforcement ring SA-274 weld joints # 1 thru 5 the QA inspector found that welds appeared to in compliance with the contract documents. See TL_6027 generated on this date.

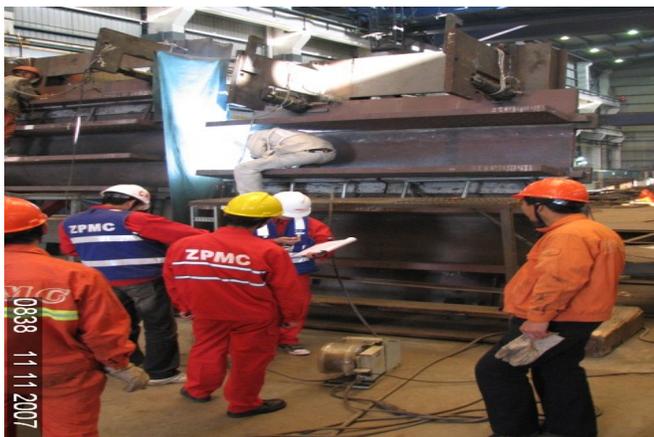
- 4 Tower 114 M Elevation Interior Splice A-58 and A-75

The QA inspector observed ZPMC performing welding operations with the flux cored arc welding process on the 1G flat position to the interior splices A-58 weld joint # 3A, welder Xu Bo, welder ID # 040427 and interior splice A-75, weld joint # 4B, welder Tao Quian, ID # 040457. The QA inspector performed random verifications of the welding parameters, preheat and interpass temperatures. The QA inspector found that the welding parameters, preheat and interpass temperatures appeared to be in accordance with the contract documents.
