**DEPARTMENT OF TRANSPORTATION**

Contract #: 04-0120F4Cty: SF/ALA Rte: 80 PM: 13.2/13.9File #: 69.28**WELDING INSPECTION REPORT****Resident Engineer:** Pursell, Gary**Address:** 333 Burma Road**City:** Oakland, CA 94607**Report No:** WIR-001137**Date Inspected:** 24-Nov-2007**Project Name:** SAS Superstructure**OSM Arrival Time:** 630**Prime Contractor:** American Bridge/Fluor Enterprises, a JV**OSM Departure Time:** 1530**Contractor:** Zhenhua Port Machinery Company, Ltd (ZPMC), Changxing Island **Location:** Shanghai, China**CWI Name:** Lu Jian Ping**CWI Present:** Yes No**Inspected CWI report:** Yes No N/A**Rod Oven in Use:** Yes No N/A**Electrode to specification:** Yes No N/A**Weld Procedures Followed:** Yes No N/A**Qualified Welders:** Yes No N/A**Verified Joint Fit-up:** Yes No N/A**Approved Drawings:** Yes No N/A**Approved WPS:** Yes No N/A**Delayed / Cancelled:** Yes No N/A**Bridge No:** 34-0006**Component:** Tower Mock-up and OBG**Summary of Items Observed:**

CALTRANS Quality Assurance (QA) Inspector, Alfredo Acuna was present for the fabrication scheduled for this project at the ZPMC facility in Shanghai, China for the San Francisco Oakland Bay Self Anchored Suspension

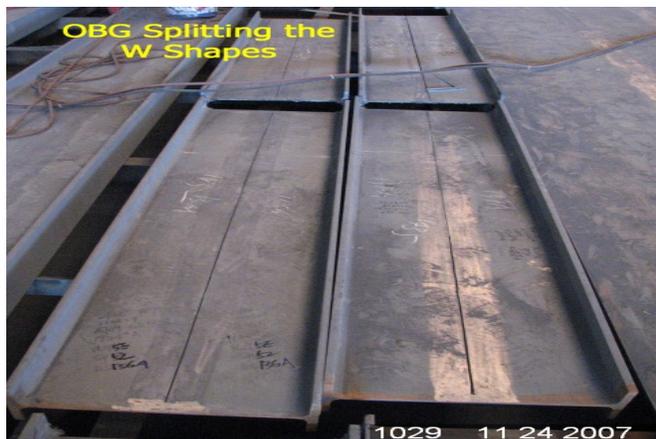
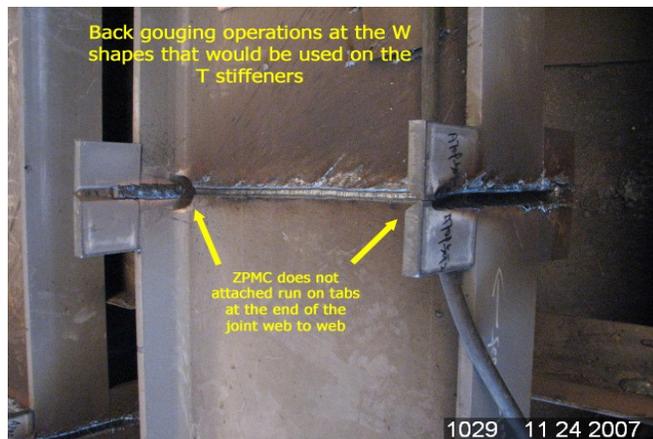
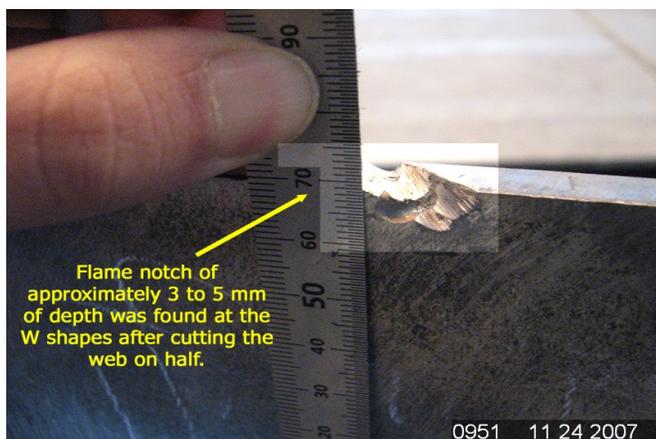
1	OBG Tee stiffeners		
---	--------------------	--	--

The QA inspector observed occasional flame notches at the edges of the split W shapes after oxyfuel gas cutting operations. The QA inspector had a conversation with the ZPMC representative Li Xiu Yang. The QA inspector asked Mr. Li Xiu Yang how ZPMC was going to repair the flame notches with less than 5 mm of depth. ZPMC representative informed that ZPMC was going to weld these areas. The QA inspector recommended ZPMC to follow the contract documents when repairing flame notches by welding.

Note: The QA inspector was concerned that ZPMC was going to weld over the notches without any preparation and cleaning.

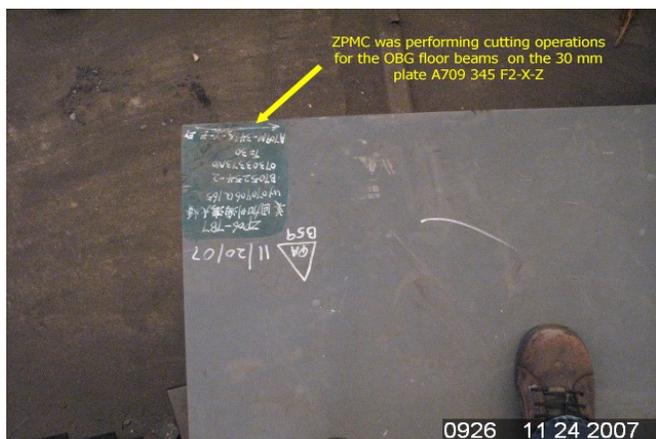
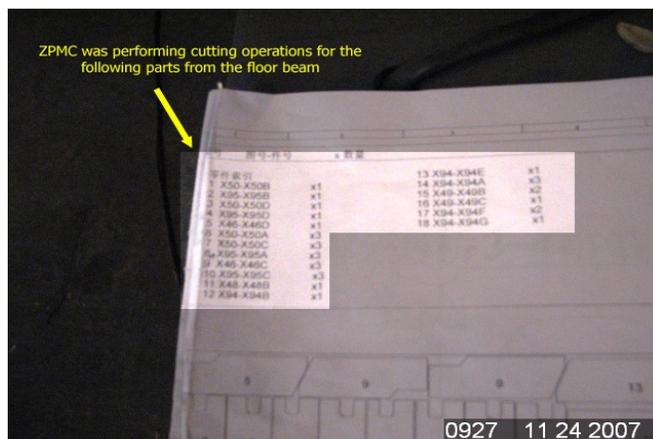
## 2 OBG Floor Beam Cutting operations

The QA inspector observed that ZPMC was performing cutting operations on the steel plate shown on digital photographs below.

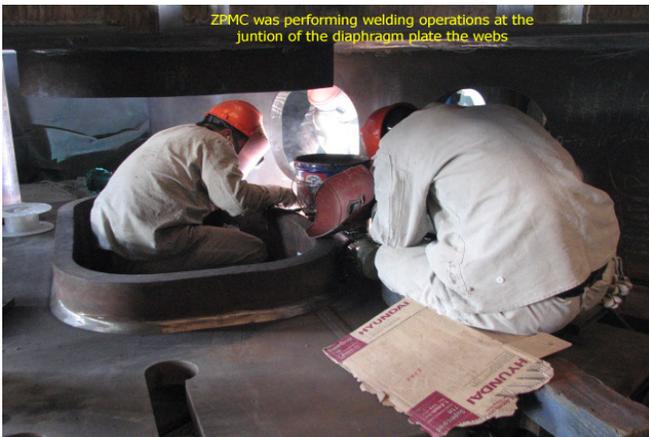
## 3 Tower Mock-up 77 Diaphragm welding

The QA inspector observed ZPMC welders Zhai Qingshan, Yang Lei, Ma Zhi Yong and Xu Wei performing welding operations with the shielded metal arc welding process (SMAW) at the junction of the SA-104 to web plates with a 4 mm diameter electrode designated as E9018 H4R. The QA inspector performed a random verifications of the welding parameters. The QA inspector found that the welding parameters appeared to be in general compliance with the contract documents.

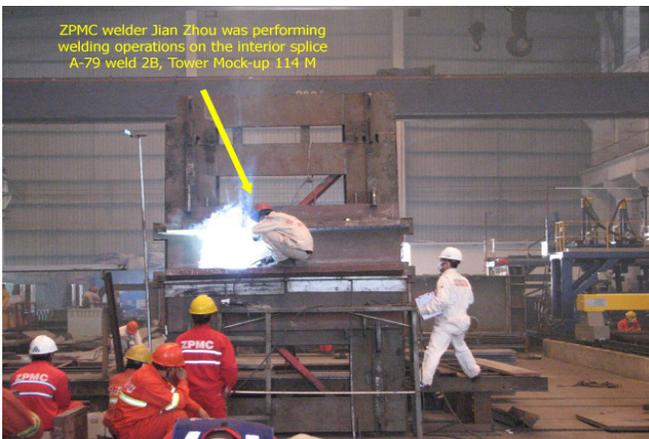
#### 4 Welding Interior splice A-79 Tower 114 M

The QA inspector observed ZPMC welder Jiang Zhou performing welding operations at the junction of the longitudinal stiffeners and the interior splice plate A-79, weld joint # 2B. The QA inspector performed a random verifications of the welding parameters. The QA found that the welding parameters appeared to be in general compliance with the contract documents.
