Quality Assurance and Source Inspection

Contract #: 04-0120F4Cty: SF/ALA Rte: 80 PM: 13.2/13.9File #: 69.28**WELDING INSPECTION REPORT****Resident Engineer:** Pursell, Gary**Address:** 333 Burma Road**City:** Oakland, CA 94607**Report No:** WIR-001122**Date Inspected:** 11-Dec-2007**Project Name:** SAS Superstructure**OSM Arrival Time:** 1400**Prime Contractor:** American Bridge/Fluor Enterprises, a JV**OSM Departure Time:** 2330**Contractor:** Zhenhua Port Machinery Company, Ltd (ZPMC), Changxing Island **Location:** Shanghai, China**CWI Name:** Chen Xi**CWI Present:** Yes No**Inspected CWI report:** Yes No N/A**Rod Oven in Use:** Yes No N/A**Electrode to specification:** Yes No N/A**Weld Procedures Followed:** Yes No N/A**Qualified Welders:** Yes No N/A**Verified Joint Fit-up:** Yes No N/A**Approved Drawings:** Yes No N/A**Approved WPS:** Yes No N/A**Delayed / Cancelled:** Yes No N/A**Bridge No:** 34-0006**Component:** 114 meter mock up assembly**Summary of Items Observed:**

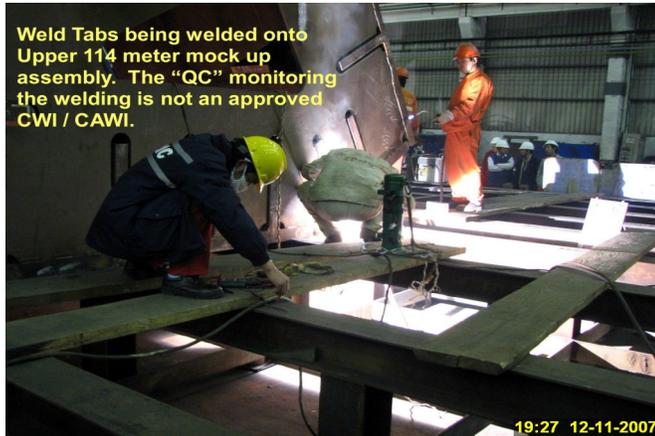
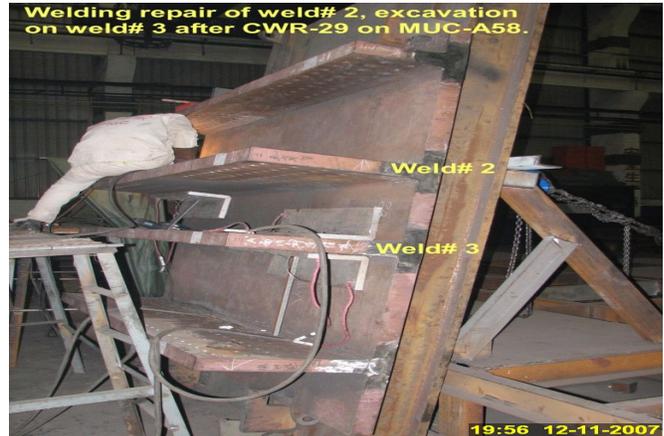
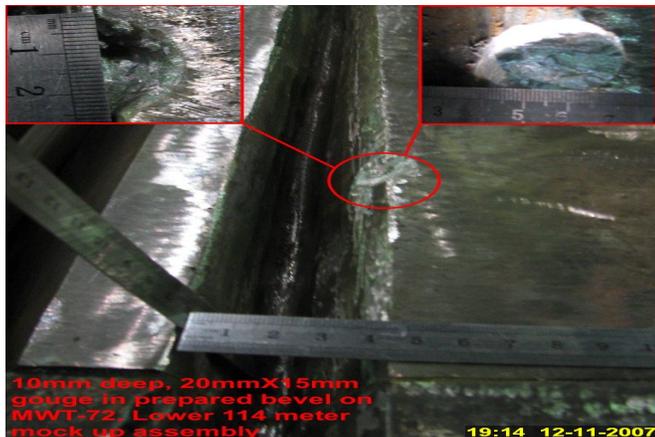
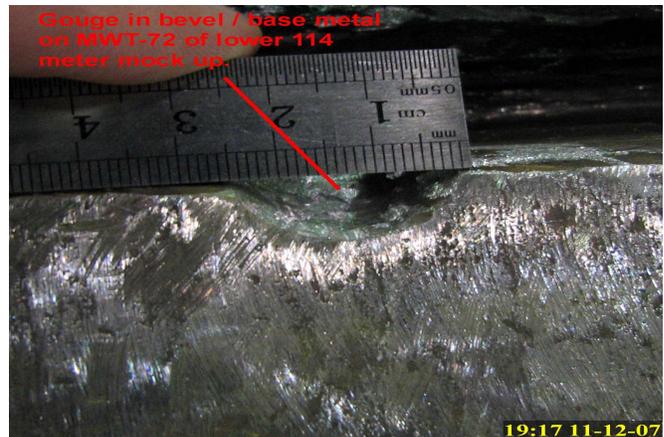
Bay 2: The QA inspector was making random observations of welds in various stages of completion and observed a large gouge in the base metal on the outside edge of weld joint MWT-72 on the lower 114 meter mock up assembly. The QA inspector noted that the gouge is located along the bevel of the weld joint and appears to have been caused by carbon arc gouging. The QA inspector measured the gouge to have approximate dimensions of 20mm long and 15mm deep with a rounded (bowl) shape from grinding. The QA inspector reviewed AWS D1.5 2002, section 3.2.3 and noted that this condition appears to require an approved base metal repair. The QA inspector could not locate any Quality Control (QC) personnel or ZPMC workers at this location when these observations were made.

The QA inspector observed temporary lifting lugs and weld tabs being welded onto the upper 114 meter mock up assembly. The QA inspector noted that shielded metal arc welding (SMAW) is being used by Li Zai Jun. The QA inspector noted that Zhen Hou Feng is monitoring the welding of the temporary lifting lugs and weld tabs. The QA inspector asked Zhen Hou Feng if he was a CWI or CAWI. Zhen Hou Feng replied that he was not a CWI or CAWI. The QA inspector asked if there was a CWI or CAWI monitoring this welding. The QA inspector was informed that Chen Xi was a CWI and he was monitoring the welding. The QA inspector noted that the approved CWI was across Bay 2 monitoring work that was being conducted on MUC-A58.

The QA inspector observed ZPMC workers making excavations on stiffener plate welds #2 and #3. The QA inspector spoke with the CWI Chen Xi to inquire about the work that was being conducted. The QA inspector was informed that weld repairs were being made. The QA inspector asked the CWI why there were weld repairs and the QA inspector was informed that ultrasonic testing (UT) by a ZPMC technician had discovered rejectable indications. The QA inspector asked to see the reports detailing where the excavations were being made. The QA inspector was shown paperwork relating to critical weld repair (CWR) 29 and the UT report that rejected welds #2 and #3. The QA inspector photographed these documents. The QA inspector reviewed the available CWR-29 documents and noted that there appears to be no approved revision of the repair of weld #3. The QA inspector noted that CWR-29 has been previously excavated and repaired.
