**DEPARTMENT OF TRANSPORTATION**

Contract #: 04-0120F4Cty: SF/ALA Rte: 80 PM: 13.2/13.9File #: 69.28**WELDING INSPECTION REPORT****Resident Engineer:** Pursell, Gary**Address:** 333 Burma Road**City:** Oakland, CA 94607**Report No:** WIR-001200**Date Inspected:** 27-Dec-2007**Project Name:** SAS Superstructure**OSM Arrival Time:** 930**Prime Contractor:** American Bridge/Fluor Enterprises, a JV**OSM Departure Time:** 1700**Contractor:** Zhenhua Port Machinery Company, Ltd (ZPMC), Changxing Island **Location:** Shanghai, China**CWI Name:** See Below**CWI Present:** Yes No**Inspected CWI report:** Yes No N/A**Rod Oven in Use:** Yes No N/A**Electrode to specification:** Yes No N/A**Weld Procedures Followed:** Yes No N/A**Qualified Welders:** Yes No N/A**Verified Joint Fit-up:** Yes No N/A**Approved Drawings:** Yes No N/A**Approved WPS:** Yes No N/A**Delayed / Cancelled:** Yes No N/A**Bridge No:** 34-0006**Component:** OBG**Summary of Items Observed:**

**Bay 3 OBG:**

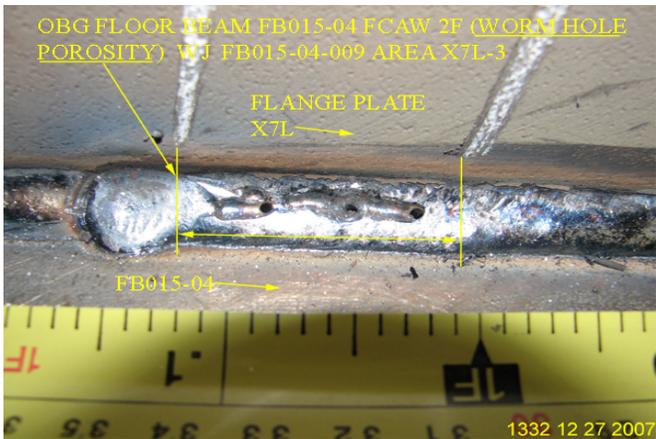
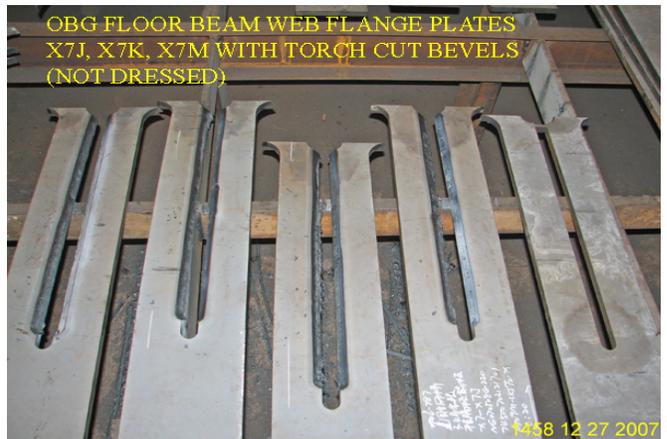
The QA Inspector randomly observed ZPMC welder Hong Shuili ID Number 044815, utilizing the FCAW Process with ZPMC approved WPS WPS-B-T-2232-TC-U4b-F-1 in the 2G position and WPS-B-T-2132-1 in the 2F position to tack weld Flange Plate X7J to Floor Beam Web FB001-04 on the outside and inside of Complete Joint Penetration (CJP) WJ FB001-04-043. WPS-B-T-2132-1 was being used to weld the reinforcing fillet weld on the inside of WJ FB001-04-043. The QA Inspector randomly observed ZPMC CWI Cui Yi Ru, monitoring weld parameters. The weld parameters appeared to comply with contract requirements. The attached photograph provides additional detail.

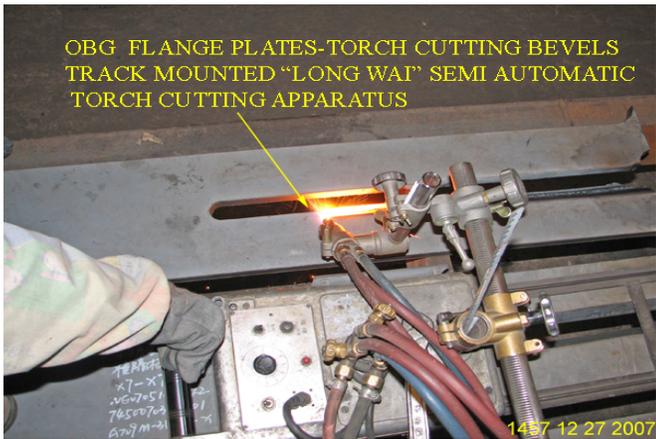
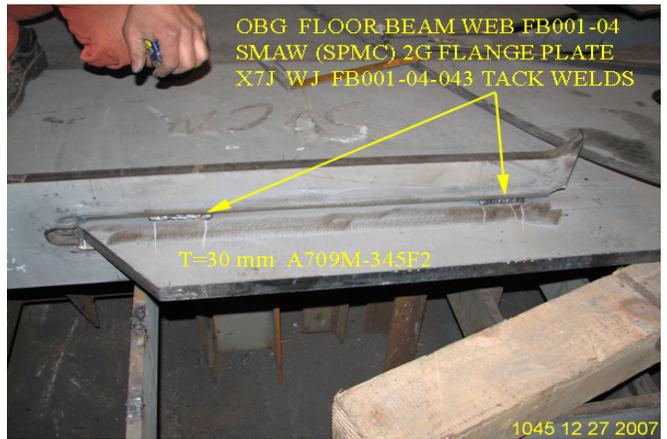
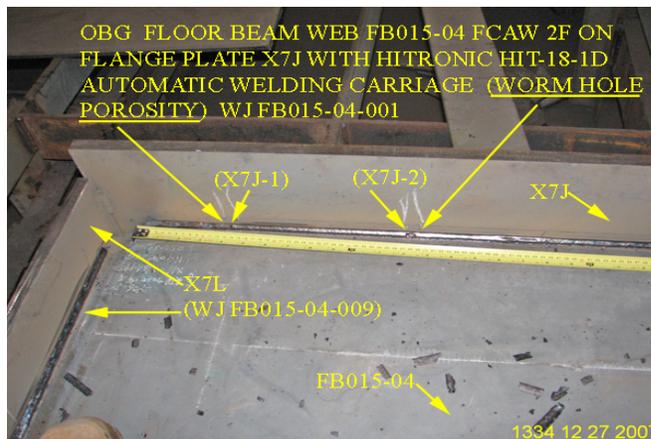
The QA Inspector randomly observed several areas of worm hole porosity in WJ's FB015-04-001 and FB015-04-009 attaching Flange Plates X7L and X7J to Floor Beam Web FB015-04. ZPMC CWI Cui Yi Ru informed the QA Inspector that WJ FB015-04-001 on Flange Plate X7J and WJ FB015-04-009 on Flange Plate X7L, were welded by ZPMC welder Yuan Wensong ID Number 055491, utilizing the FCAW Process with ZPMC approved WPS WPS-B-T-2132-2 in the 2F position utilizing a Hitronic HIT-18-1D Automatic Welding Carriages. The attached photographs provide additional detail.

The QA Inspector asked ZPMC CWI Cui Yi Ru why the FCAW welding on WJ's FB015-04-001, 009 was continued after the worm hole porosity was observed. Mr. Cui did not have an explanation for the QA Inspector.
