Contract #: 04-0120F4Cty: SF/ALA Rte: 80 PM: 13.2/13.9File #: 69.28**WELDING INSPECTION REPORT****Resident Engineer:** Pursell, Gary**Address:** 333 Burma Road**City:** Oakland, CA 94607**Report No:** WIR-001252**Date Inspected:** 10-Jan-2008**Project Name:** SAS Superstructure**OSM Arrival Time:** 1000**Prime Contractor:** American Bridge/Fluor Enterprises, a JV**OSM Departure Time:** 2300**Contractor:** Zhenhua Port Machinery Company, Ltd (ZPMC), Changxing Island **Location:** Shanghai, China**CWI Name:** See Below**CWI Present:** Yes No**Inspected CWI report:** Yes No N/A**Rod Oven in Use:** Yes No N/A**Electrode to specification:** Yes No N/A**Weld Procedures Followed:** Yes No N/A**Qualified Welders:** Yes No N/A**Verified Joint Fit-up:** Yes No N/A**Approved Drawings:** Yes No N/A**Approved WPS:** Yes No N/A**Delayed / Cancelled:** Yes No N/A**Bridge No:** 34-0006**Component:** OBG**Summary of Items Observed:**

Bay 2 Tower Mock Up:

89M Diaphragm/Skin Plate Assembly:

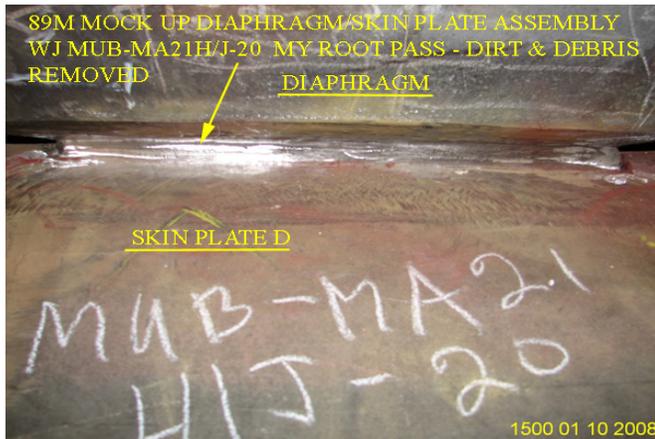
The QA Inspector utilized the Magnetic Particle Testing (MT) Method to perform a random 10% inspection of the root passes in Weld Joint (WJ) Numbers MUB-MA21H/J-14, 15, 16 and 17 of Skin Plates C and D to the 89M Diaphragm. There were no apparent indications. The attached photograph provides additional detail.

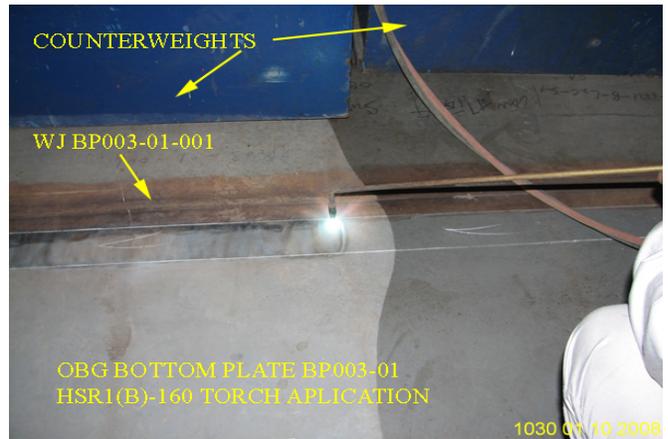
The QA Inspector randomly observed ZPMC personnel performing heat straightening operations on WJ BP003-01-001 per ZPMC HSR1(B)-160. The attached photograph provides additional detail.
