DEPARTMENT OF TRANSPORTATION

Quality Assurance and Source Inspection

Contract #: 04-0120F4Cty: SF/ALA Rte: 80 PM: 13.2/13.9File #: 69.28**WELDING INSPECTION REPORT****Resident Engineer:** Pursell, Gary**Address:** 333 Burma Road**City:** Oakland, CA 94607**Report No:** WIR-001309**Date Inspected:** 04-Jan-2008**Project Name:** SAS Superstructure**OSM Arrival Time:** 930**Prime Contractor:** American Bridge/Fluor Enterprises, a JV**OSM Departure Time:** 1700**Contractor:** Zhenhua Port Machinery Company, Ltd (ZPMC), Changxing Island **Location:** Shanghai, China**CWI Name:** See Below**CWI Present:** Yes No**Inspected CWI report:** Yes No N/A**Rod Oven in Use:** Yes No N/A**Electrode to specification:** Yes No N/A**Weld Procedures Followed:** Yes No N/A**Qualified Welders:** Yes No N/A**Verified Joint Fit-up:** Yes No N/A**Approved Drawings:** Yes No N/A**Approved WPS:** Yes No N/A**Delayed / Cancelled:** Yes No N/A**Bridge No:** 34-0006**Component:** OBG**Summary of Items Observed:**

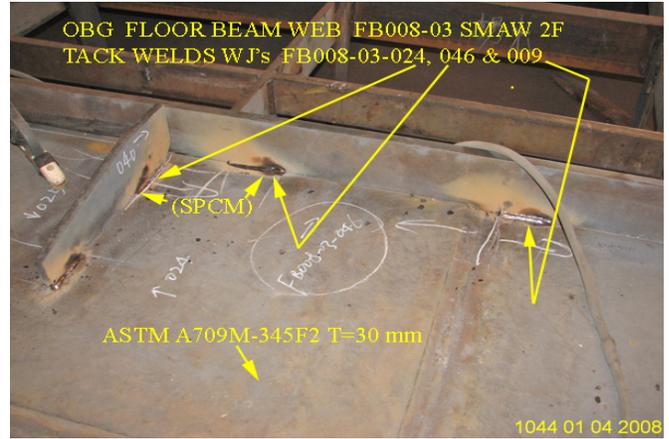
The QA Inspector randomly observed ZPMC welder Ren Jinzhu ID Number 044837, utilizing the SMAW Process with ZPMC approved WPS WPS-B-P-2112(FCM) in the 2F position to tack weld Flange Plate X2M (WJ's FB008-03-009, 046) and Gusset Type Stiffeners X3K and X3L to Floor Beam Web FB008-03. The QA Inspector randomly observed ZPMC CWI Cui Yi Ru, monitoring weld parameters. The weld parameters appeared to comply with contract requirements. The attached photograph provides additional detail.

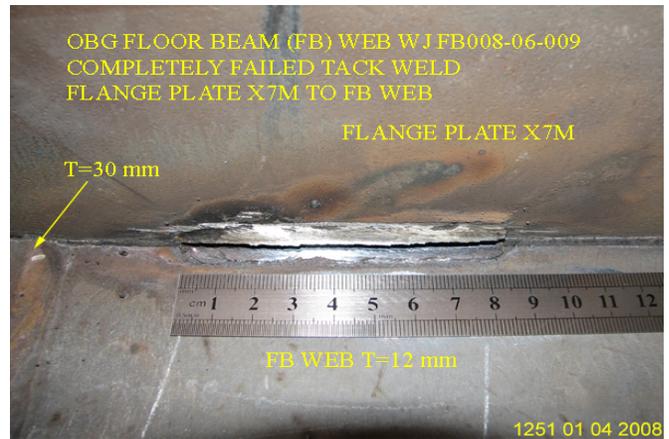
The QA Inspector randomly observed a completely failed tack weld in WJ FB008-06-009 attaching Flange Plate X7M to Floor Beam Web FB008-06. The QA Inspector informed ZPMC CWI Cui Yi Ru of the situation. The QA Inspector randomly observed the complete removal of the failed tack weld in WJ FB008-06-009. The attached photographs provide additional detail.
