DEPARTMENT OF TRANSPORTATION

Caltrans Quality Assurance (QA) Inspector, Mr. Paul Dawson, arrived on site at the Zhenhua Port Machinery Company (ZPMC) facility at Changxing Island, in Shanghai, China, for the purpose of monitoring welding and fabrication of the San Francisco / Oakland Bay Bridge (SFOBB) components. The QA Inspector observed the following:

Orthotropic Box Girder (OBG) and Tower Mock Up:

WELDING INSPECTION REPORT

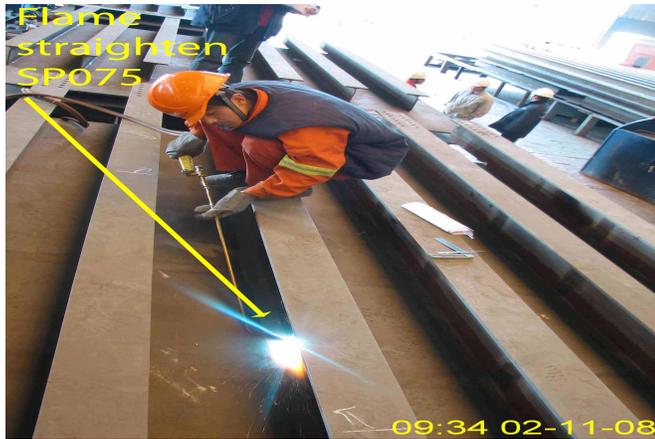
The QA Inspector observed ZPMC personnel perform heat straightening of OBG side plate SP075 stiffener plates as directed by HSR(B)-035. This HSR has been approved by Caltrans Engineering 01-30-2008. The QA inspector observed ZPMC Quality Control personnel monitoring the heat temperature using a laser indicating device and the maximum temperatures that had had recorded are all less than the maximum limit of 600°C. See the photograph below for additional information.

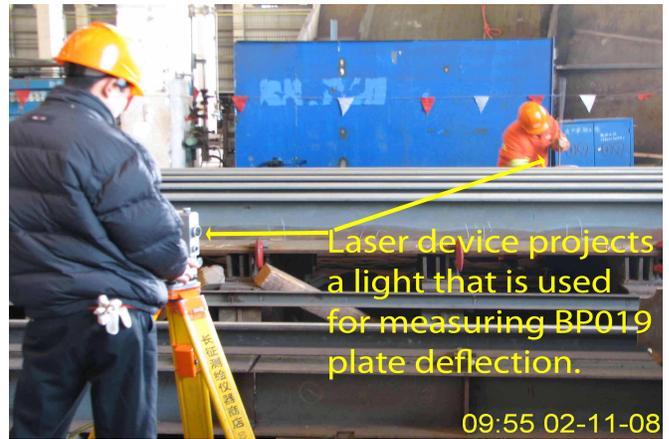
The QA Inspector observed base plate BP019 with stiffer plate welds BP019-01-013 through BP019-01-024 clamped into a precamber table adjacent at the west overhead gantry welding station. ZPMC personnel used a laser device to measure the amount of camber that has been made in BP019. One person is aiming the laser light and the second person is using a scale to measure the amount of plate deflection. ZPMC personnel used See the

photograph below for additional information.
