Contract #: 04-0120F4Cty: SF/ALA Rte: 80 PM: 13.2/13.9File #: 69.28**WELDING INSPECTION REPORT****Resident Engineer:** Pursell, Gary**Address:** 333 Burma Road**City:** Oakland, CA 94607**Report No:** WIR-001517**Date Inspected:** 19-Feb-2008**Project Name:** SAS Superstructure**OSM Arrival Time:** 1830**Prime Contractor:** American Bridge/Fluor Enterprises, a JV**OSM Departure Time:** 900**Contractor:** Zhenhua Port Machinery Company, Ltd (ZPMC), Changxing Island **Location:** Shanghai, China

WELDING INSPECTION REPORT

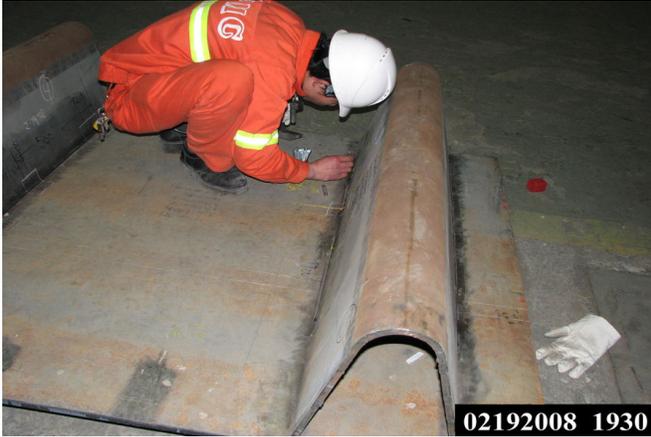
Item Description	WBS	Dwg No.	Status
1 corner 89M Mock-Up: Caltrans QA Inspector observed shield metal arc welding (SMAW) partial joint penetration (PJP) welding in progress. The assembly is identified weld joints are identified as MUB-MA21 J/J-16 & 17. The welders are identified as welder #070409063 and 066398, welding in the 3G (vertical position). The welders are using welding procedure specification WPS-B-T-4313-P5-12233-B-U2a-F, Revision 0. Caltrans QA observed ZPMC Quality Control (QC) Certified Welding Inspector (CWI) Mr. Sha Zhi monitoring welding activities at the workstation.	NA	NA	welding in progress
2 PMT location marking OBG Bay 1: Caltrans QA Inspector performed Visual Test (VT) examination on the welds for Production Monitoring Test (PMT) for deck plate DP059. Caltrans QA Inspector witnessed ZPMC Quality Control Inspector, Mr. Fu Yu hong identify locations for test specimen removal for specimen #1, 2 and 3, in accordance with Caltrans Special Provisions requirements. Caltrans QA Inspector identified locations test specimens 4 and 5 for removal. The specimen locations were marked with a paint stick for future removal. The following digital picture illustrates the identification marking of the test specimens.	NA	NA	ZPMC QC
