Contract #: 04-0120F4Cty: SF/ALA Rte: 80 PM: 13.2/13.9File #: 69.28**WELDING INSPECTION REPORT****Resident Engineer:** Pursell, Gary**Address:** 333 Burma Road**City:** Oakland, CA 94607**Report No:** WIR-001542**Date Inspected:** 27-Feb-2008**Project Name:** SAS Superstructure**OSM Arrival Time:** 600**Prime Contractor:** American Bridge/Fluor Enterprises, a JV**OSM Departure Time:** 1530**Contractor:** Zhenhua Port Machinery Company, Ltd (ZPMC), Changxing Island **Location:** Shanghai China**CWI Name:****CWI Present:** Yes No**Inspected CWI report:** Yes No N/A**Rod Oven in Use:** Yes No N/A**Electrode to specification:** Yes No N/A**Weld Procedures Followed:** Yes No N/A**Qualified Welders:** Yes No N/A**Verified Joint Fit-up:** Yes No N/A**Approved Drawings:** Yes No N/A**Approved WPS:** Yes No N/A**Delayed / Cancelled:** Yes No N/A**Bridge No:** 34-0006**Component:** Tower mock-up 89m**Summary of Items Observed:**

OBG Bay 1

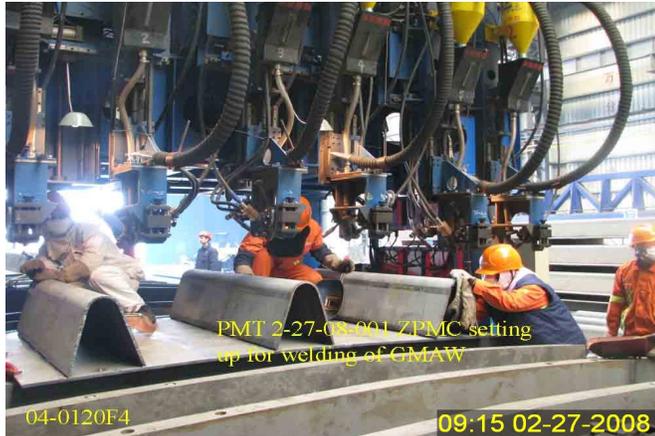
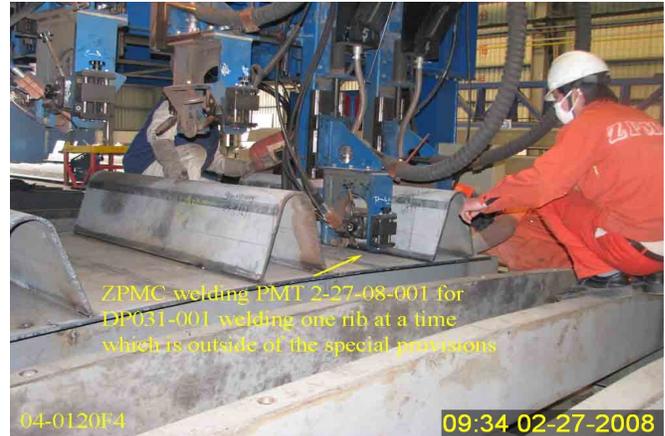
This Quality Control Inspector observed ZPMC performing Gas Metal Arc Welding (GMAW) process for orthotropic bridge deck number DP-031-001 with Production Monitoring Test plate (PMT) 2-27-08-01 (see digital photo below) The GMAW was performed on the PMT first for the root pass. ZPMC elected to run the welds one rib (2 welds) individually instead of simultaneously as stated in the special provisions (see digital photo below) an incident report will be generated for this process. This QA Inspector recorded all pertinent data associated with the welding (IE amps, volts, travel speed) that was recorded on the PMT inspection sheets. Once the PMT root pass was completed ZPMC proceeded to DP-031-001 for the production welding using GMAW root pass. Two zones were welded, zone A consisted of welds 1&2, 5&6 and 9&10 welded simultaneously. Zone B consisted of welds, 3&4 and 7&8. ZPMC, once the root pass was completed proceeded with the grinding of any irregularities associated with the tack welds that were welded over to bring the profile back into an acceptable range so as when the Submerged Arc Welding (SAW) process is ran the final weld should be with acceptable tolerances with profile size. Later in the shift this QA inspector observed Deck plate DP-018-001 placed at gantry number 1 behind the PMT. A verification of the root gap was performed and discovered that once the deck plate was secured to the reverse camber table that multiple areas were discovered to be great than the .5mm tolerance had allowed. This was brought to the attention of the SMR Ady Velasco by Task Leader Robert Ceullar and was relayed that the allowance was acceptable for the welding process due to being in the camber position. This QA inspector observed ZPMC setting up to weld the PMT with the SAW welding process it was observed by this QA inspector that ZPMC continued the same welding sequence welding one rib at a time as stated above.
