DEPARTMENT OF TRANSPORTATION

Quality Assurance and Source Inspection

Contract #: 04-0120F4Cty: SF/ALA Rte: 80 PM: 13.2/13.9File #: 69.28**WELDING INSPECTION REPORT****Resident Engineer:** Pursell, Gary**Address:** 333 Burma Road**City:** Oakland, CA 94607**Report No:** WIR-002027**Date Inspected:** 08-Feb-2008**Project Name:** SAS Superstructure**OSM Arrival Time:** 630**Prime Contractor:** American Bridge/Fluor Enterprises, a JV**OSM Departure Time:** 1500**Contractor:** Zhenhua Port Machinery Company, Ltd (ZPMC), Changxing Island **Location:** Shanghai, China**CWI Name:** Sun Wei, Xu Xianping**CWI Present:** Yes No**Inspected CWI report:** Yes No N/A**Rod Oven in Use:** Yes No N/A**Electrode to specification:** Yes No N/A**Weld Procedures Followed:** Yes No N/A**Qualified Welders:** Yes No N/A**Verified Joint Fit-up:** Yes No N/A**Approved Drawings:** Yes No N/A**Approved WPS:** Yes No N/A**Delayed / Cancelled:** Yes No N/A**Bridge No:** 34-0006**Component:** 89-meter Mock-Up, OBG Components**Summary of Items Observed:**

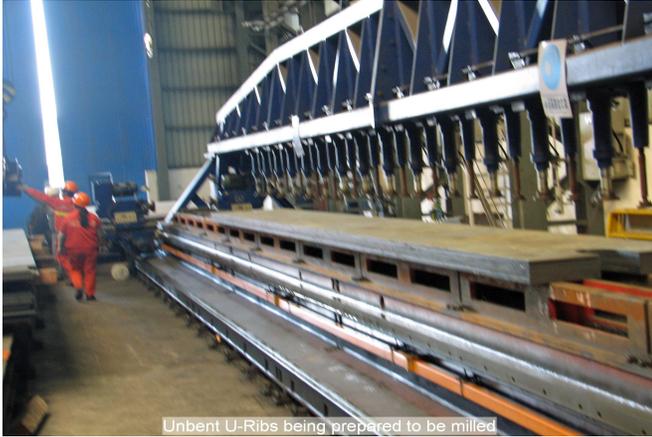
Bay 1) Z. P. M. C. personnel milled each edge of unbent U-Ribs simultaneously. Z. P. M. C. personnel, after drilling bolt holes, deburred the bolt hole edges and the edge of the cut out “U” section, then using a crane with a magnetic lift, moved and stacked the pieces, five (5) high.
