**DEPARTMENT OF TRANSPORTATION**

Contract #: 04-0120F4Cty: SF/ALA Rte: 80 PM: 13.2/13.9File #: 69.28**WELDING INSPECTION REPORT****Resident Engineer:** Pursell, Gary**Address:** 333 Burma Road**City:** Oakland, CA 94607**Report No:** WIR-001647**Date Inspected:** 09-Mar-2008**Project Name:** SAS Superstructure**OSM Arrival Time:** 600**Prime Contractor:** American Bridge/Fluor Enterprises, a JV**OSM Departure Time:** 1730**Contractor:** Zhenhua Port Machinery Company, Ltd (ZPMC), Changxing Island **Location:** Shanghai, China**CWI Name:** Sun Wei**CWI Present:** Yes No**Inspected CWI report:** Yes No N/A**Rod Oven in Use:** Yes No N/A**Electrode to specification:** Yes No N/A**Weld Procedures Followed:** Yes No N/A**Qualified Welders:** Yes No N/A**Verified Joint Fit-up:** Yes No N/A**Approved Drawings:** Yes No N/A**Approved WPS:** Yes No N/A**Delayed / Cancelled:** Yes No N/A**Bridge No:** 34-0006**Component:** OBG**Summary of Items Observed:**

## WELDING INSPECTION REPORT

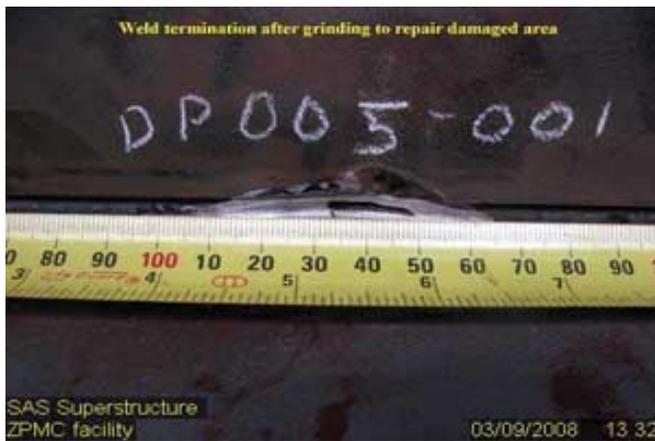
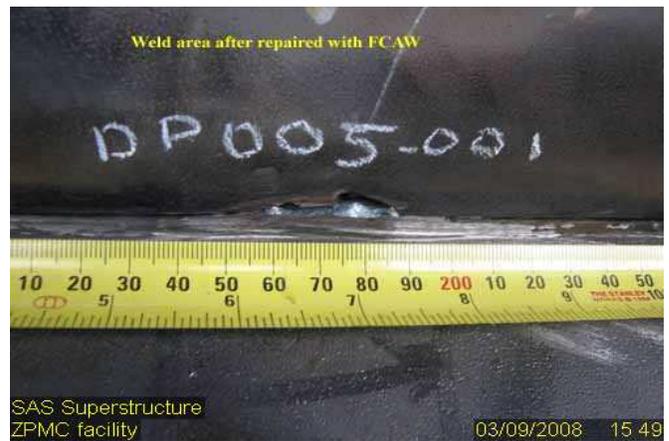
During the GMAW welding of DP-005-001 at gantry # 2 the mobile welding gantry for the welding of weld-6 on the panel hit one of the clamps used to hold the panel to the curved table. The welding arc undercut the base material prior to the welding being halted. The GMAW root pass on weld-6 was ground out for approximately 60mm. The grinding removed the root pass creating an opening beyond the allowed tolerance for root gap and greatly reduced the bevel angle. ZPMC used an unapproved welding procedure using Flux Cored Arc Welding FCAW in order to repair this area. See photograph below for additional information. An Incident Report is to be written on these issues.

Caltrans representatives observed rust areas tears and fins on weld joints prior to GMAW welding. Areas were shown to ZPMC personnel prior to welding.
