**DEPARTMENT OF TRANSPORTATION**

Contract #: 04-0120F4Cty: SF/ALA Rte: 80 PM: 13.2/13.9File #: 69.28**WELDING INSPECTION REPORT****Resident Engineer:** Pursell, Gary**Address:** 333 Burma Road**City:** Oakland, CA 94607**Report No:** WIR-001814**Date Inspected:** 22-Mar-2008**Project Name:** SAS Superstructure**OSM Arrival Time:** 600**Prime Contractor:** American Bridge/Fluor Enterprises, a JV**OSM Departure Time:** 1800**Contractor:** Zhenhua Port Machinery Company, Ltd (ZPMC), Changxing Island **Location:** Shanghai China**CWI Name:** Sun Wei and Hu Wei Ging**CWI Present:** Yes No**Inspected CWI report:** Yes No N/A**Rod Oven in Use:** Yes No N/A**Electrode to specification:** Yes No N/A**Weld Procedures Followed:** Yes No N/A**Qualified Welders:** Yes No N/A**Verified Joint Fit-up:** Yes No N/A**Approved Drawings:** Yes No N/A**Approved WPS:** Yes No N/A**Delayed / Cancelled:** Yes No N/A**Bridge No:** 34-0006**Component:** OBG deck panels and side panels**Summary of Items Observed:**

# WELDING INSPECTION REPORT

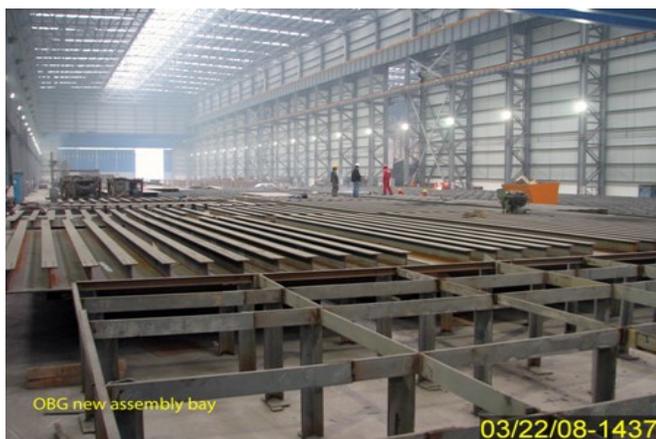
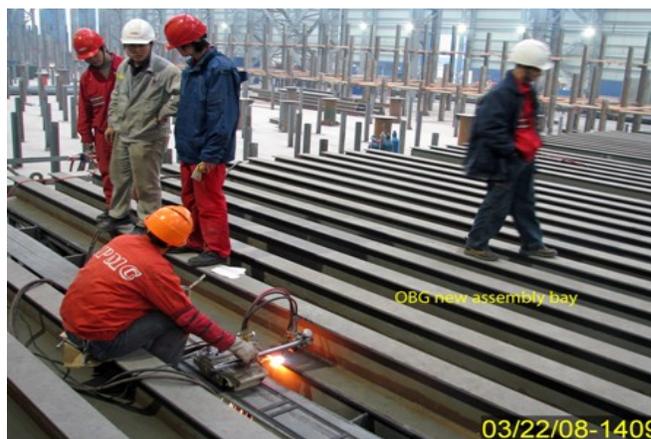
QA observed ZPMC personnel beveling OBG side panel plates in preparation for fit-up and welding. On this day there was no welding being performed in this area. QA took a random inventory of the OBG side panel segments that have the CJP splice joints completely welded. It is as follows:

- SEG-015A-001
- SEG-015A-003
- SEG-015A-005
- SEG-013A-012
- SEG-019A-020
- SEG-013A-017
- SEG-016A-004
- SEG-016A-006
- SEG-016A-002
- SEG-014A-012
- SEG-014A-017
- SEG-014A-006
