Contract #: 04-0120F4Cty: SF/ALA Rte: 80 PM: 13.2/13.9File #: 69.28**WELDING INSPECTION REPORT****Resident Engineer:** Pursell, Gary**Address:** 333 Burma Road**City:** Oakland, CA 94607**Report No:** WIR-001815**Date Inspected:** 21-Mar-2008**Project Name:** SAS Superstructure**OSM Arrival Time:** 1800**Prime Contractor:** American Bridge/Fluor Enterprises, a JV**OSM Departure Time:** 730**Contractor:** Zhenhua Port Machinery Company, Ltd (ZPMC), Changxing Island **Location:** Shanghai, China**CWI Name:****CWI Present:**

Bridge No: 34-0006**Component:** OBG Deck Plate**Summary of Items Observed:**

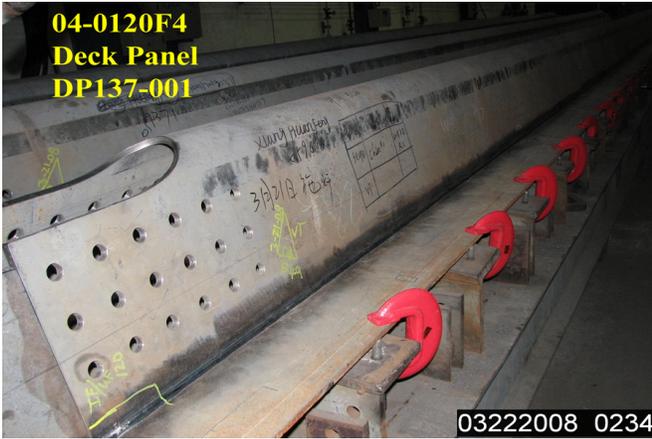
OBG Bay 1: Caltrans QA Inspector performed visual inspection of the completed submerged arc welding (SAW) cover pass welds; partial joint penetration (PJP) welds joining the closed ribs to deck plate panel DP137-001, u-rib U51, welds 1 & 2; u-rib U41, welds 3 & 4; u-rib U46, welds 5 & 6, u-rib U45 welds 7 & 8, u-rib U57 welds 9 & 10 and DP002-001, u-rib U74/25 weld 1, u-rib U149/27 welds 5 & 6 and u-rib U75/31 welds 7 & 8. However DP137-001, weld 3 SAW cover-pass weld was partially welded out. The weld was terminated at the 3050mm mark. DP002-002 weld 1, SAW cover-pass weld was also partially welded out. This weld was terminated at the 3255mm mark. The weld that were completed; Caltrans QA observed welding overlap, over size welds, underfill and incomplete fusion. These indications observed at the weld were marked in yellow paint stick along the distance from the "Y" axis, starting at the weld start too weld completion end. The weld indications observed were recorded on Caltrans spreadsheet for future reference. The following digital picture illustrates u-rib deck plate panel DP137-001.
