**DEPARTMENT OF TRANSPORTATION**

Contract #: 04-0120F4Cty: SF/ALA Rte: 80 PM: 13.2/13.9File #: 69.28**WELDING INSPECTION REPORT****Resident Engineer:** Pursell, Gary**Address:** 333 Burma Road**City:** Oakland, CA 94607**Report No:** WIR-001838**Date Inspected:** 22-Mar-2008**Project Name:** SAS Superstructure**OSM Arrival Time:** 600**Prime Contractor:** American Bridge/Fluor Enterprises, a JV**OSM Departure Time:** 2230**Contractor:** Zhenhua Port Machinery Company, Ltd (ZPMC), Changxing Island **Location:** Shanghai China**CWI Name:** Zhao Chen Sun**CWI Present:** Yes No**Inspected CWI report:** Yes No N/A**Rod Oven in Use:** Yes No N/A**Electrode to specification:** Yes No N/A**Weld Procedures Followed:** Yes No N/A**Qualified Welders:** Yes No N/A**Verified Joint Fit-up:** Yes No N/A**Approved Drawings:** Yes No N/A**Approved WPS:** Yes No N/A**Delayed / Cancelled:** Yes No N/A**Bridge No:** 34-0006**Component:** Tower/OBG**Summary of Items Observed:**

This Quality Assurance (QA) inspector arrived at ZPMC to perform observations of Self Anchored Suspension (SAS) Bridge for the SFOBB western span. Below is an account of the day's observation during the fabrication process at

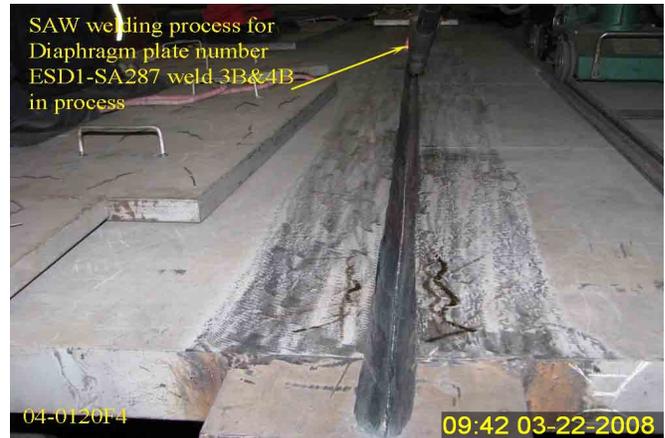
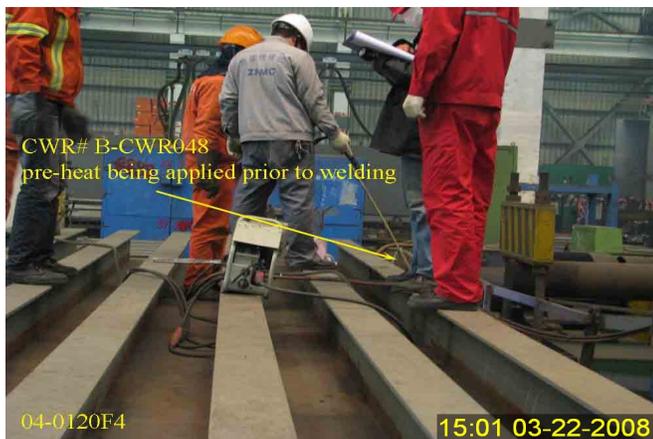
This QA inspector continued his observation at ZPMC in bay 4 for diaphragm plate splices. It was observed that diaphragm number ESD1-SA287 was being spliced together using a double V groove for the Complete Joint Penetration (CJP) weldment with Submerged Arc Welding (SAW) in the flat position. This QA inspector witnessed ZPMC's QC and CWI personnel monitoring the required preheat temperatures as required by WPS-B-T-3221-B-U3c-S-1 which has a high end of 230°C and a low end of 180°C. ZPMC welding personnel Gu Caihong was observed as operating the SAW system during the welding process and the welding parameters were verified by this QA inspector as 580 amps, 30 volts, and a travel speed of 488 mm/min. This is within the tolerances of the above stated WPS. This QA inspector observed ZPMC's CWI monitor the welding parameters and welding progression during this process. When ZPMC had approximately 21 passes completed they then turned the diaphragm plate over again to reduce the welding distortion. The joints being welded were 3A, 3B, 4A and 4B. ZPMC's QC/CWI that was present during this operation was Zhao Chen Sun along with an additional 6 QC personnel working in bay 4 monitoring the heat striating process of multiple diaphragm plate according to procedure HSR(T)-243. ZPMC personnel was observed grinding the lug weldments on the partial 89m mock up. No other welding or work was being performed for this component (see digital photo below). The above noted work appeared to be within general requirements of the contract document
