**DEPARTMENT OF TRANSPORTATION**

Contract #: 04-0120F4Cty: SF/ALA Rte: 80 PM: 13.2/13.9File #: 69.28**WELDING INSPECTION REPORT****Resident Engineer:** Pursell, Gary**Address:** 333 Burma Road**City:** Oakland, CA 94607**Report No:** WIR-001897**Date Inspected:** 23-Mar-2008**Project Name:** SAS Superstructure**OSM Arrival Time:** 1800**Prime Contractor:** American Bridge/Fluor Enterprises, a JV**OSM Departure Time:** 730**Contractor:** Zhenhua Port Machinery Company, Ltd (ZPMC), Changxing Island **Location:** Shanghai, China**CWI Name:****CWI Present:**

**Bridge No:** 34-0006**Component:** Deck Panels**Summary of Items Observed:**

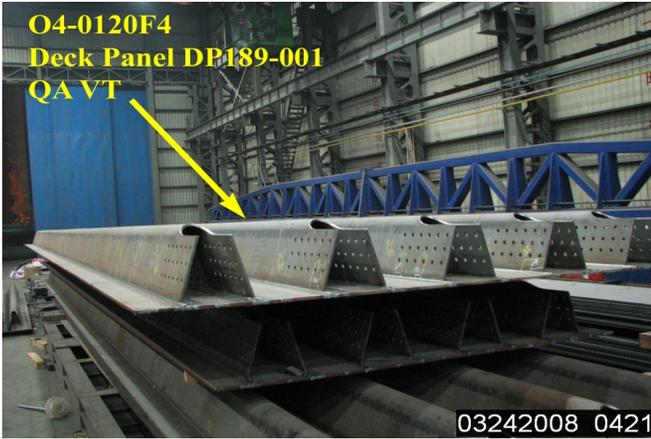
OBG Bay 1: Caltrans QA Inspector performed visual inspection of the completed submerged arc welding (SAW) cover pass welds; partial joint penetration (PJP) welds joining the closed ribs to deck plate panel DP189-001, u-rib U75, welds 1 & 2; u-rib U77, welds 3 & 4; u-rib U120, welds 5 & 6, u-rib U29 welds 7 & 8, u-rib U84 welds 9 & 10 and DP002-002, u-rib U125/44 welds 1 & 2, u-rib U160/43 weld 3 and u-rib U224/19 weld 8. Caltrans QA observed welding overlap, over size welds, underfill and incomplete fusion. These indications observed at the weld were marked in yellow paint stick along the distance from the "Y" axis, starting at the weld start to weld completion end. The weld indications observed were recorded on Caltrans spreadsheet for future reference. The following digital pictures illustrate u-rib deck plate panel DP189-001.
