**DEPARTMENT OF TRANSPORTATION**

Contract #: 04-0120F4Cty: SF/ALA Rte: 80 PM: 13.2/13.9File #: 69.28**WELDING INSPECTION REPORT****Resident Engineer:** Pursell, Gary**Address:** 333 Burma Road**City:** Oakland, CA 94607**Report No:** WIR-001937**Date Inspected:** 12-Apr-2008**Project Name:** SAS Superstructure**OSM Arrival Time:** 6300**Prime Contractor:** American Bridge/Fluor Enterprises, a JV**OSM Departure Time:** 1530**Contractor:** Zhenhua Port Machinery Company, Ltd (ZPMC), Changxing Island **Location:** Shanghai, China**CWI Name:** Li Yan Hua**CWI Present:** Yes No**Inspected CWI report:** Yes No N/A**Rod Oven in Use:** Yes No N/A**Electrode to specification:** Yes No N/A**Weld Procedures Followed:** Yes No N/A**Qualified Welders:** Yes No N/A**Verified Joint Fit-up:** Yes No N/A**Approved Drawings:** Yes No N/A**Approved WPS:** Yes No N/A**Delayed / Cancelled:** Yes No N/A**Bridge No:** 34-0006**Component:** OBG**Summary of Items Observed:**

# WELDING INSPECTION REPORT

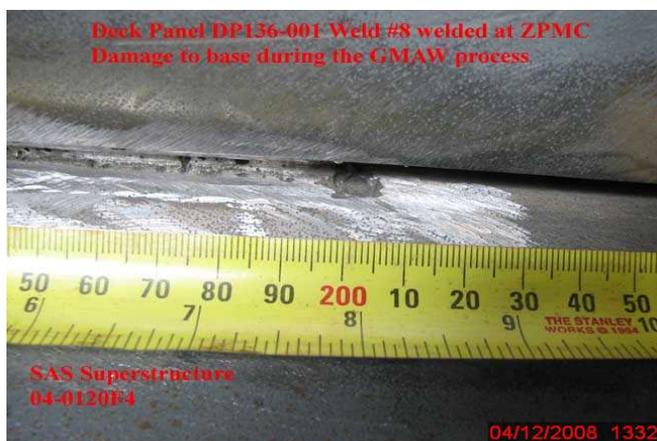
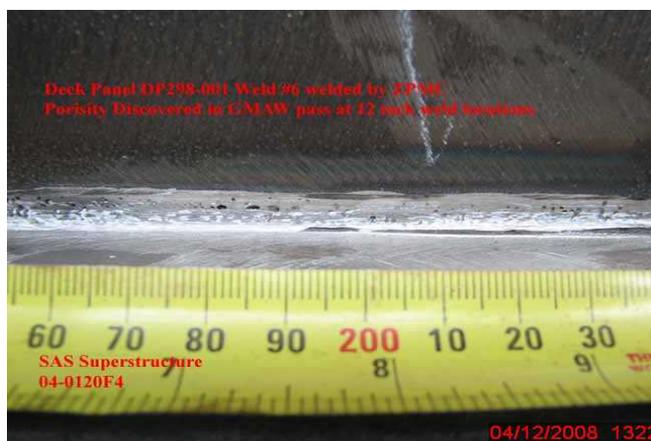
After completion of the GMAW welding on Production Panel DP298-001, ZPMC personnel performed welding utilizing GMAW process on DP136-001, on U-rib #U154 for wj #1 and wj #2, #U156for wj #3, wj #4, and #U170 for wj #5 and #6, #U171 for wj #7 and #8 and #U172 for wj #9 and #10. The following welders were observed welding production deck plate on closed U-ribs PJP welds, Mr. Gao Xin Dong welded wj #1, Mr. Jiang Ting Guang welded wj #2, Mr. Xiang Huan Feng welded wj #5, Mr. Xi De Hua welded wj #6, Mr. Xu Guo Yin welded wj #9 and Mr. Xiang Jie welded wj #10.. The welding variables of the GMAW pass on production panel closed U-ribs PJP welds were observed and recorded for each welder. The minimum and maximum weld parameters are as follows, amperage 356 to 378, and voltage 30.0 to 30.7 with a travel speed of 530mm/min. At the start of welding wj #3, wj #4, wj #7 and wj #8the entire weld length contained porosity and welding was halted on these welds. The porosity indications was also discovered in the base metal an attempt was being made to remove the damaged areas by grinding at the end of this inspectors shift. See photographs below for additional details.
