Contract #: 04-0120F4Cty: SF/ALA Rte: 80 PM: 13.2/13.9File #: 69.28**WELDING INSPECTION REPORT****Resident Engineer:** Pursell, Gary**Address:** 333 Burma Road**City:** Oakland, CA 94607**Report No:** WIR-002005**Date Inspected:** 17-Apr-2008**Project Name:** SAS Superstructure**OSM Arrival Time:** 2300**Prime Contractor:** American Bridge/Fluor Enterprises, a JV**OSM Departure Time:** 730**Contractor:** Zhenhua Port Machinery Company, Ltd (ZPMC), Changxing Island **Location:** Shanghai, China**CWI Name:** An Qing Xiang**CWI Present:** Yes No**Inspected CWI report:** Yes No N/A**Rod Oven in Use:** Yes No N/A**Electrode to specification:** Yes No N/A**Weld Procedures Followed:** Yes No N/A**Qualified Welders:** Yes No N/A**Verified Joint Fit-up:** Yes No N/A**Approved Drawings:** Yes No N/A**Approved WPS:** Yes No N/A**Delayed / Cancelled:** Yes No N/A**Bridge No:** 34-0006**Component:** Tower**Summary of Items Observed:**

Caltrans Quality Assurance (QA) Inspector, Mike Hasler was present to observe the fitup, welding and related activities associated with the fabricating of Caltrans Mock-up, 77M, 89M, 114M, Orthotropic Box Girders (OBG) and Tower, for the San Francisco Oakland Bay

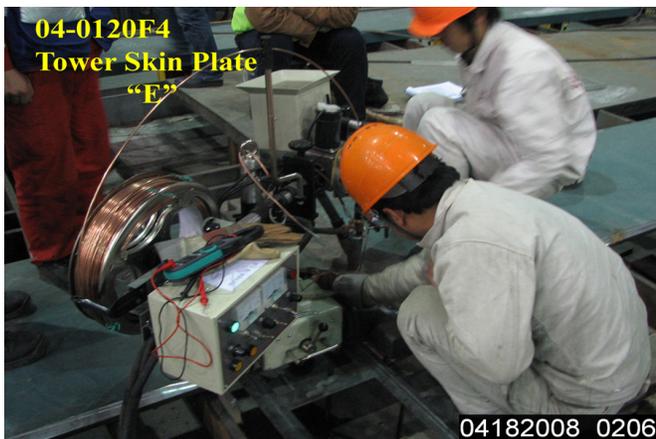
New Tower Shop Bay 2: ZPMC performed submerged arc welding (SAW), tower skin plate splice weld, joining plate P1303-1 (E) to P1318 (E) plate. The welder operator is identified as Mr. Xu Yian, welder stamp 040634, utilizing welding procedure WPS-B-T-2221-B-U3c-S; weld joint ESD1-SA216 A/K- 16B. Caltrans QA measured current welding parameters at approximately 660 amps, 33.0 volts and 590mm/min (millimeters per minute) travel speed.

Caltrans QA verified preheat and interpass temperatures during the welding activities. The preheat temperature prior to the start of welding measures more than 110 degrees Celsius but less than 230 degrees Celsius during maximum interpass temperature verification. Caltrans QA observed ZPMC QC inspector, Mr. An Qing Xiang and ABF Inspector, Mr. Li Han jie monitoring welding activities at the work station. The following digital picture illustrates welding in progress.

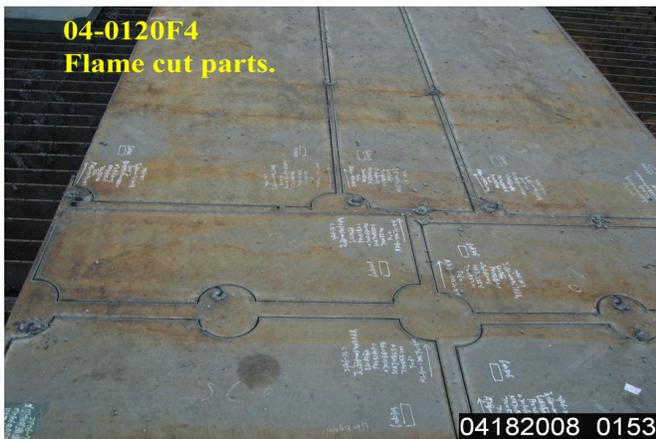
- 2 Tower Small Parts NA NA Flame Cut Parts
New Tower Shop Bay 1: Caltrans QA observed ZPMC shop worker flame cutting nested parts at the burn table for tower subassemblies identified as P229, P222 and P4. The following digital picture illustrates nested parts.
