Quality Assurance and Source Inspection

Contract #: 04-0120F4Cty: SF/ALA Rte: 80 PM: 13.2/13.9File #: 69.28**WELDING INSPECTION REPORT****Resident Engineer:** Pursell, Gary**Address:** 333 Burma Road**City:** Oakland, CA 94607**Report No:** WIR-002238**Date Inspected:** 05-May-2008**Project Name:** SAS Superstructure**OSM Arrival Time:** 1400**Prime Contractor:** American Bridge/Fluor Enterprises, a JV**OSM Departure Time:** 2300**Contractor:** Zhenhua Port Machinery Company, Ltd (ZPMC), Changxing Island **Location:** Shanghai, China**CWI Name:** Li yan hao/Chen Xi**CWI Present:** Yes No**Inspected CWI report:** Yes No N/A**Rod Oven in Use:** Yes No N/A**Electrode to specification:** Yes No N/A**Weld Procedures Followed:** Yes No N/A**Qualified Welders:** Yes No N/A**Verified Joint Fit-up:** Yes No N/A**Approved Drawings:** Yes No N/A**Approved WPS:** Yes No N/A**Delayed / Cancelled:** Yes No N/A**Bridge No:** 34-0006**Component:** Deck Panels**Summary of Items Observed:**

WELDING INSPECTION REPORT

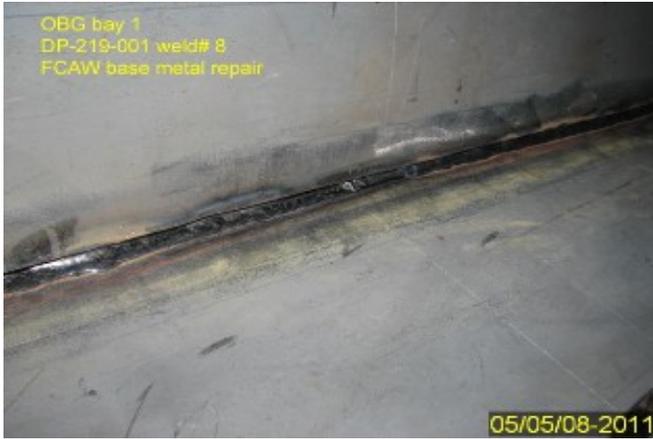
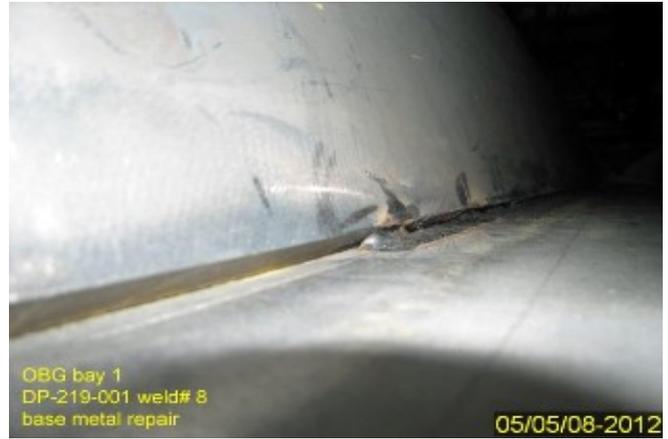
QA observed ZPMC qualified welding personnel perform the GMAW and SAW welds joining the closed U-Ribs to deck panels DP-219-001 and DP-192-001. QA observed 3 ZPMC QC inspectors in the vicinity of the welding operations including ZPMC CWI's identified as Li yan hao and Chen Xi. There were also 3 American Bridge/Fluor (ABF) inspectors in the area as well.

Upon returning from lunch QA observed ZPMC welding personnel performing weld repairs on weld# 8 deck panel DP-219-001 GMAW root pass using the FCAW process and following the guide lines of repair WPS-345-FCAW-1G-(1F)-1. According to ZPMC CWI identified as Chen Xi, during the Visual Testing (VT) of the GMAW root pass on this weld an area of porosity measuring approximately 1660mm in length was discovered approximately 900mm from the opposite end of the weld designated "Y". The weld and some of the base metal was removed by grinding and the base metal was being repaired per the above mentioned repair WPS. The GMAW weld itself would be repaired using the Gantry and the GMAW process. However, there is not an approved procedure to perform this repair. QA informed ZPMC CWI identified as Chen Xi that an incident would be forth coming concerning this issue.
