DEPARTMENT OF TRANSPORTATION

Quality Assurance and Source Inspection

Contract #: 04-0120F4Cty: SF/ALA Rte: 80 PM: 13.2/13.9File #: 69.28**WELDING INSPECTION REPORT****Resident Engineer:** Pursell, Gary**Address:** 333 Burma Road**City:** Oakland, CA 94607**Report No:** WIR-002415**Date Inspected:** 01-May-2008**Project Name:** SAS Superstructure**OSM Arrival Time:** 700**Prime Contractor:** American Bridge/Fluor Enterprises, a JV**OSM Departure Time:** 1700**Contractor:** Zhenhua Port Machinery Company, Ltd (ZPMC), Changxing Island **Location:** Shanghai, China

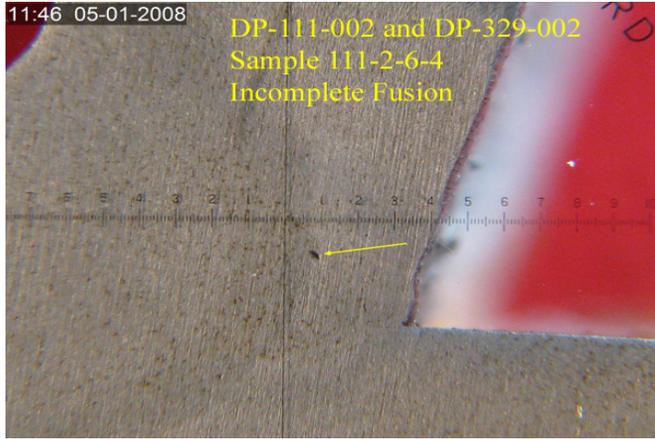
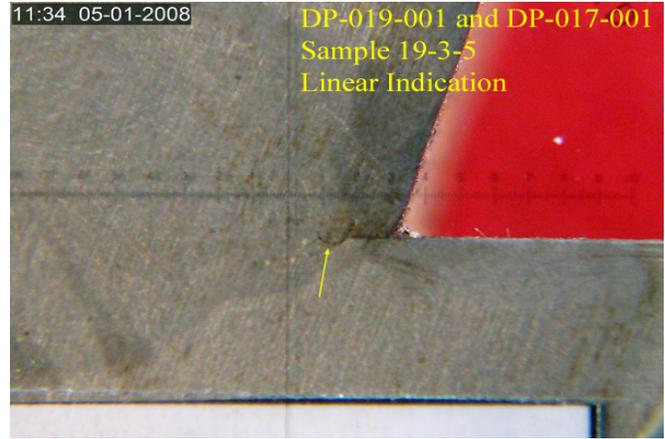
The Quality Assurance Inspector performed a visual inspection of two sets of production monitoring tests (PMT) macro etch samples, identified as DP-019-001/DP-017-001 and DP-111-002/DP-329-001. The PMT's were welded on 2-25-2008 and 4-29-2008. All samples appeared to contain penetration greater than 80 percent. The Quality Assurance Inspector observed two samples that contained Incomplete fusion and two with linear indications. All the data from the review was recorded in a tracking log and forwarded to Quality Assurance Task Leaders and Structural Materials Representatives. The Samples were digitally photographed and placed on the internal server for future review. Below are two digital photographs of a sample with a linear indication and one with what appears to be lack of fusion.
