DEPARTMENT OF TRANSPORTATION

Contract #: 04-0120F4Cty: SF/ALA Rte: 80 PM: 13.2/13.9File #: 69.28**WELDING INSPECTION REPORT****Resident Engineer:** Pursell, Gary**Address:** 333 Burma Road**City:** Oakland, CA 94607**Report No:** WIR-002500**Date Inspected:** 08-May-2008**Project Name:** SAS Superstructure**OSM Arrival Time:** 1500**Prime Contractor:** American Bridge/Fluor Enterprises, a JV**OSM Departure Time:** 2230**Contractor:** Zhenhua Port Machinery Company, Ltd (ZPMC), Changxing Island **Location:** Shanghai, China**CWI Name:** Wang SaiFa, Lu Li Qing**CWI Present:** Yes No**Inspected CWI report:** Yes No N/A**Rod Oven in Use:** Yes No N/A**Electrode to specification:** Yes No N/A**Weld Procedures Followed:** Yes No N/A**Qualified Welders:** Yes No N/A**Verified Joint Fit-up:** Yes No N/A**Approved Drawings:** Yes No N/A**Approved WPS:** Yes No N/A**Delayed / Cancelled:** Yes No N/A**Bridge No:** 34-0006**Component:** Tower/OBG**Summary of Items Observed:**

WELDING INSPECTION REPORT

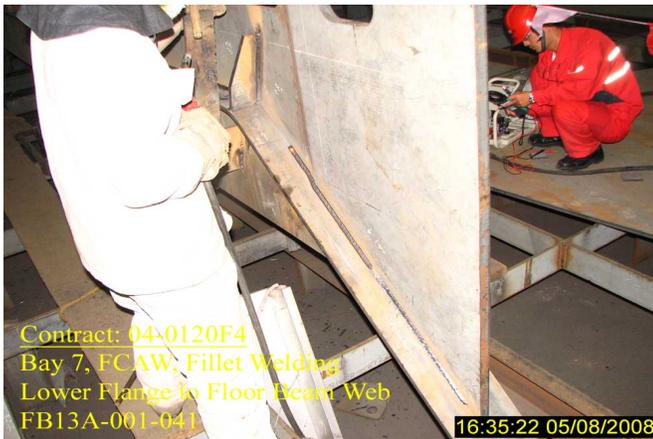
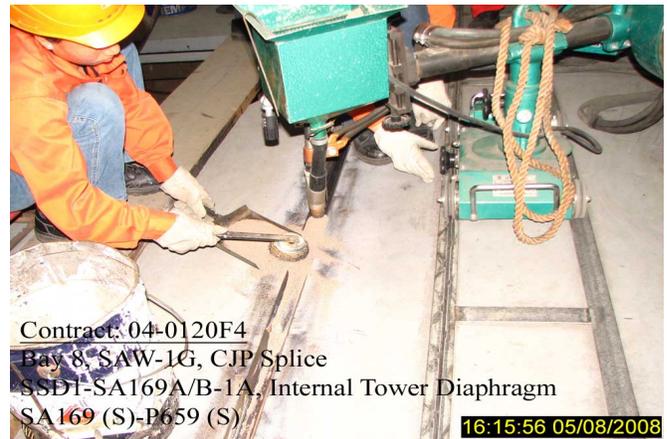
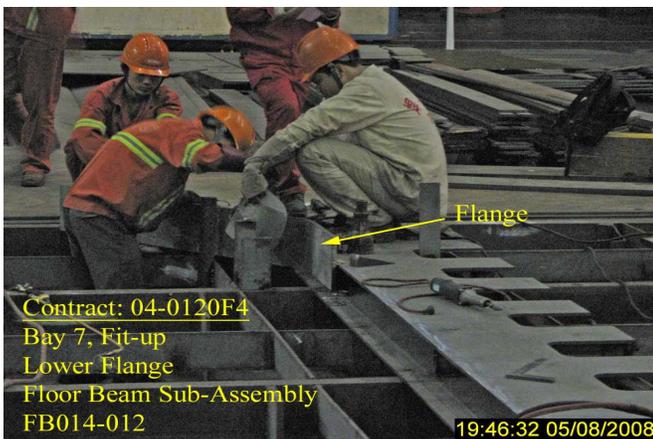
The QA Inspector randomly observed in process submerged arc welding (SAW) at one location for internal tower diaphragm plate designation SSD1-SA169A/B-1A, SA169(S) to P659(S). At the time of observation the QA Inspector observed ZPMC welding personnel Xu Pei Pei, welder ID #050323 utilizing the SAW process in the flat (1G) position with LA-85, 4.8mm diameter electrode to weld the complete joint penetration (CJP) weld splice.

The QA Inspector performed random observations to bay 7 and observed ZPMC personnel in multiple locations performing fit-up, tack welding and production welding on various floor beam sub-assemblies. The QA Inspector observed in-process fillet welding for floor beam sub-assembly FB13A-001-041. The QA Inspector identified the

welder as Zhang Qing Quan, weld identification 044774. Mr. Zhang Qing Quan was in the process of welding the lower flange to the diaphragm plate with the Flux Cored Arc Welding (FCAW) process with Supercored 71H, 1.4mm diameter electrode. The electrical welding parameters, travel speed and interpass temperature were recorded by ZPMC CWI personnel Wang Sai Fa and the WPS used for this application is WPS-B-T-2133. The welder was observed using proper interpass cleaning methods with a slag hammer and wire brush. The work in progress appeared to comply with the noted WPS and the contract specifications.

Also in bay 7 the QA Inspector observed ZPMC welding personnel Xie Jin Xia utilizing the FCAW process in the flat position with Supercored 71H, 1.4mm diameter electrode to perform tack welding operations for a CJP weld splice on diaphragm plate FB011-001. ZPMC was performing the welding to the requirements of WPS-B-T-2231-B-U2-F-1. The QA Inspector observed ZPMC CWI personnel Li Zhi Jiang monitoring the electrical welding parameters, travel speed and interpass temperature. The welder was observed using proper interpass cleaning methods with a slag hammer and a wire brush. The work in progress appeared to comply with the noted WPS and the contract specifications.
