Contract #: 04-0120F4Cty: SF/ALA Rte: 80 PM: 13.2/13.9File #: 69.28**WELDING INSPECTION REPORT****Resident Engineer:** Pursell, Gary**Address:** 333 Burma Road**City:** Oakland, CA 94607**Report No:** WIR-002660**Date Inspected:** 22-May-2008**Project Name:** SAS Superstructure**OSM Arrival Time:** 700**Prime Contractor:** American Bridge/Fluor Enterprises, a JV**OSM Departure Time:** 1700**Contractor:** Zhenhua Port Machinery Company, Ltd (ZPMC), Changxing Island **Location:** Shanghai, China**CWI Name:** Sun Wei**CWI Present:** Yes No**Inspected CWI report:** Yes No N/A**Rod Oven in Use:** Yes No N/A**Electrode to specification:** Yes No N/A**Weld Procedures Followed:** Yes No N/A**Qualified Welders:** Yes No N/A**Verified Joint Fit-up:** Yes No N/A**Approved Drawings:** Yes No N/A**Approved WPS:** Yes No N/A**Delayed / Cancelled:** Yes No N/A**Bridge No:** 34-0006**Component:** OBG**Summary of Items Observed:**

Production Monitoring Test

WELDING INSPECTION REPORT

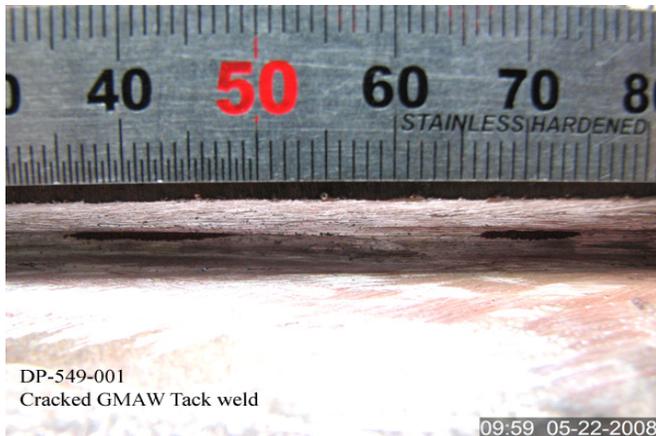
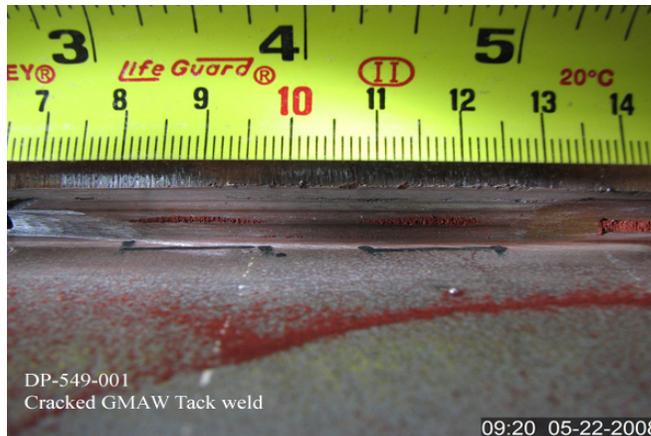
The previous day, the Quality Assurance Inspector randomly performed a visual inspection of the closed rib partial joint penetration tack welds. The Quality Assurance marked 15 tack welds which contained cracked tack welds. ZPMC ground the welds and Quality Control Inspector Sun Wei stated the indications were removed. The Quality Assurance Inspector asked if ZPMC performed magnetic particle verification to the repaired cracks. Sun Wei stated they have not but will do prior to welding. The Quality Assurance Inspector witnessed ZPMC magnetic particle technician Wang Wei perform magnetic particle testing to only the 15 tack welds marked by the Quality Assurance Inspector. Of the 15 marked, 12 still contained linear indications indicative of cracks. ZPMC ground the indications and retested. Below are digital photographs of the magnetic particle indications.
