Contract #: 04-0120F4Cty: SF/ALA Rte: 80 PM: 13.2/13.9File #: 69.28**WELDING INSPECTION REPORT****Resident Engineer:** Pursell, Gary**Address:** 333 Burma Road**City:** Oakland, CA 94607**Report No:** WIR-002843**Date Inspected:** 05-Jun-2008**Project Name:** SAS Superstructure**OSM Arrival Time:** 2300**Prime Contractor:** American Bridge/Fluor Enterprises, a JV**OSM Departure Time:** 730**Contractor:** Zhenhua Port Machinery Company, Ltd (ZPMC), Changxing Island **Location:** Shanghai, China**CWI Name:** Jiang Jian Fei**CWI Present:** Yes No**Inspected CWI report:** Yes No N/A**Rod Oven in Use:** Yes No N/A**Electrode to specification:** Yes No N/A**Weld Procedures Followed:** Yes No N/A**Qualified Welders:** Yes No N/A**Verified Joint Fit-up:** Yes No N/A**Approved Drawings:** Yes No N/A**Approved WPS:** Yes No N/A**Delayed / Cancelled:** Yes No N/A**Bridge No:** 34-0006**Component:** Tower, OBG**Summary of Items Observed:**

WELDING INSPECTION REPORT

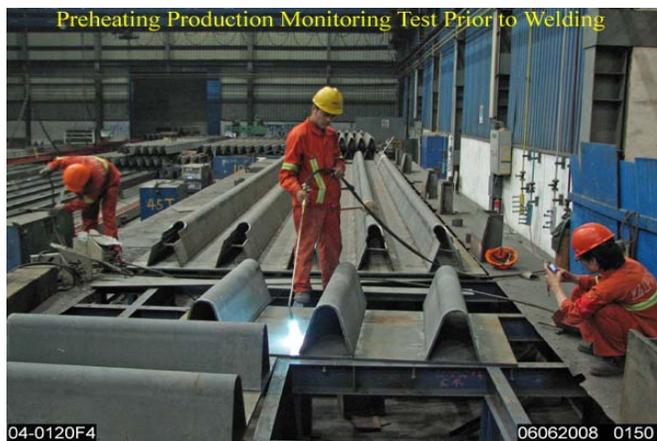
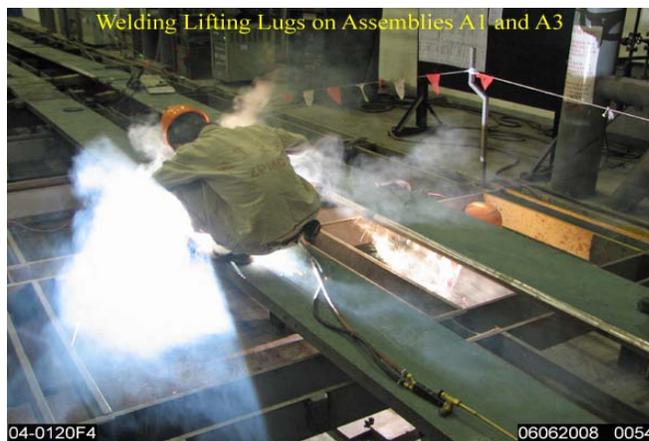
OBG Shop 1

The Caltrans QA Inspector also randomly observed the gas metal arc welding of tack welds joining U-ribs to deck plate for production monitoring tests (PMT's). Two assemblies of three ribs each were observed being welded in the horizontal groove (2G) position. No ZPMC QC or QA personnel were present during this welding. The tack welder was Liu Xiaomin and the WPS posted at the work location was WPS-B-T-2342-U2 (u-rib). The QA Inspector measured the voltage and amperage; and verified the gas flow rate, the electrode type (ER70S-6) and electrode diameter (1.2 mm). The measured amperage was 230-240. The specified range on the WPS was 320-350. This did not appear to meet the WPS requirements. An Incident Report was drafted and e-mailed to Jim Cochran, Caltrans Task Leader.
