DEPARTMENT OF TRANSPORTATION

Contract #: 04-0120F4Cty: SF/ALA Rte: 80 PM: 13.2/13.9File #: 69.28**WELDING INSPECTION REPORT****Resident Engineer:** Pursell, Gary**Address:** 333 Burma Road**City:** Oakland, CA 94607**Report No:** WIR-003091**Date Inspected:** 27-Jun-2008**Project Name:** SAS Superstructure**OSM Arrival Time:** 1000**Prime Contractor:** American Bridge/Fluor Enterprises, a JV**OSM Departure Time:** 2000**Contractor:** Zhenhua Port Machinery Company, Ltd (ZPMC), Changxing Island **Location:** Shanghai, China**CWI Name:** Chen Chih-Ming**CWI Present:** Yes No**Inspected CWI report:** Yes No N/A**Rod Oven in Use:** Yes No N/A**Electrode to specification:** Yes No N/A**Weld Procedures Followed:** Yes No N/A**Qualified Welders:** Yes No N/A**Verified Joint Fit-up:** Yes No N/A**Approved Drawings:** Yes No N/A**Approved WPS:** Yes No N/A**Delayed / Cancelled:** Yes No N/A**Bridge No:** 34-0006**Component:** OBG side, bottom and deck panels**Summary of Items Observed:**

WELDING INSPECTION REPORT

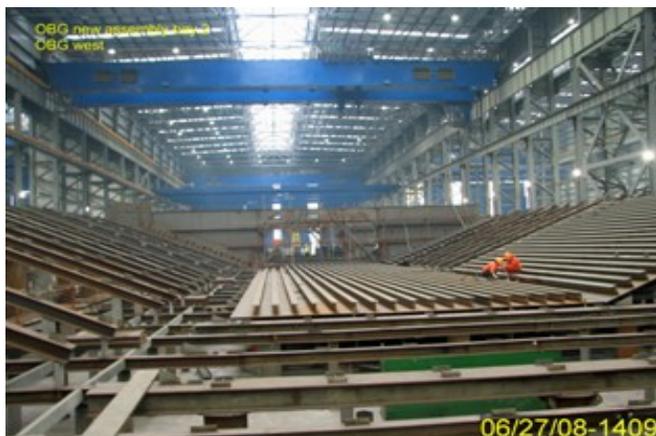
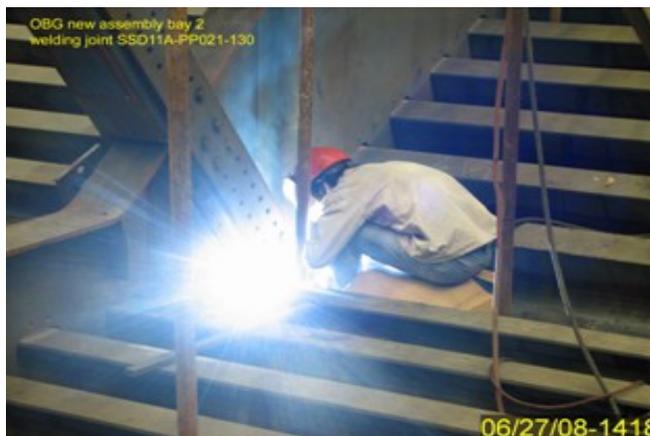
QA observed ZPMC qualified welding personnel perform SAW on SEG-025A-006 BP-031 to BP-139 following the guide lines of WPS# WPS-B-T-2221-B-L2c-S-1. QC monitored the welding process continuously throughout the evening. The welding parameters as measured with Quality Controls calibrated instruments appeared to be in conformance with the posted WPS's and were as follows:

QA observed ZPMC qualified welding personnel perform FCAW 3G welding on floor beam @ PP-021 FL2-1 to FL1 south joint# SSD11A-PP021-130 and FL2-1 to FL1 north joint# SSD11A-PP021-013 following the guide lines of WPS# WPS-B-T-2233-B-U2-F. QC monitored the welding process continuously throughout the evening. The welding parameters as measured with Quality Controls calibrated instruments appeared to be in conformance with the posted WPS's and were as follows:

QA performed 10% Ultrasonic Testing (UT) verification on the following floor beam weld joints on segment 4AW: FB-001-PP025-021 and 026 / FB-004-PP025-002 and 020, FB-003-PP025-010, 022, 034 and 046. All welds examined appeared to be compliant with AWS D1.5 2002 and the contract documents.
