**DEPARTMENT OF TRANSPORTATION**

Contract #: 04-0120F4Cty: SF/ALA Rte: 80 PM: 13.2/13.9File #: 69.28**WELDING INSPECTION REPORT****Resident Engineer:** Pursell, Gary**Address:** 333 Burma Road**City:** Oakland, CA 94607**Report No:** WIR-003472**Date Inspected:** 07-Aug-2008**Project Name:** SAS Superstructure**OSM Arrival Time:** 630**Prime Contractor:** American Bridge/Fluor Enterprises, a JV**OSM Departure Time:** 1530**Contractor:** Zhenhua Port Machinery Company, Ltd (ZPMC), Changxing Island **Location:** Shanghai, China

## WELDING INSPECTION REPORT

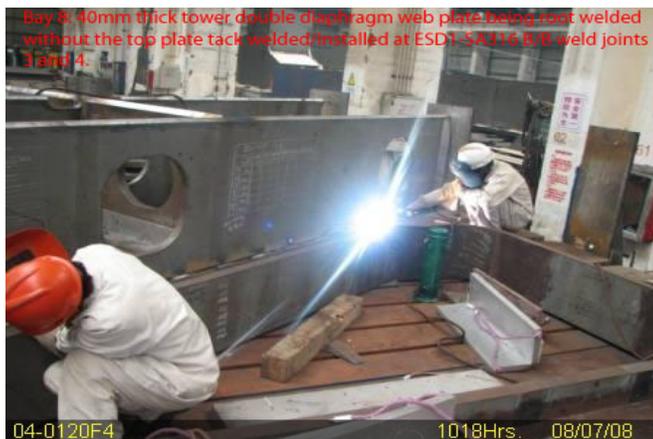
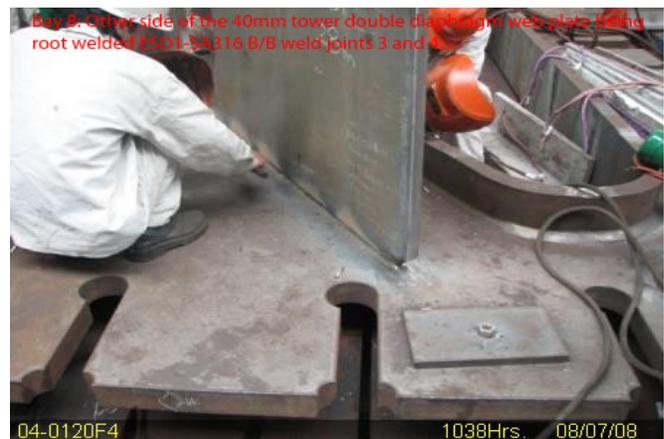
This QA observed SMAW(2G) welding root pass on 40mm web plate to tower diaphragm plate (bottom) ESD1-SA316 B/B weld joints 3 and 4 without tacking/installing the top diaphragm plate violating steps 2 and 3 of the Fabrication Procedure reference drawing number FP-MUA-20. With this infraction, incident report was issued against ZPMC.
